COLORADO CULTURAL RESOURCES INVENTORY

Historical and Architectural Reconnaissance

1. Property Name: St. John's Episcopal Chur	<u>ch</u>	⊠ Histor	ric 🛛 🗆 Current	□ Other:			
2. Resource Classification: 🛛 🖾 Building	□ Structure	Object	□ Sites/Landsc	ape

3. Ownership: \Box Federal \Box State	□ Local	🛛 Non-profit	Private	Unknown			
LOCATION 4. Street Address: <u>100 East Main Street</u>							
5. Municipality: New Castle, CO		□ Vicinity:

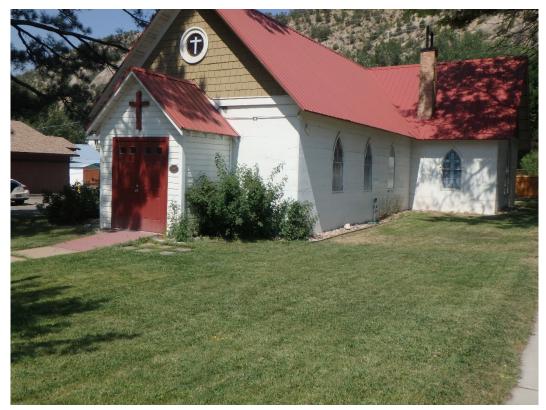
Photo Number: 5GF.2368_1

Description: Looking at the primary (south) and east elevations of the building. Note the historic brick masonry chimney; exposed rafter tails under the eaves; and the gothic arch window units. Date: 9/6/2022

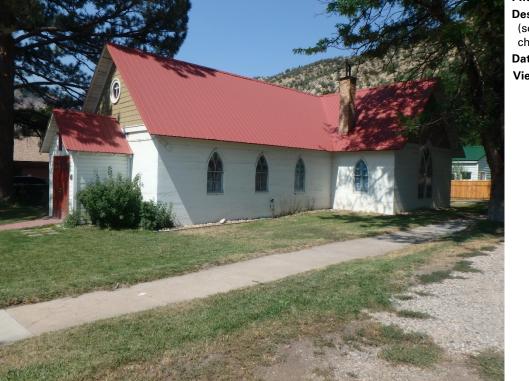
Photo Number: 5GF.2368_2 Description: Looking at the primary (south) and east elevations of the church. Date: 9/6/2022 View: Northwest

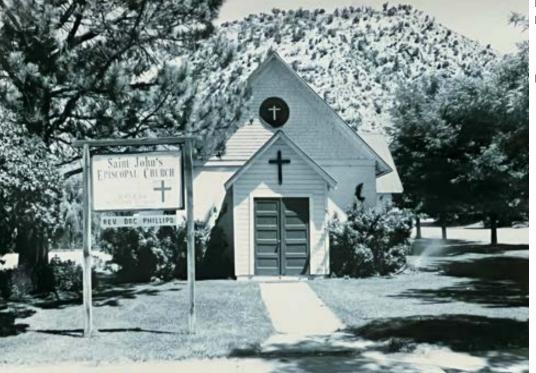
Historic Photo 2

Description: Looking at the primary (south) elevation of the church. Note the historic double wood panel doors are extant at the time. **Date:** Unknown

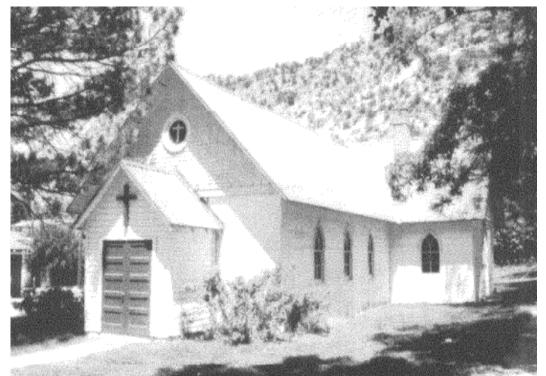
Historic Photo 3

Description: Looking at the primary (south) and east elevations of the church.
