COLORADO CULTURAL RESOURCES INVENTORY

Historical and Architectural Reconnaissance

1. Property Name: Bernoudy Brother's Saloon Historic Current Other:
2. Resource Classification: Building Structure Object Sites/Landscape
3. Ownership: Federal State Local Non-profit Private Unknown

4. Street Address: 201 West Main Street
5. Municipality: New Castle, CO Vicinity:
6. County: Garfield
- **7. USGS Quad: New Castle, CO Year: 2022 7.5'
- **8. Parcel Number: 212331408013
- **9. Parcel Information: Lot(s): 13 Block: 3 Addition: ORIGINAL TWNSTE NEW CASTLE

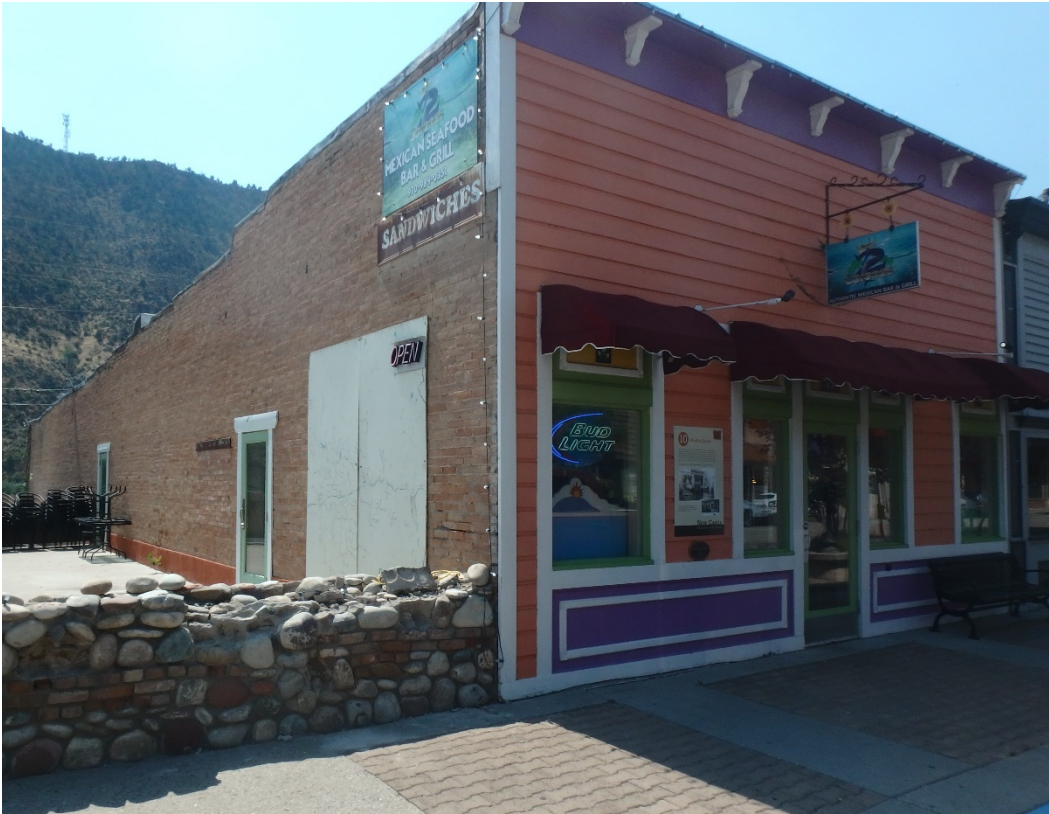
Photo Number: 5GF.2371_1
Description: Looking at the east and primary (north) elevations of the building.
Date: 9/6/2022
View: Southwest

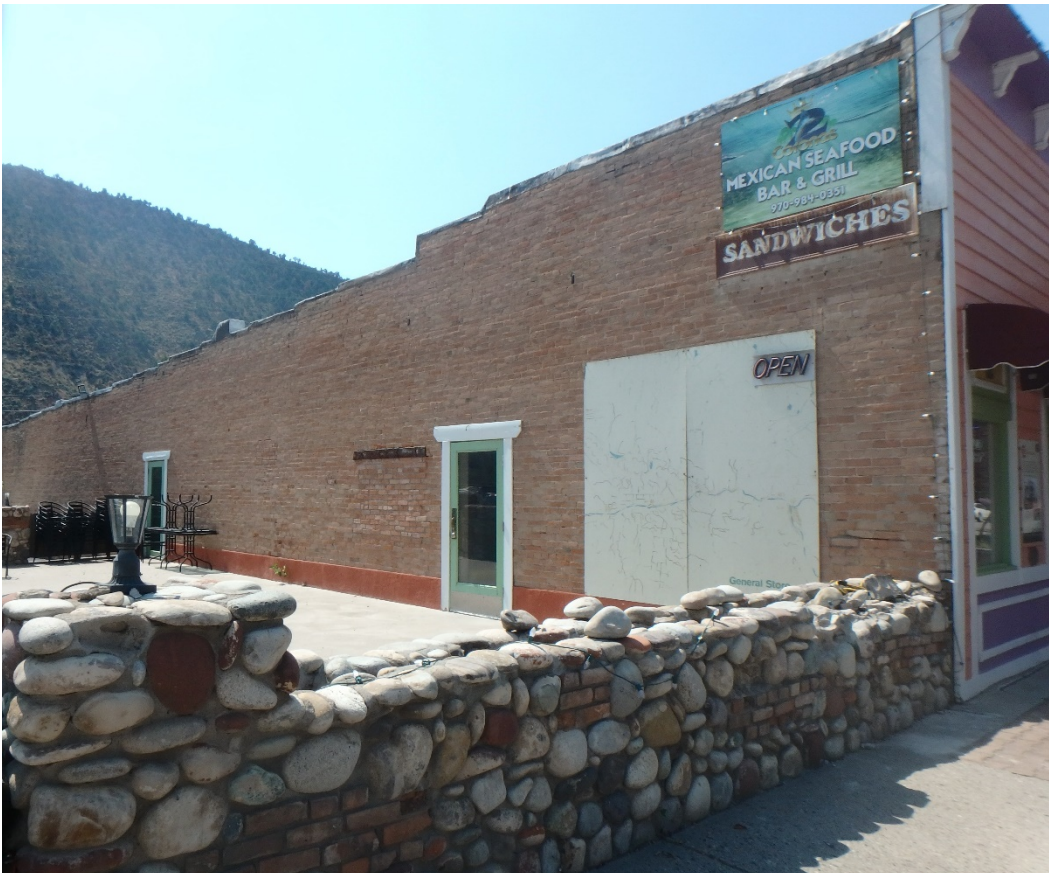
Photo Number: 5GF.2371_2
Description: Looking at the east elevation of the building.
Date: 9/6/2022
View: Southwest

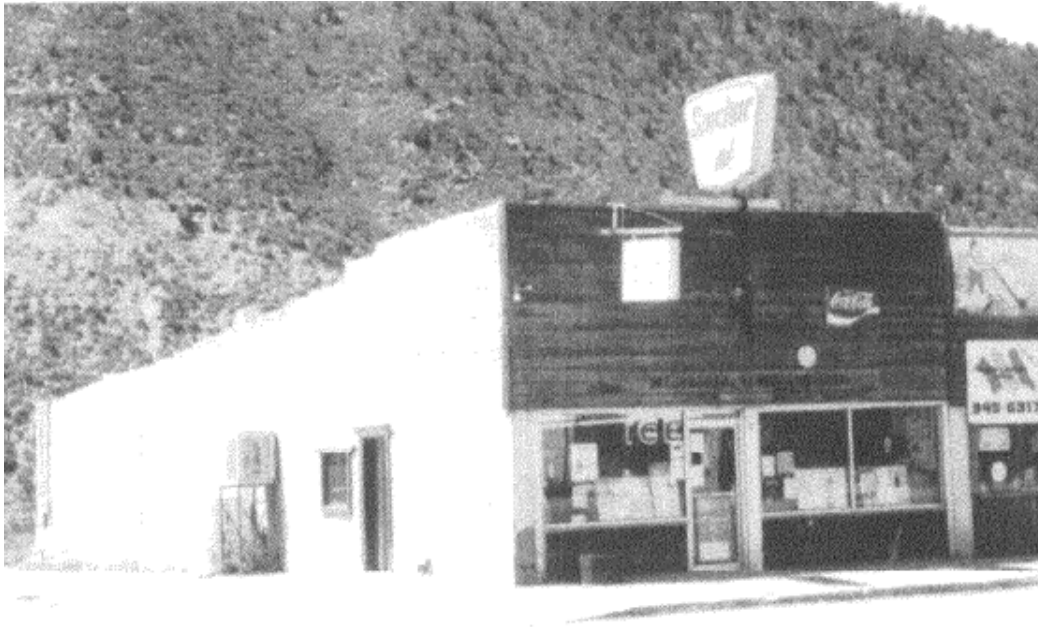
Reference Photo 1

Description: Looking at the west and primary (north) elevations of the building. Note the façade treatment prior to the 2012 alterations.

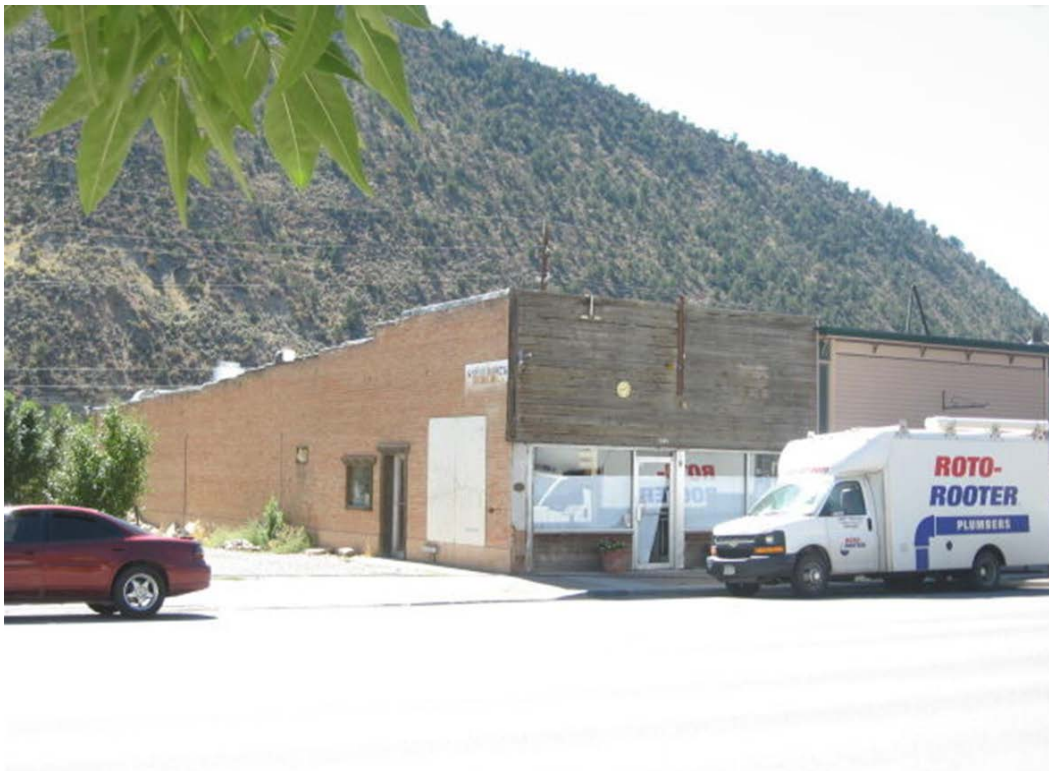
Reference Photo 2

Description: Looking at the west and primary (north) elevations of the building.

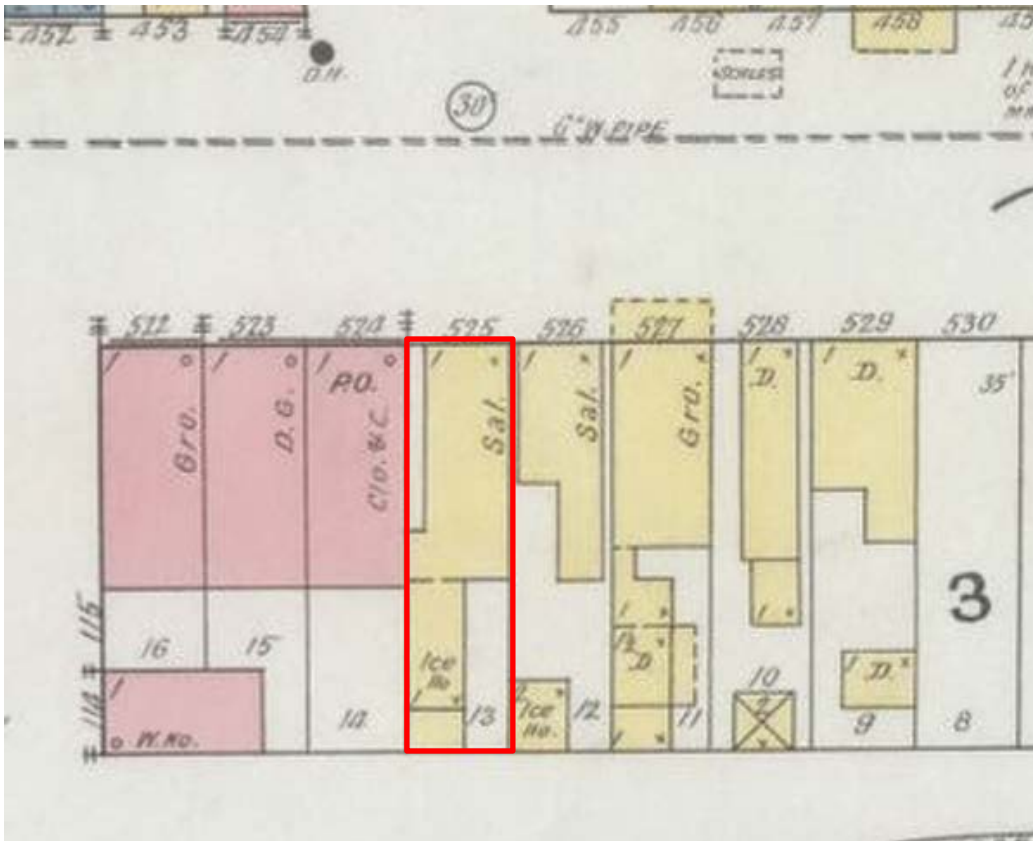
Reference Photo 3

Description: 1893 Sanborn Fire Insurance map of the resource located on lot 13 of block 3. The property is outlined in red.

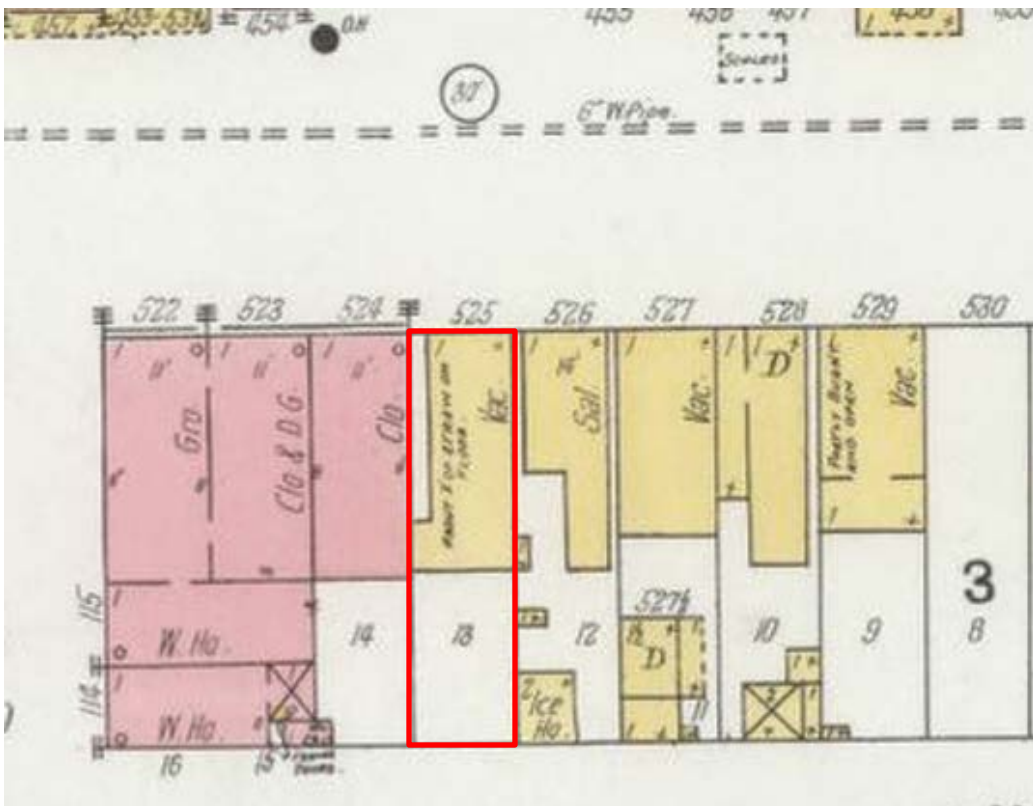
Reference Photo 4

Description: 1899 Sanborn Fire Insurance map of the resource. The property is outlined in red. Note that the building is labeled as vacant at the time.

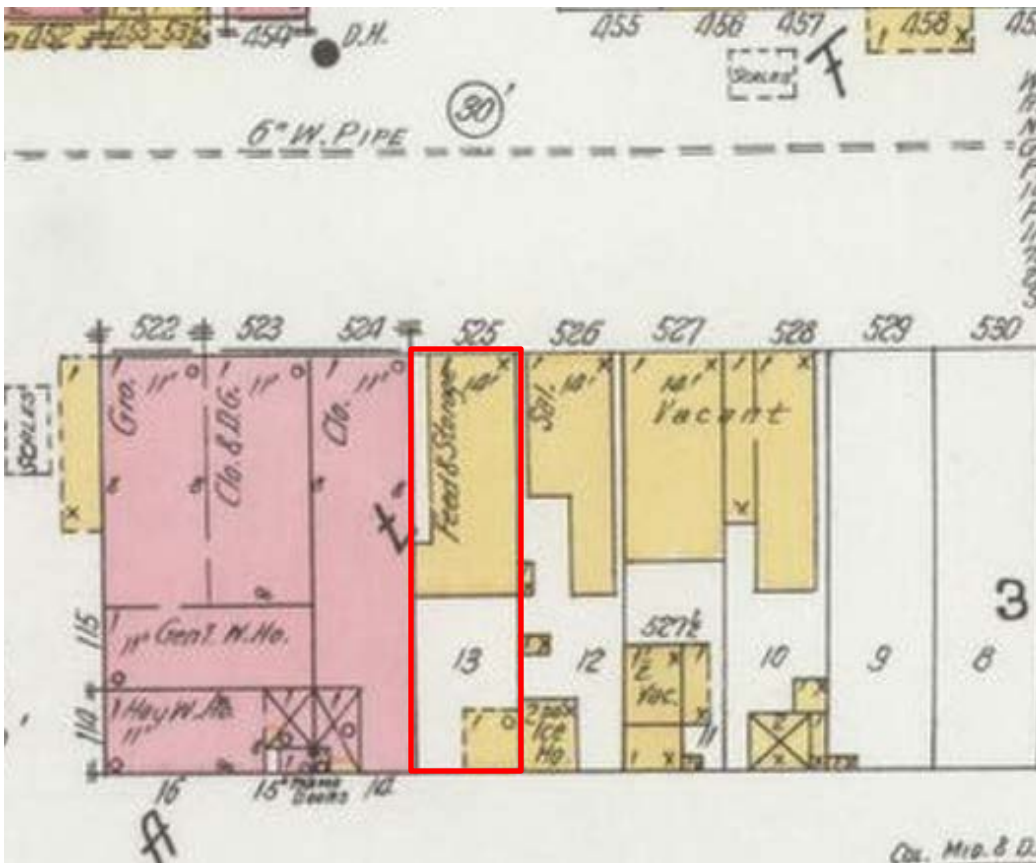
Reference Photo 5

Description: 1904 Sanborn Fire Insurance map of the resource. The property is outlined in red. Note that the building was utilized as a feed storage at the time.
