COLORADO CULTURAL RESOURCES INVENTORY

Historical and Architectural Reconnaissance

1. Property Name: Odd Fellows Hall 🛛 Historic 🗆 Current 🗆 Other:						
2. Resource Classification: 🛛 🖾 Building	□ Structure	\Box Object \Box	Sites/Landsca	аре

3. Ownership: □ Federal □ Stat	e 🗆 Local	\Box Non-profit \boxtimes	Private			
LOCATION						
4. Street Address: 500 West Main Street						
5. Municipality: New Castle, CO		□ Vicinity:

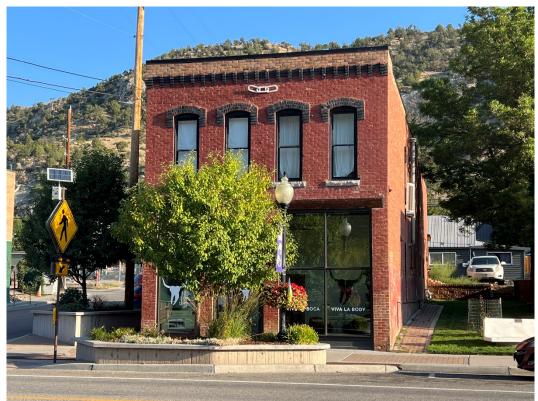
Photo Number: 5GF.1488_1 Description: Looking at the primary (south) elevation of the building. Date: 9/6/2022 View: North

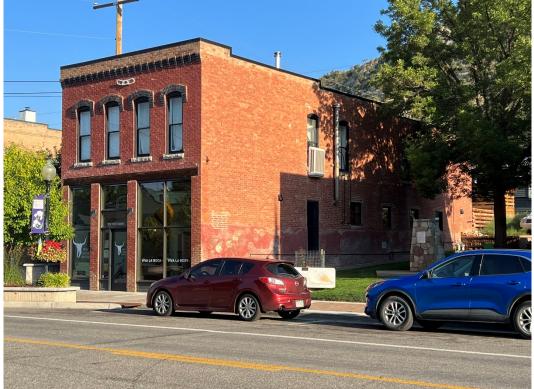
Photo Number: 5GF.1488_2
Description: Looking at the primary (south) and east elevation of the building.
Date: 9/6/2022
View: Northwest

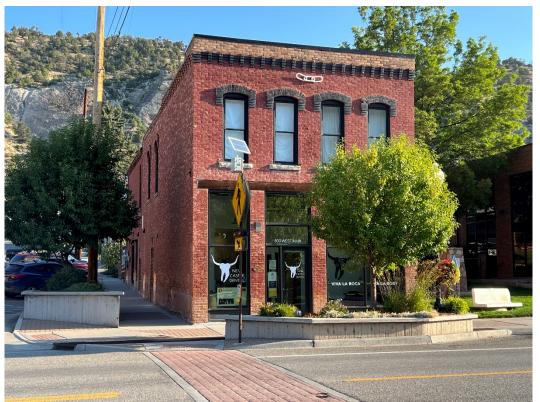
Photo Number: 5GF.1488_3

Description: Looking at the west and primary (south) elevations of the building.Date: 9/6/2022View: Northeast

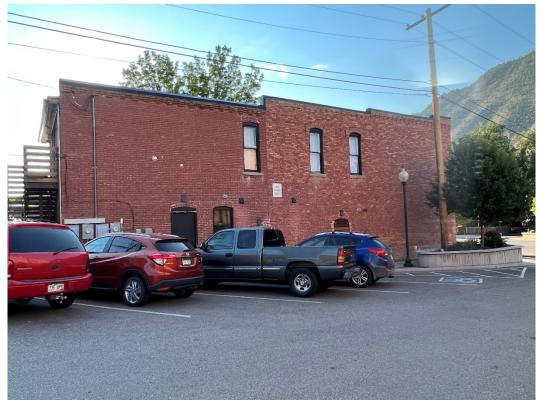
Photo Number: 5GF.1488_4 Description: Looking at the west elevation of the building. Date: 9/6/2022 View: Southeast

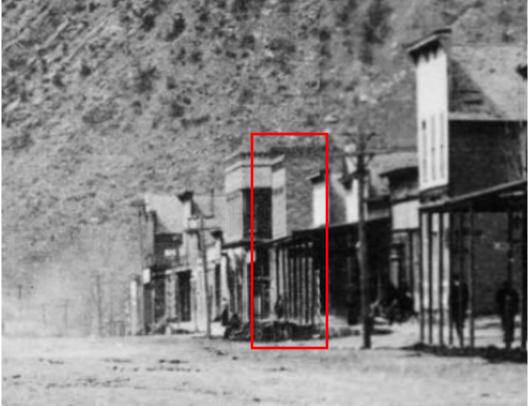
Historic Photo 1

Description: Image of downtown New Castle looking west down Main Stret from the intersection of Main Street and North 4th Street. Note that the resource is behind the shed roof overhang which is not associated with the building. The resource is outline in red.

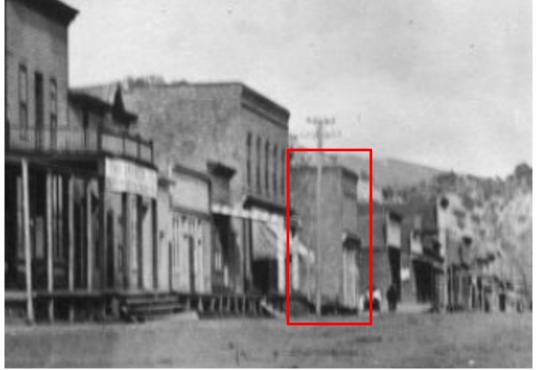
Historic Photo 2

Description: Image of downtown New Castle looking east down Main Stret from the intersection of Main Street and North 6th Street. The resource is outline in red.

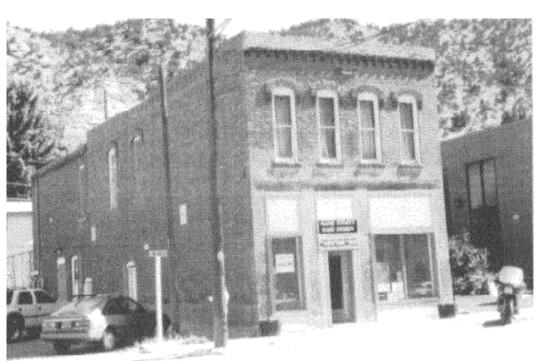
Reference Photo 1

Description: Image states, "Odd Fellows Hall built in 1909. Ground floor housed a meat market, then a mercantile store, and later a "Mane Street Beauty Shop." Note the plywood that covers the first floor of the façade.
