## **COLORADO CULTURAL RESOURCES INVENTORY**

# **Historical and Architectural Reconnaissance**

1. Property Name: Breslin Residence						oric	⊠ Curren	t D Other:	
2. Resource Class	ification: 🛛 🛛 🛛	Building	□ Structure	<b>)</b>	Object	□ S	ites/Landsc	ape

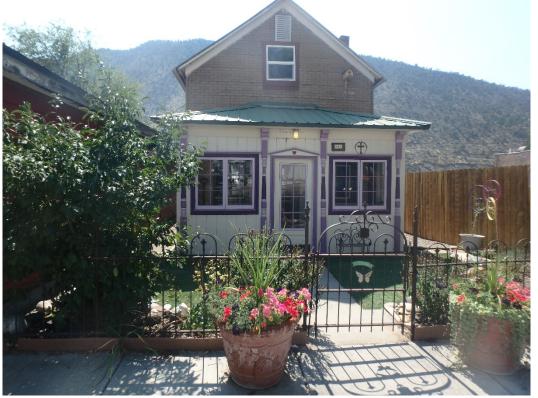
Photo Number: 5GF.2370\_1 Description: Looking at the primary (north) elevation of the building. Note the 1976 enclosed porch addition to the façade. Date: 9/6/2022

View: South

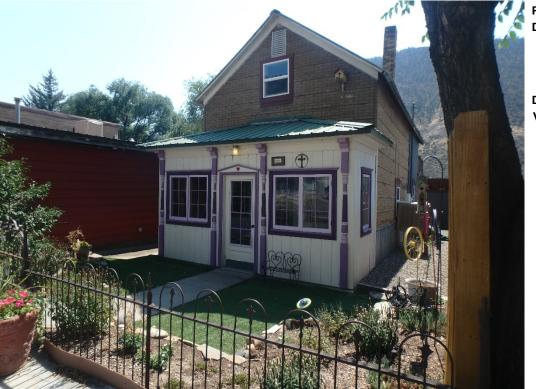
Photo Number: 5GF.2370\_2
Description: Looking at the primary (north) and west elevations of the residence. Note the weatherboard, asphalt, and corrugated metal siding transitions.
Date: 9/6/2022
View: Southeast

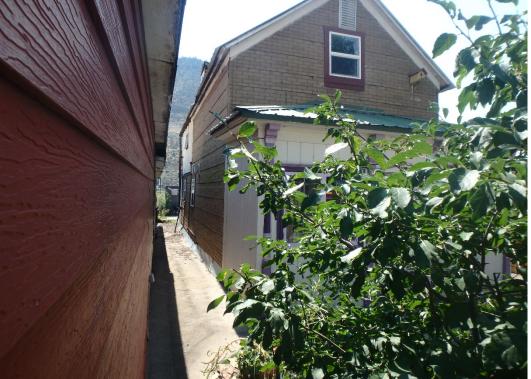
### Photo Number: 5GF.2370\_3

Description: Looking at the east and primary (north) elevations of the building. Date: 9/6/2022 View: Southwest

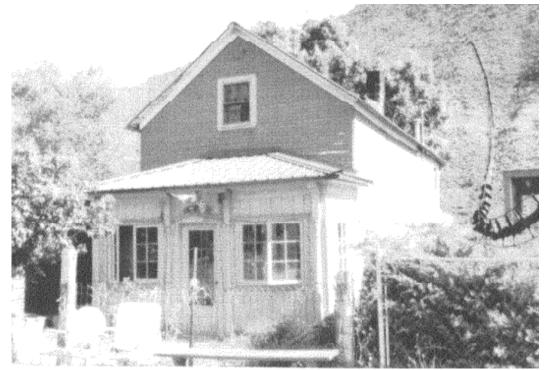
#### **Historic Photo 1**

**Description:** Looking at the primary (north) and west elevations of the building in 1996.
