COLORADO CULTURAL RESOURCES INVENTORY

Historical and Architectural Reconnaissance

1. Property Name: Turtle Residence		☐ Histo	oric 🗵 Currer	nt 🗆 Other:
2. Resource Classification: ⊠ Building	☐ Structure	☐ Object	☐ Sites/Lands	cape
3. Ownership: \square Federal \square State	☐ Local	☐ Non-profit	□ Private	☐ Unknown
LOCATION

4. Street Address: 782 West Main Street				
5. Municipality: New Castle, CO		☐ Vicinity:		
6. County: Garfield				**Please check with your project
**7. USGS Quad: New Castle, CO	Year: 2022	⊠ 7.5'		sponsor to determine which fields

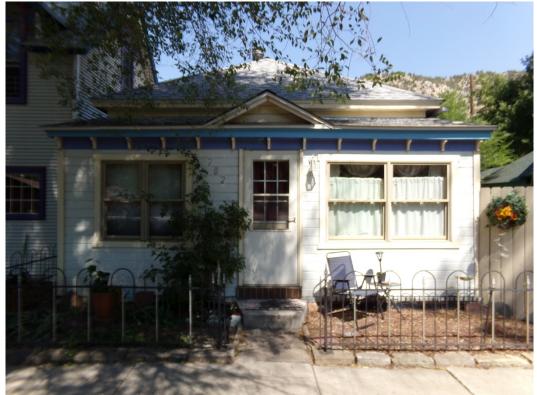
Photo Number: 5GF.5893_1

Description: Looking at the primary (south) elevation of the building.

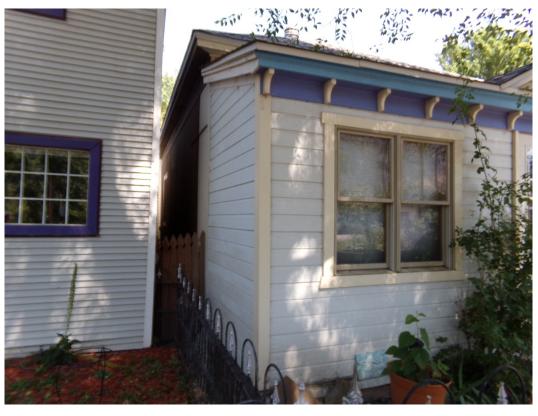
Photo Number: 5GF.5893_2

Description: Looking at the west and left side of the primary (south)

elevation of the building.

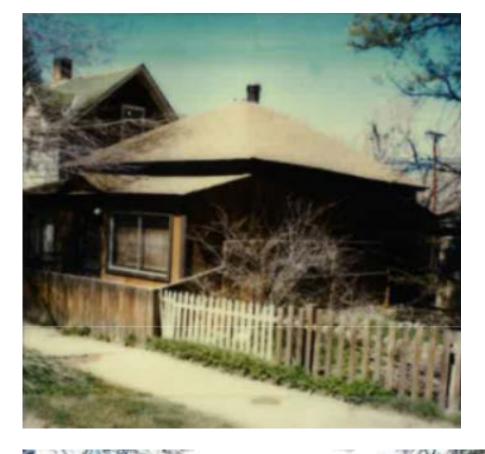
Description: Looking at the primary (south) and east elevations of the building.

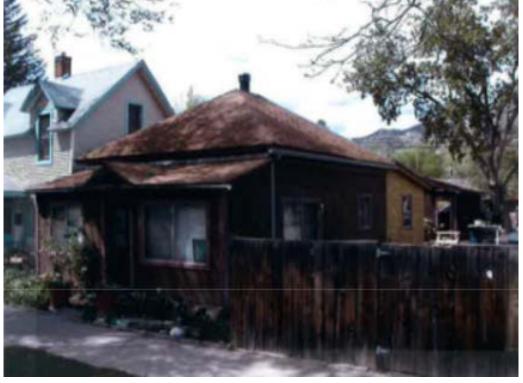
Reference Photo 2

Description: Looking at the primary (south) and east elevations of the building. Note the addition along the north elevation is under construction.

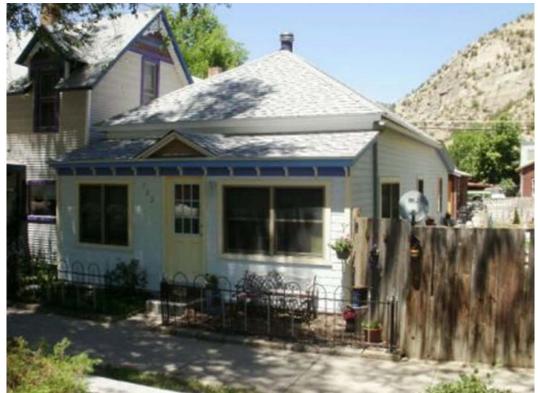
Reference Photo 3

Description: Looking at the primary (south) and east elevations of the building.

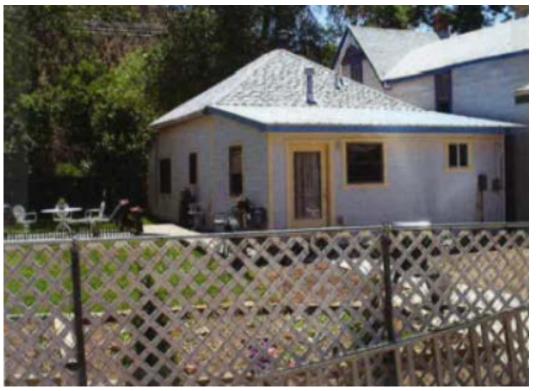
Reference Photo 4

Description: Looking at the east and north elevations of the building.

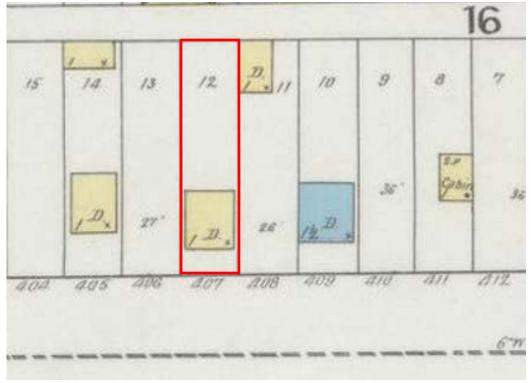
Description: 1893 Sanborn Fire Insurance map illustrating the residence on lot 12 of block 16. The property is outlined in red.

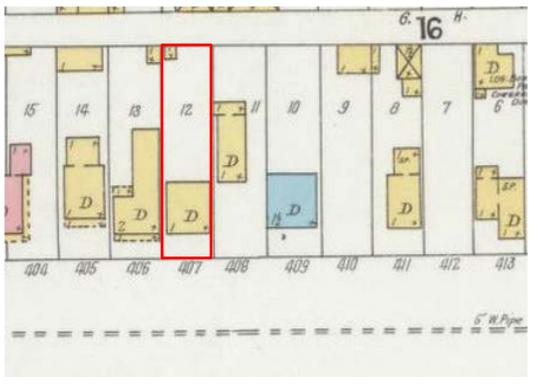
Reference Photo 6

Description: 1899 Sanborn Fire Insurance map illustrating the resource. The property is outlined

in red. **Date**: 1899

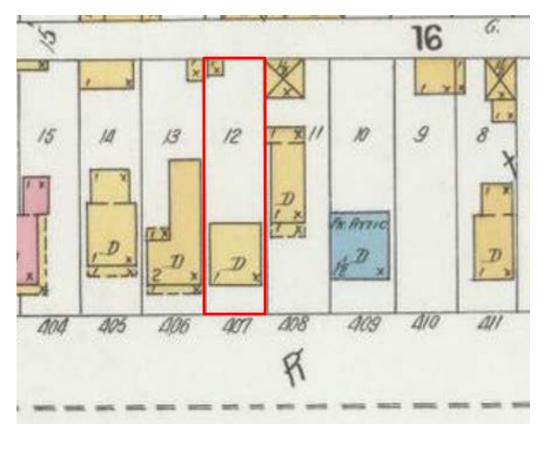
Reference Photo 7

Description: 1904 Sanborn Fire Insurance map illustrating the resource. The property is outlined

in red. **Date**: 1904
