COLORADO CULTURAL RESOURCES INVENTORY

Historical and Architectural Reconnaissance

1. Property Name: Saint John's Guild Hall Historic Current Other:
2. Resource Classification: Building Structure Object Sites/Landscape
3. Ownership: Federal State Local Non-profit Private Unknown

4. Street Address: 102 East Main Street
5. Municipality: New Castle, CO Vicinity:
6. County: Garfield
- **7. USGS Quad: New Castle, CO Year: 2022 7.5'
- **8. Parcel Number: 212331106003

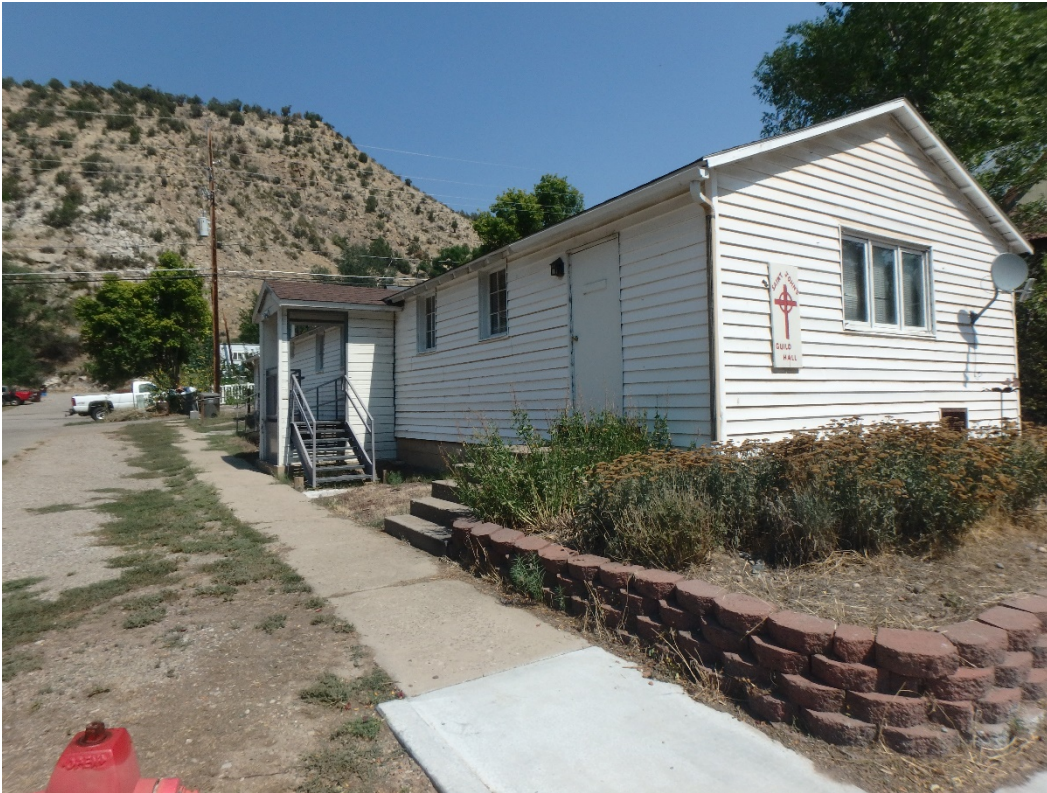
Photo Number: 5GF.5921_1
Description: Looking at the primary (west) and south elevations of the building.
Date: 9/6/2022
View: Northeast

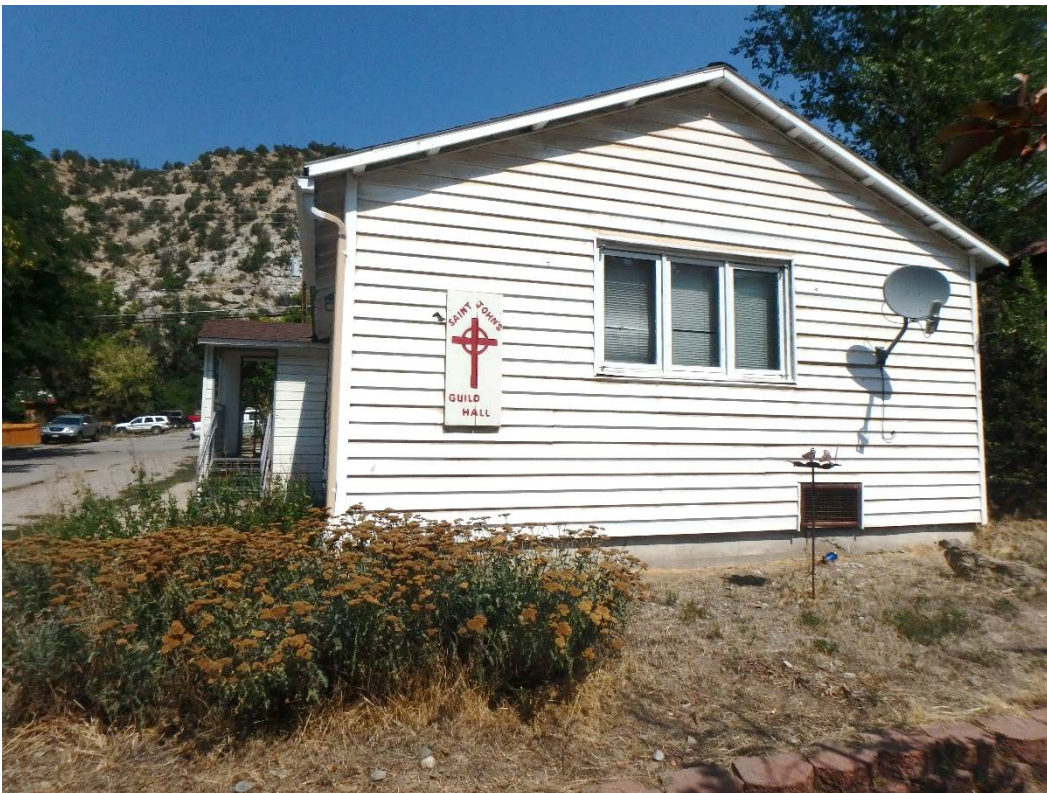
Photo Number: 5GF.5921_2
Description: Looking at the south elevation of the building.
Date: 9/6/2022
View: North

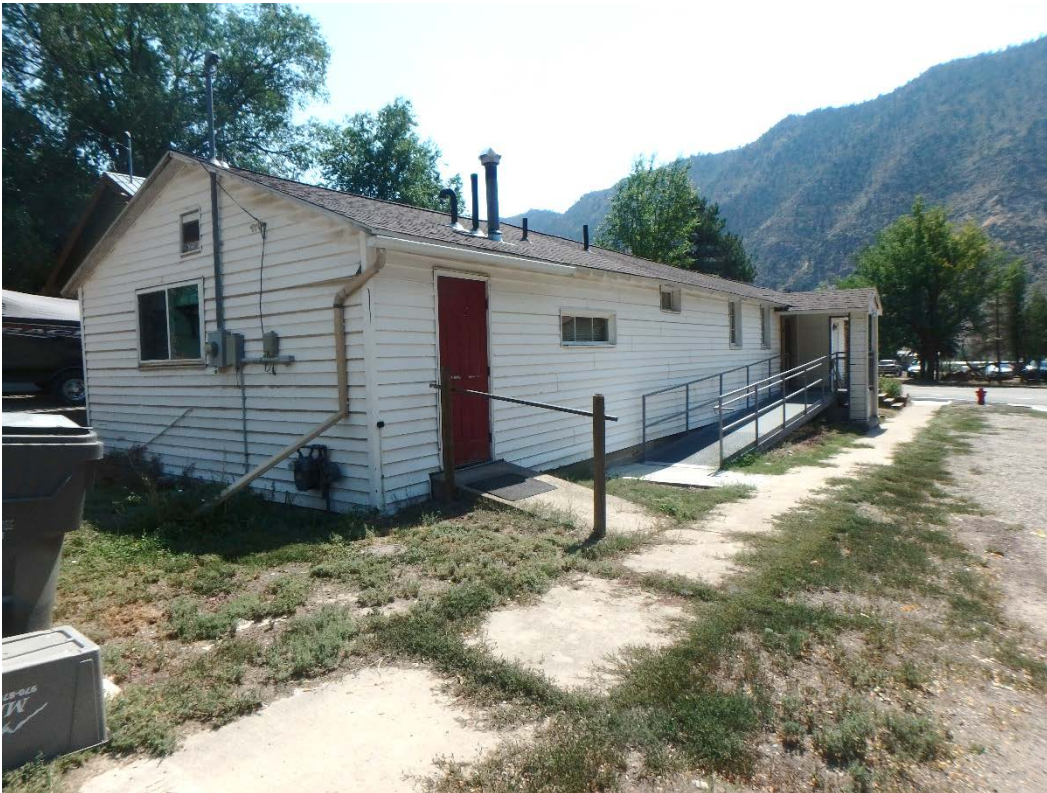
Photo Number: 5GF.5921_3
Description: Looking at the north and primary (west) elevations of the building.
Date: 9/6/2022
View: Southeast

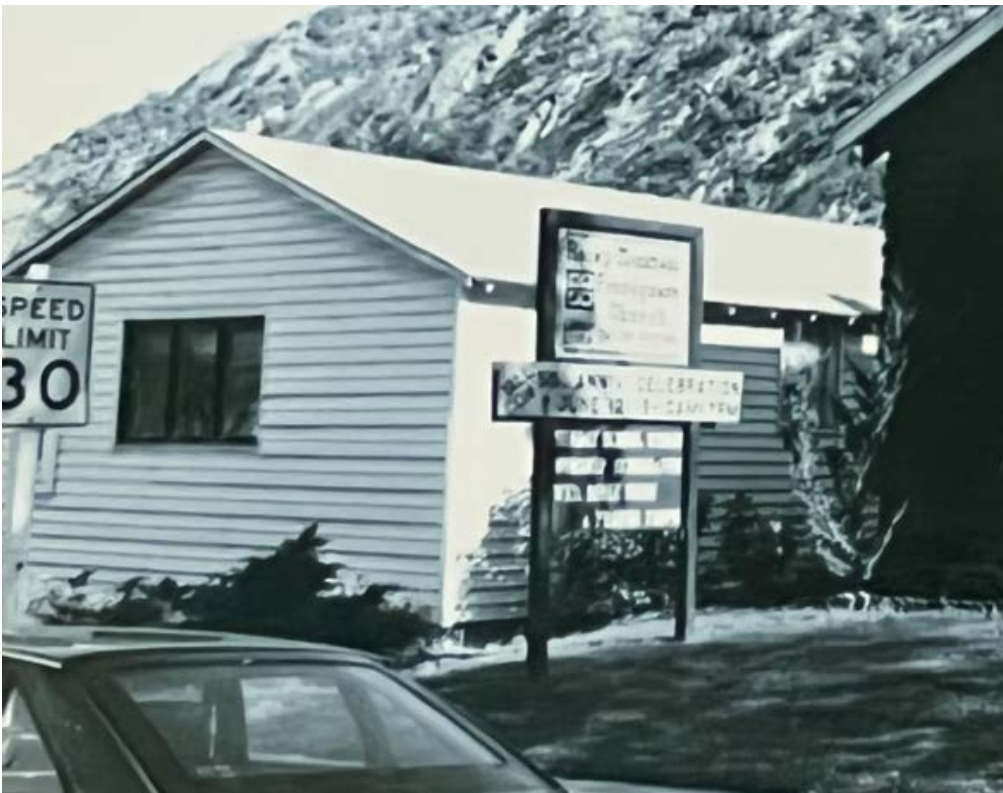
Historic Photo 1
Description: Looking at the south and a portion of the east elevation of the building.
Date: Unknown
Source: New Castle Museum collections
