COLORADO CULTURAL RESOURCES INVENTORY

Historical and Architectural Reconnaissance

1. Property Name: Eric Janusz Residence Historic Current Other:
2. Resource Classification: Building Structure Object Sites/Landscape
3. Ownership: Federal State Local Non-profit Private Unknown

4. Street Address: 122 East Main Street
5. Municipality: New Castle, CO Vicinity:
6. County: Garfield
- **7. USGS Quad: New Castle, CO Year: 2022 7.5'
- **8. Parcel Number: 212331106008

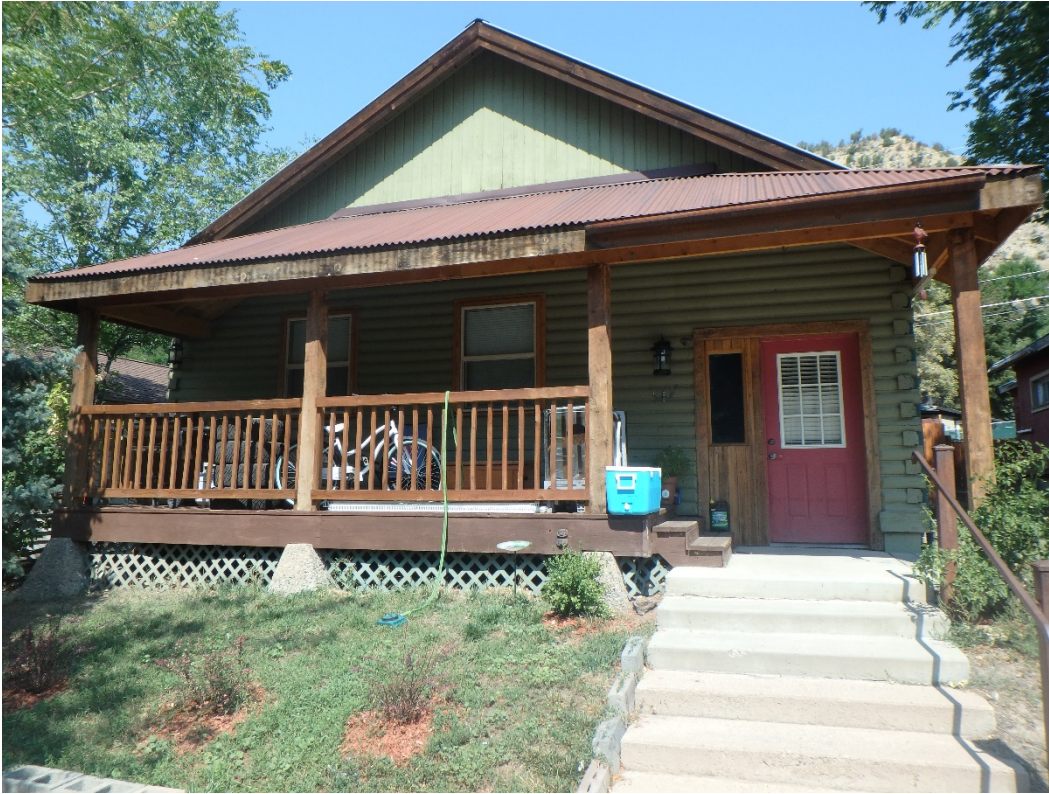
Photo Number: 5GF.5922_1
Description: Looking at the primary (south) elevation of the building.
Date: 9/6/2022
View: North

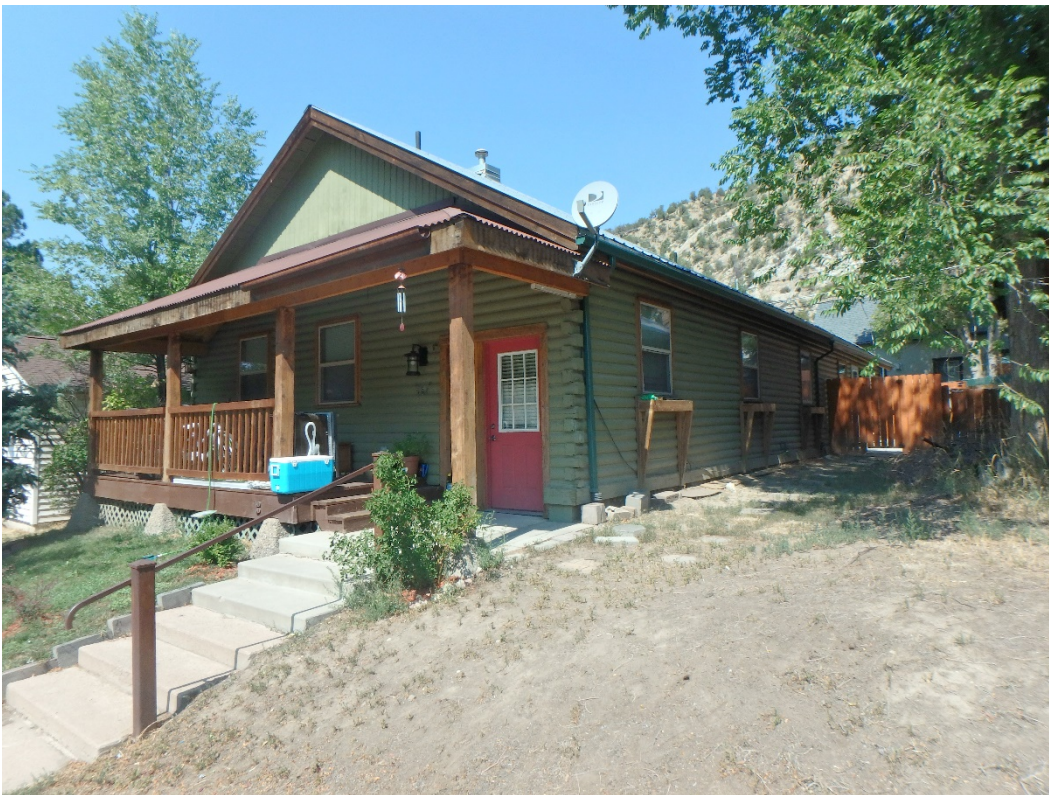
Photo Number: 5GF.5922_2
Description: Looking at the primary (south) and east elevations of the building.
Date: 9/6/2022
View: Northwest

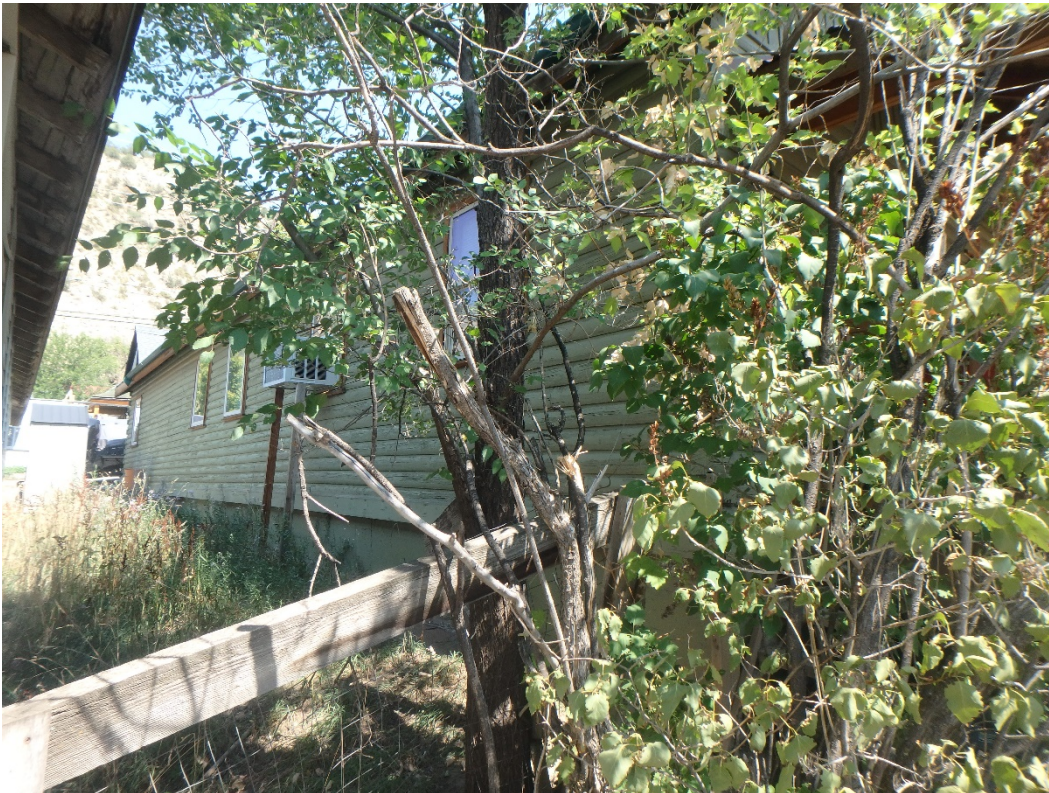
Photo Number: 5GF.5922_3

Description: Looking at the west elevation of the building.
