COLORADO CULTURAL RESOURCES INVENTORY

Historical and Architectural Reconnaissance

1. Property Name: Lawrence & Joshua Brooks House Historic Current Other:
2. Resource Classification: Building Structure Object Sites/Landscape
3. Ownership: Federal State Local Non-profit Private Unknown

4. Street Address: 142 East Main Street
5. Municipality: New Castle, CO Vicinity:
6. County: Garfield
- **7. USGS Quad: New Castle, CO Year: 2022 7.5'
- **8. Parcel Number: 212331106009

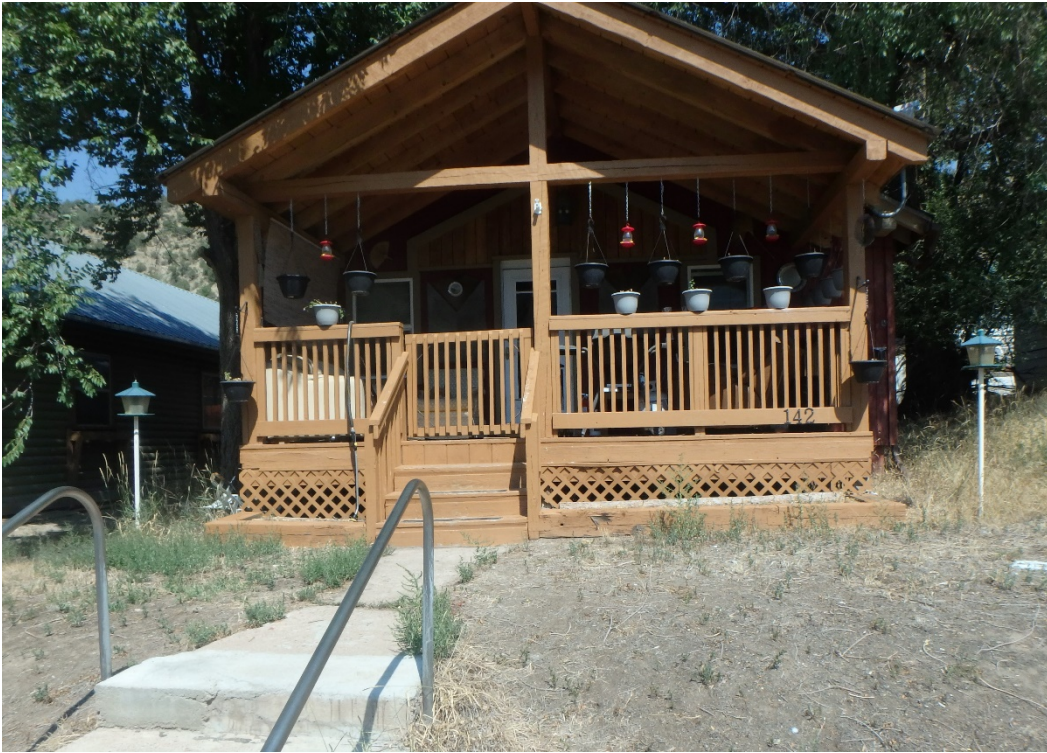
Photo Number: 5GF.5923_1
Description: Looking at the primary (south) elevation of the building. Note the decorative arrangement of the overhang support posts and the woodwork along the facade.
Date: 9/6/2022
View: North

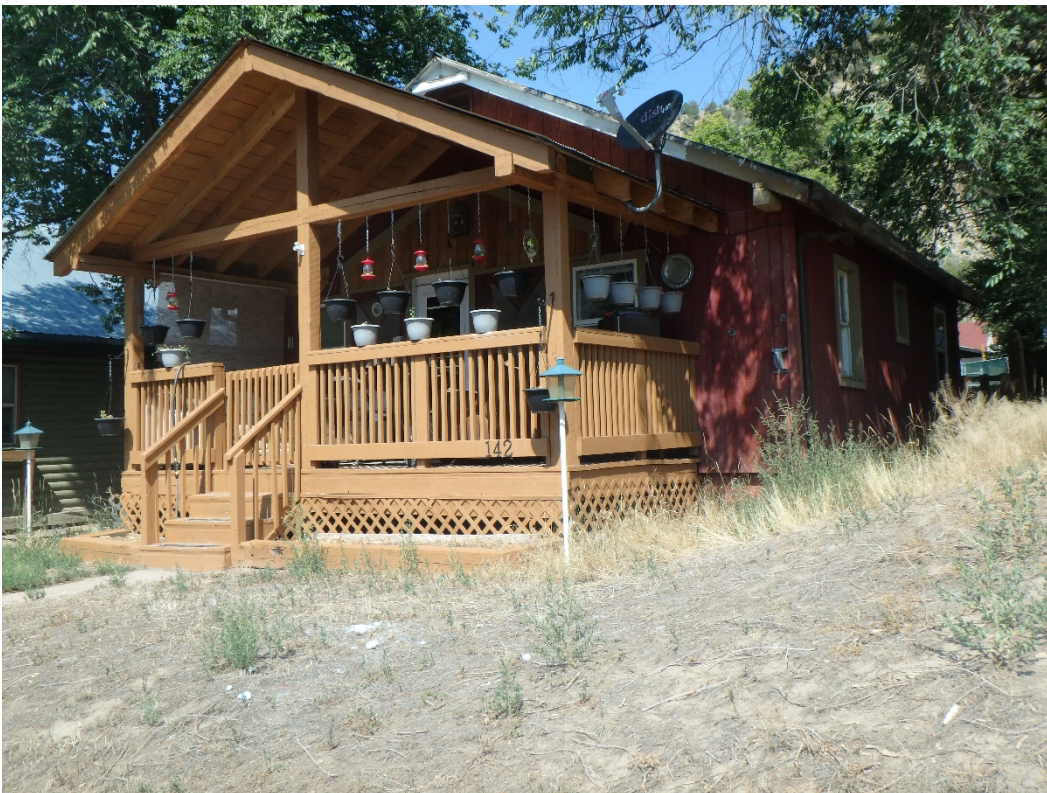
Photo Number: 5GF.5923_2
Description: Looking at the primary (south) elevation and east elevation of the residence.
Date: 9/6/2022
View: Northeast

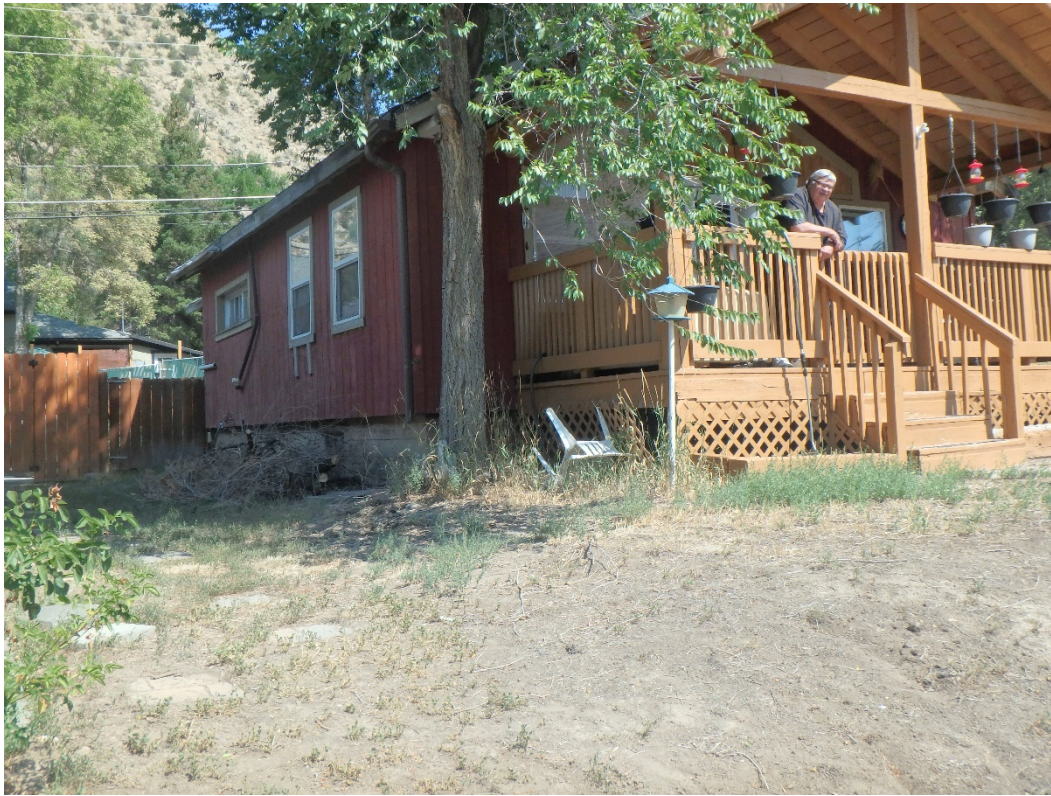
Photo Number: 5GF.5923_3
Description: Looking at the west and primary (south) elevations of the residence.
Date: 9/6/2022
View: Northeast
