## COLORADO CULTURAL RESOURCES INVENTORY

### Historical and Architectural Reconnaissance

1. Property Name: Ambleside School Rocky Mountains       Historic     Current     Other:
2. Resource Classification:     Building     Structure     Object     Sites/Landscape
3. Ownership:     Federal     State     Local     Non-profit     Private     Unknown

4. Street Address: 151 West Main Street
5. Municipality: New Castle, CO       Vicinity:
6. County: Garfield
- \*\*7. USGS Quad: New Castle, CO      Year: 2022     7.5'
- \*\*8. Parcel Number: 212331407002
- \*\*9. Parcel Information: Lot(s): 1-11      Block: 2      Addition: ORIGINAL TWNSTE NEW CASTLE
- \*\*10. Acreage: 0.85       Actual     Estimated
11. PLSS information: Principal Meridian: 6<sup>th</sup>      Township: 5S      Range: 90W  
NW ¼ of NE ¼ of NW ¼ of SE ¼ of section: 31
- \*\*12. Location Coordinates:  
 UTM reference: Zone 13      ;mE 282588      ;mN 4383012     NAD 1927       NAD 1983  
 or  
 Lat/Long: Latitude \_\_\_\_\_ ; Longitude \_\_\_\_\_     WGS84     Other:

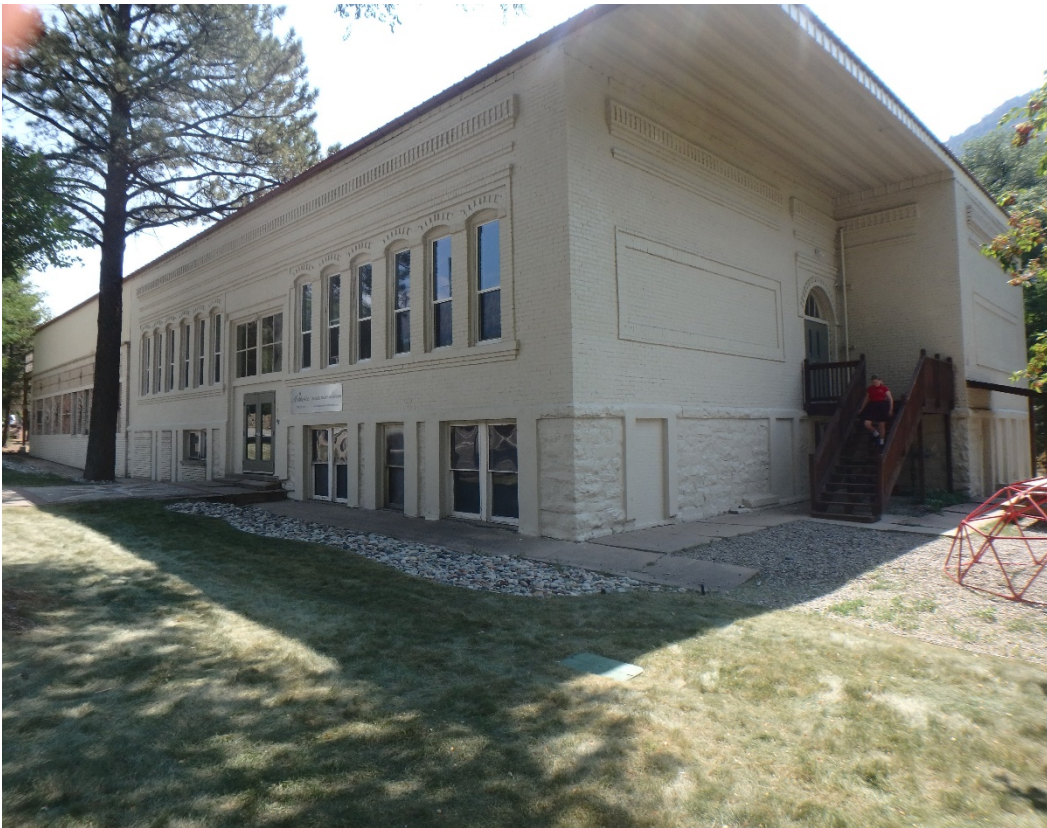
**Photo Number:** 5GF.2369\_1  
**Description:** Looking at the primary (north) and west elevations of the building. Note the several ornate brickwork features along the facade.  
**Date:** 9/6/022  
**View:** Southeast

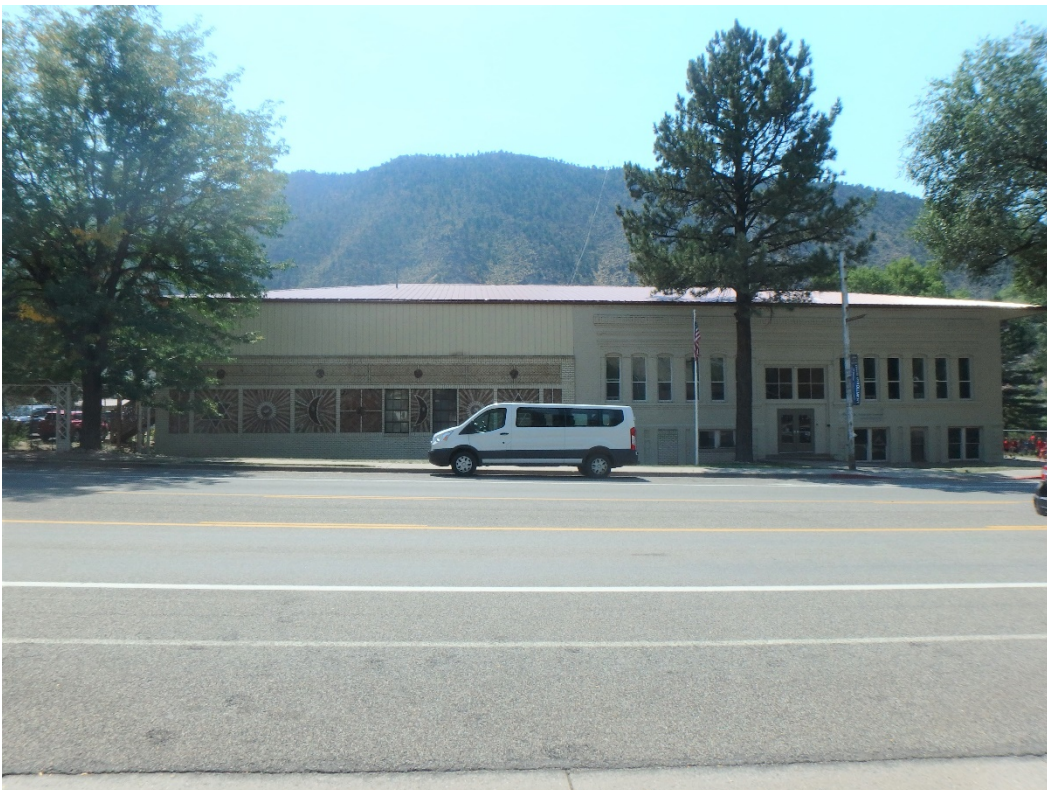
**Photo Number:** 5GF.2369\_2  
**Description:** Looking at the primary (north) elevation of the building.  
**Date:** 9/6/2022  
**View:** South

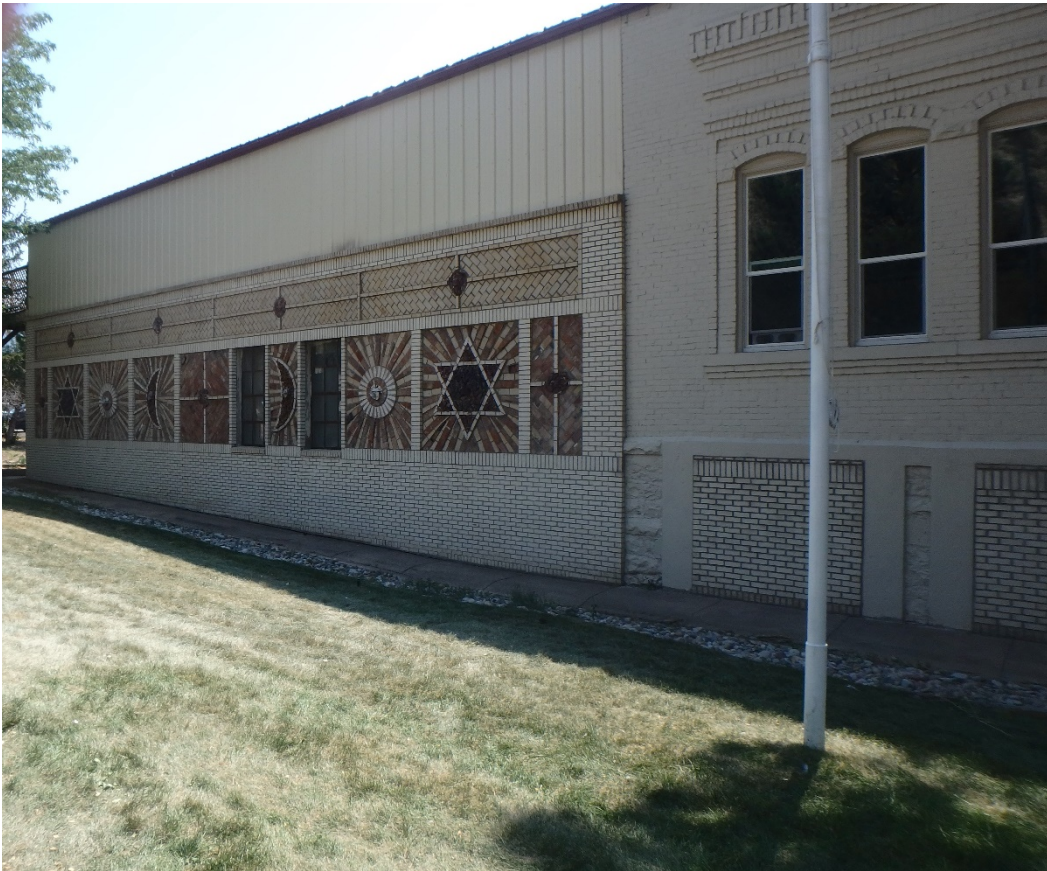
**Photo Number:** 5GF.2369\_3  
**Description:** Looking at the 1939 adobe brick addition to the original 1913 building.  
**Date:** 9/6/2022  
**View:** Southeast

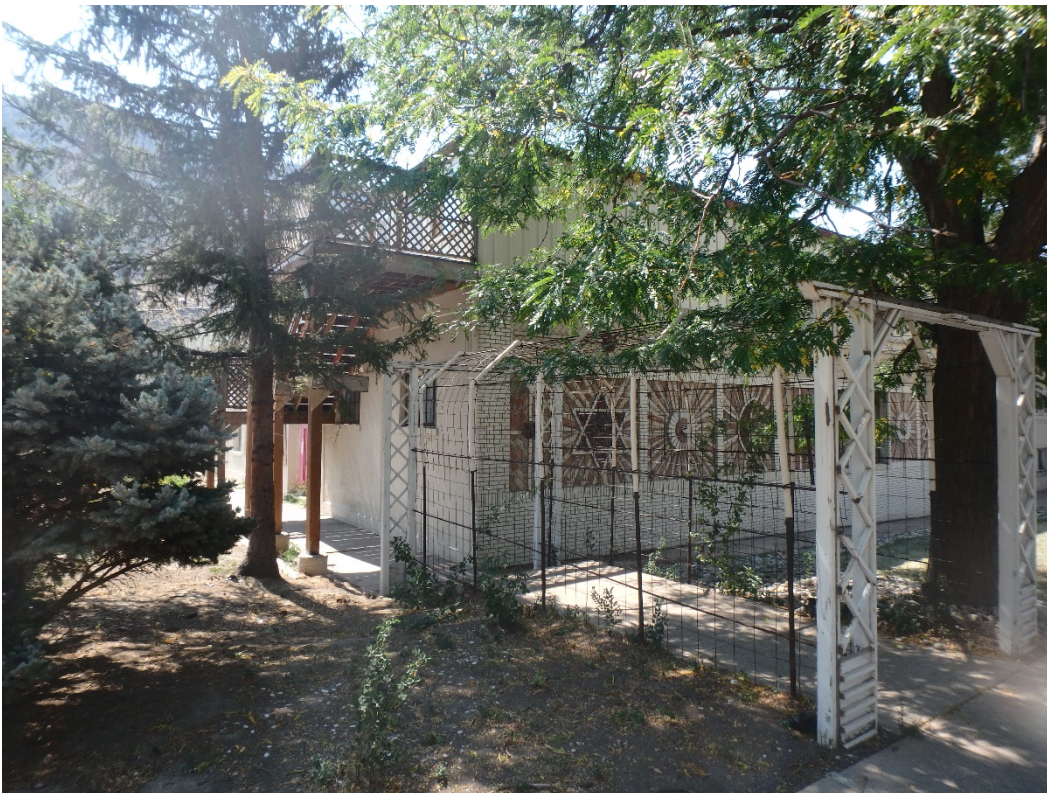
**Photo Number:** 5GF.2369\_4  
**Description:** Looking at the corner of the east elevation and the primary (north) elevation. Note the staircase leading to the second level addition to the building.  
**Date:** 9/6/2022  
**View:** Southwest

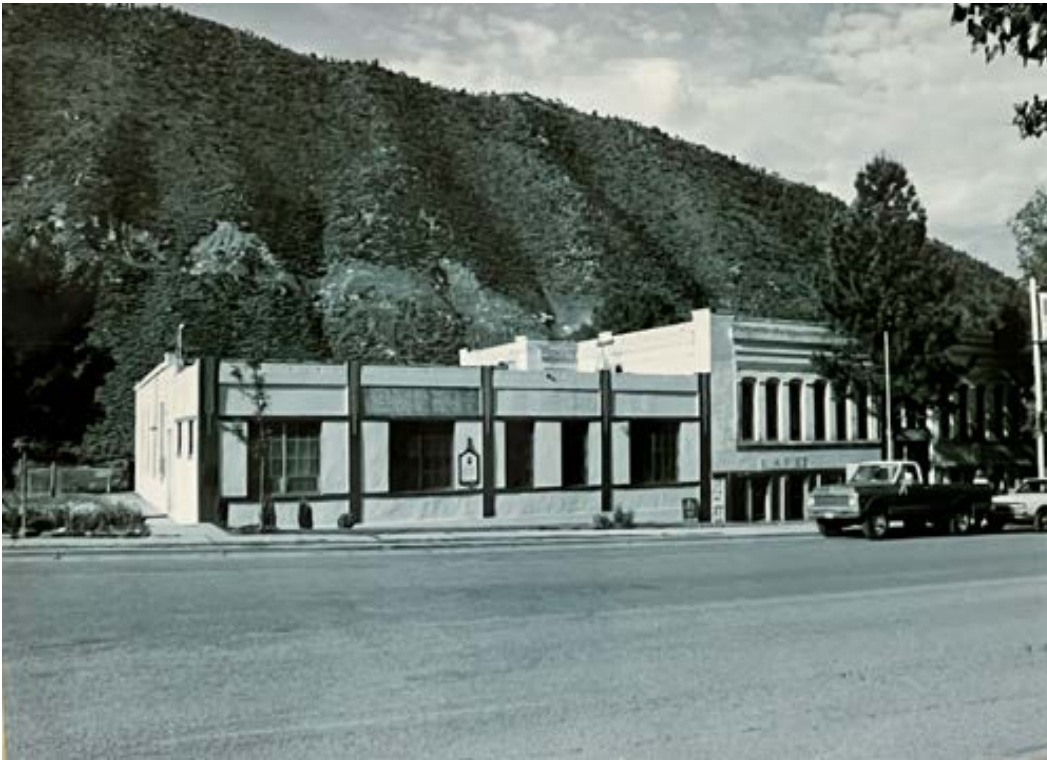
**Historic Photo 1**

**Description:** New Castle School built in 1913, addition of adobe brick made in 1939. School operated until 1978, later becoming apartments. It was converted back to a private school in 2021.

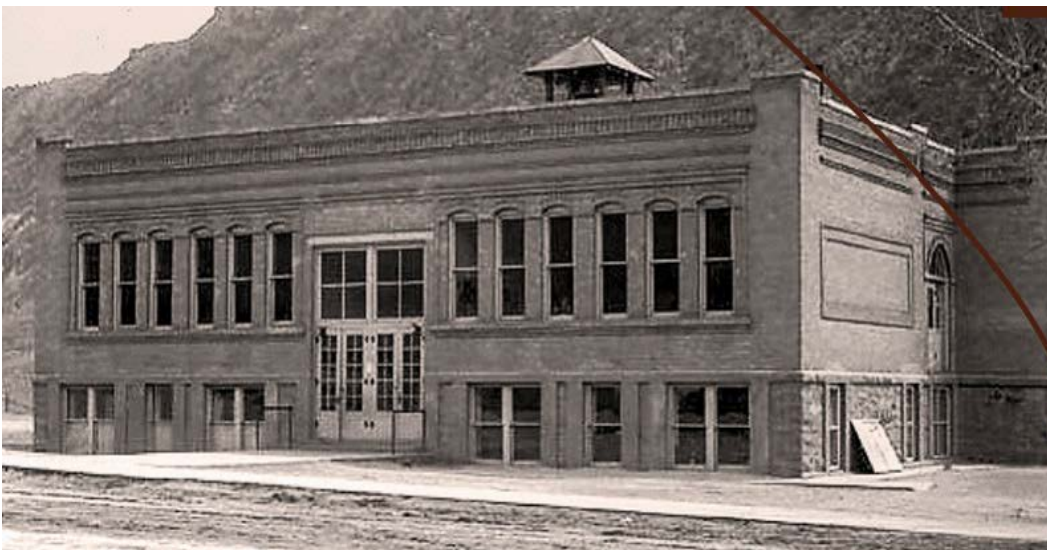
**Historic Photo 2**

**Description:** Image of the primary (north) and a portion of the east elevations of the building. Note the school bell on the flat roof that is protected by a pyramid roof.

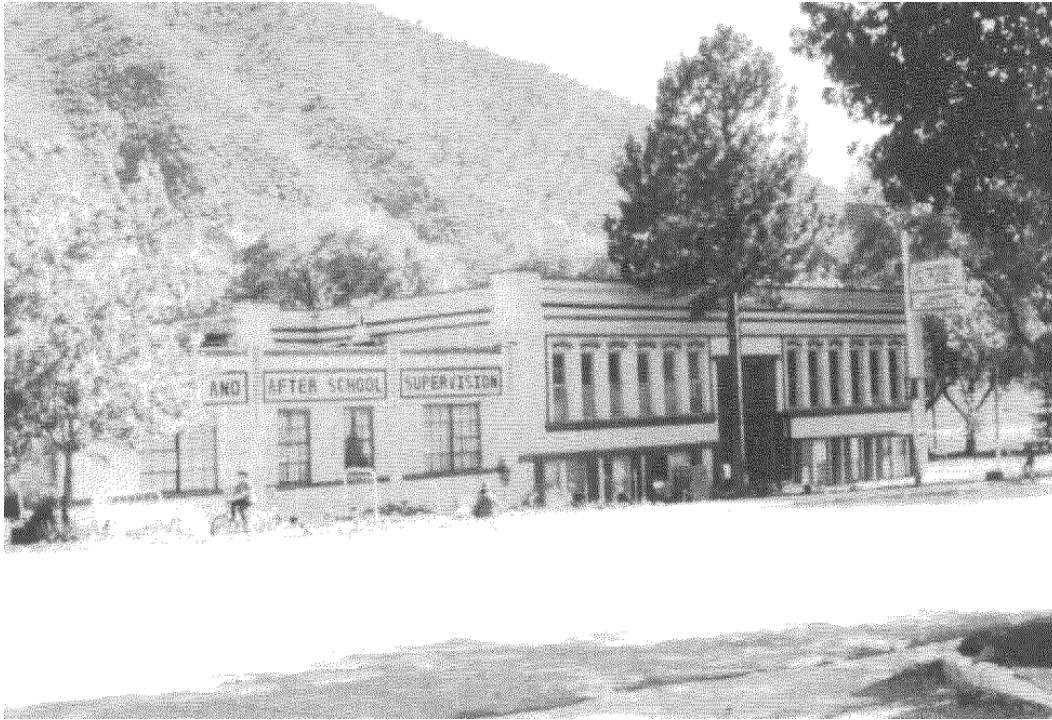
**Historic Photo 3**

**Description:** Looking at the primary (north) elevation of the building.
