COLORADO CULTURAL RESOURCES INVENTORY

Historical and Architectural Reconnaissance

1. Property Name: Don Meyer & Tina Sachleben Residence Historic Current Other:
2. Resource Classification: Building Structure Object Sites/Landscape
3. Ownership: Federal State Local Non-profit Private Unknown

4. Street Address: 162 East Main Street
5. Municipality: New Castle, CO Vicinity:
6. County:
- **7. USGS Quad: New Castle, CO Year: 2022 7.5'

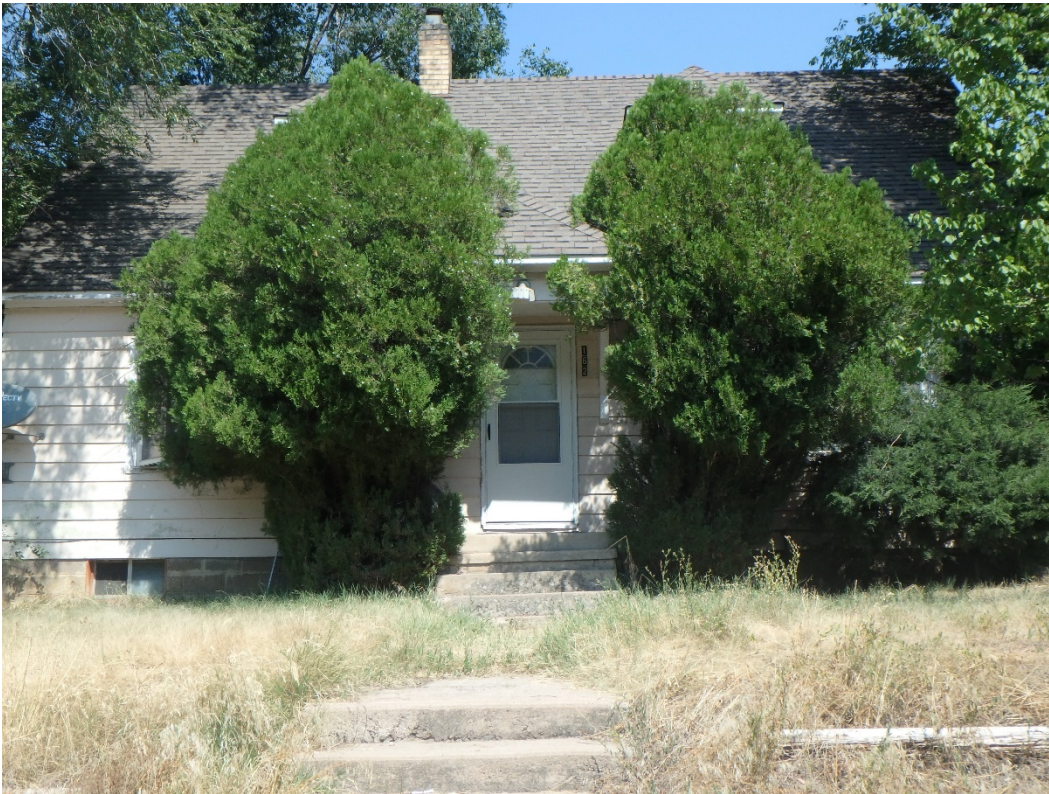
Photo Number: 5GF.5924_1
Description: Looking at the primary (south) elevation of the building. Note that the two recessed dormers are mostly obscured by the tall vegetation.
Date: 9/6/2022
View: North

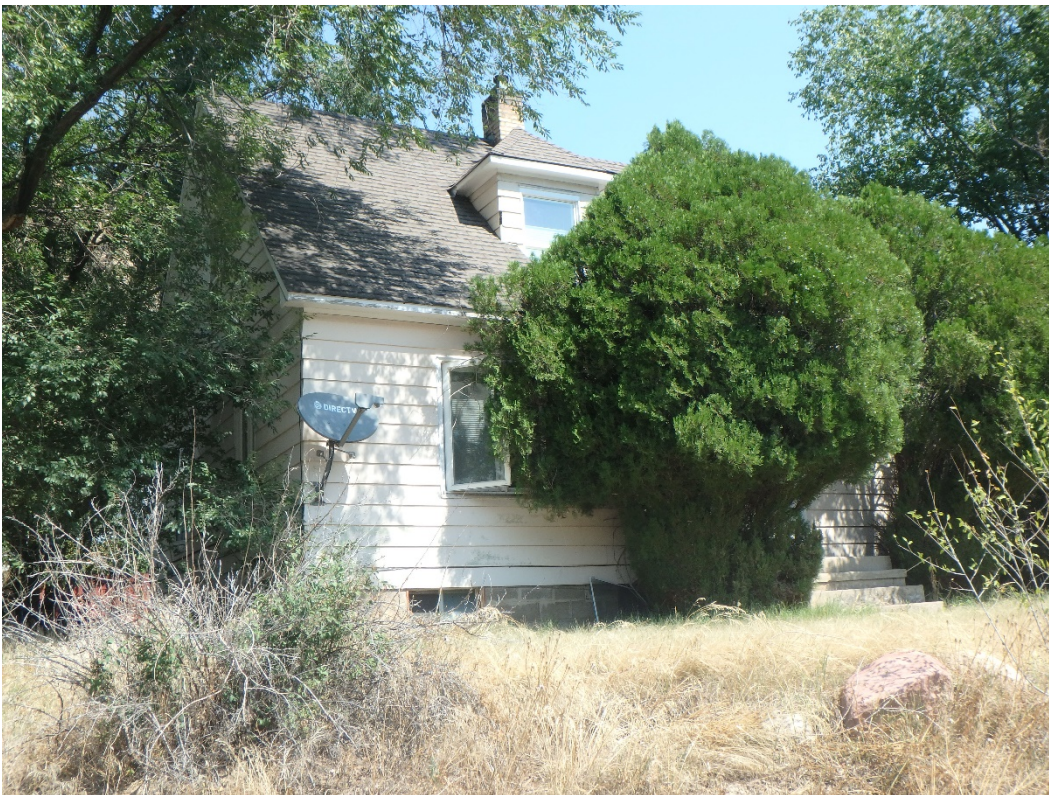
Photo Number: 5GF.5924_2
Description: Looking at the west and primary (south) elevation of the building.
Date: 9/6/2022
View: Northeast

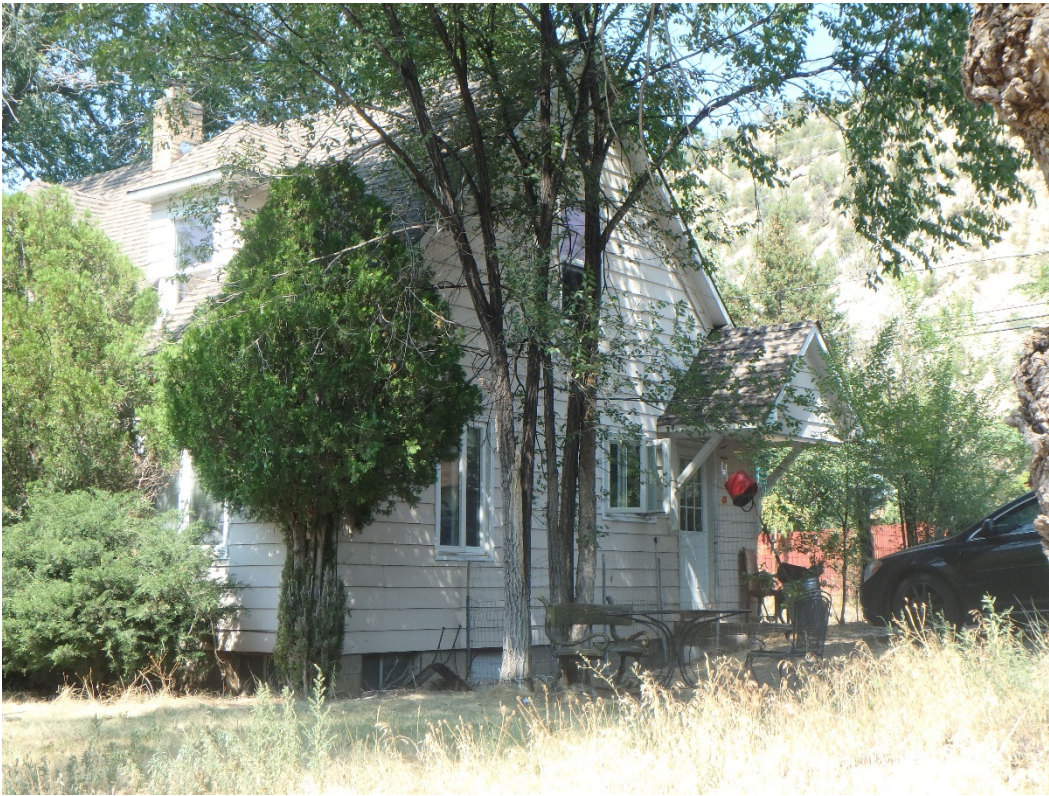
Photo Number: 5GF.5924_3
Description: Looking at the primary (south) and east elevations of the residence. Note the gable overhang that protects the secondary entryway.
Date: 9/6/2022
View: Northwest

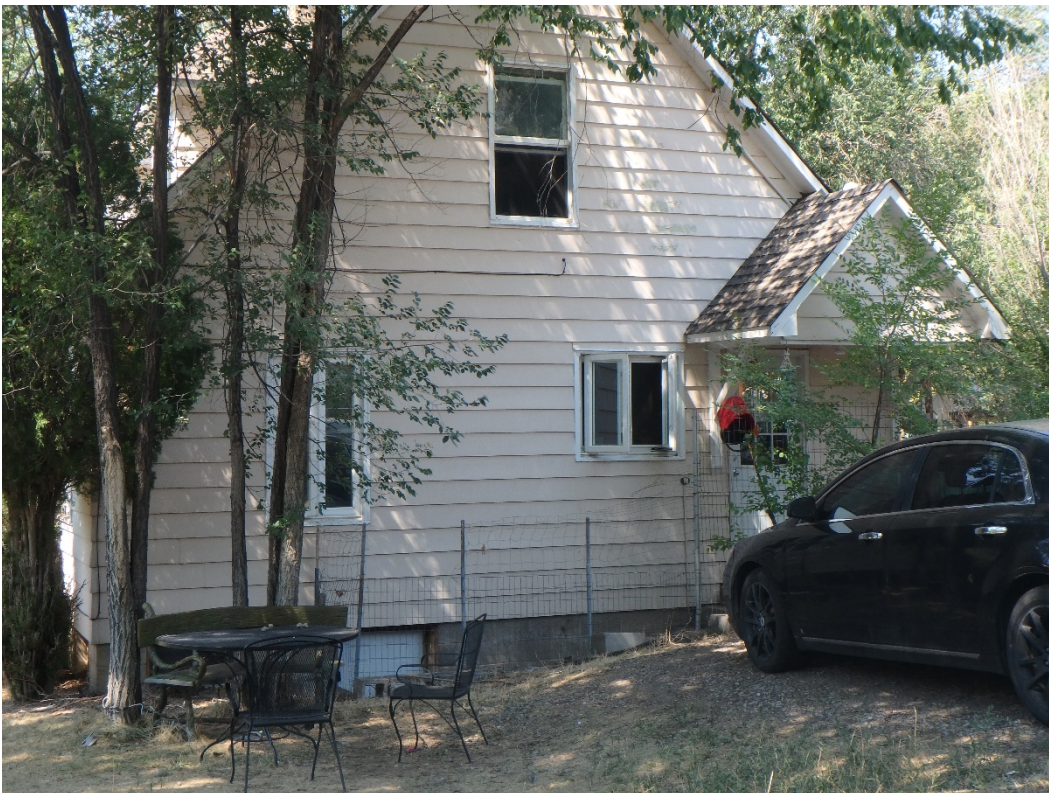
Photo Number: 5GF.5924_4
Description: Looking at the east elevation of the building.
Date: 9/6/2022
View: Northwest

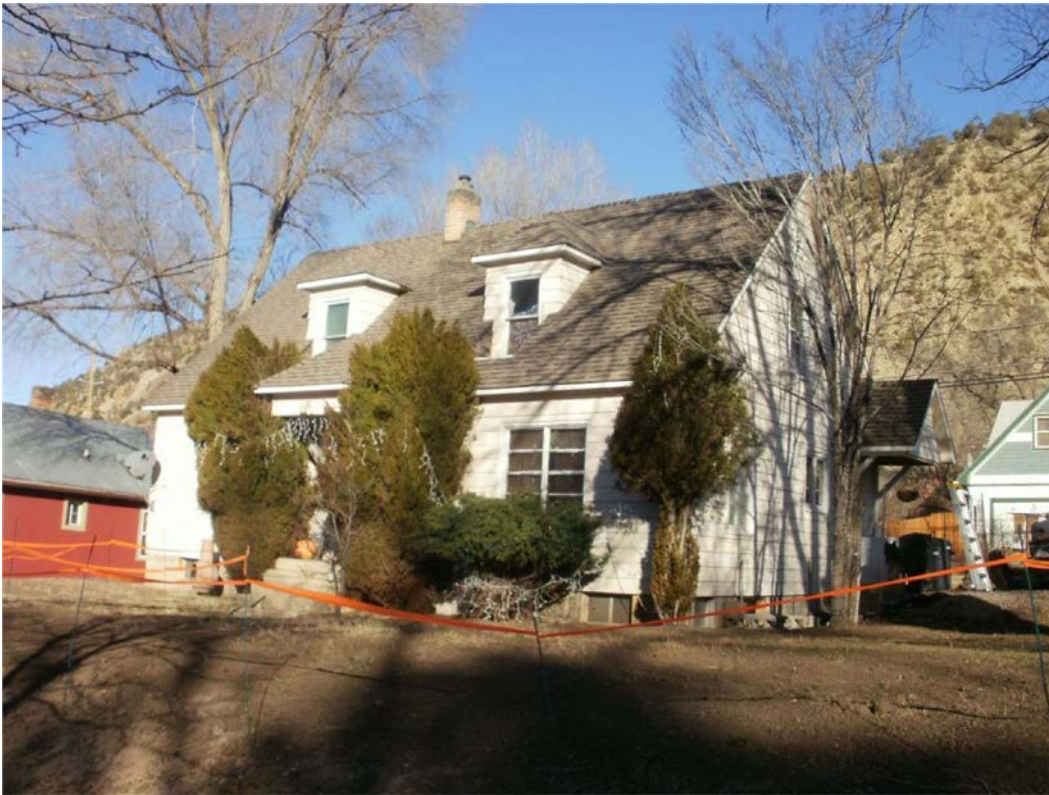
Reference Photo 1

Description: Looking at the primary (south) and east elevations of the residence. The image was taken prior to 2012 due to historic windows remaining extant.
