COLORADO CULTURAL RESOURCES INVENTORY

Historical and Architectural Reconnaissance

1. Property Name: Nancie Shauger Residence Historic Current Other:
2. Resource Classification: Building Structure Object Sites/Landscape
3. Ownership: Federal State Local Non-profit Private Unknown

4. Street Address: 191 East Main Street
5. Municipality: New Castle, CO Vicinity:
6. County: Garfield
- **7. USGS Quad: New Castle, CO Year: 2022 7.5'
- **8. Parcel Number: 212331406001
- **9. Parcel Information: Lot(s): 2-3 Block: 1 Addition: ORIGINAL TWNSTE NEW CASTLE
- **10. Acreage: 0.14 Actual Estimated
11. PLSS information: Principal Meridian: 6th Township: 5S Range: 90W
NE ¼ of NE ¼ of NW ¼ of SE ¼ of section: 31

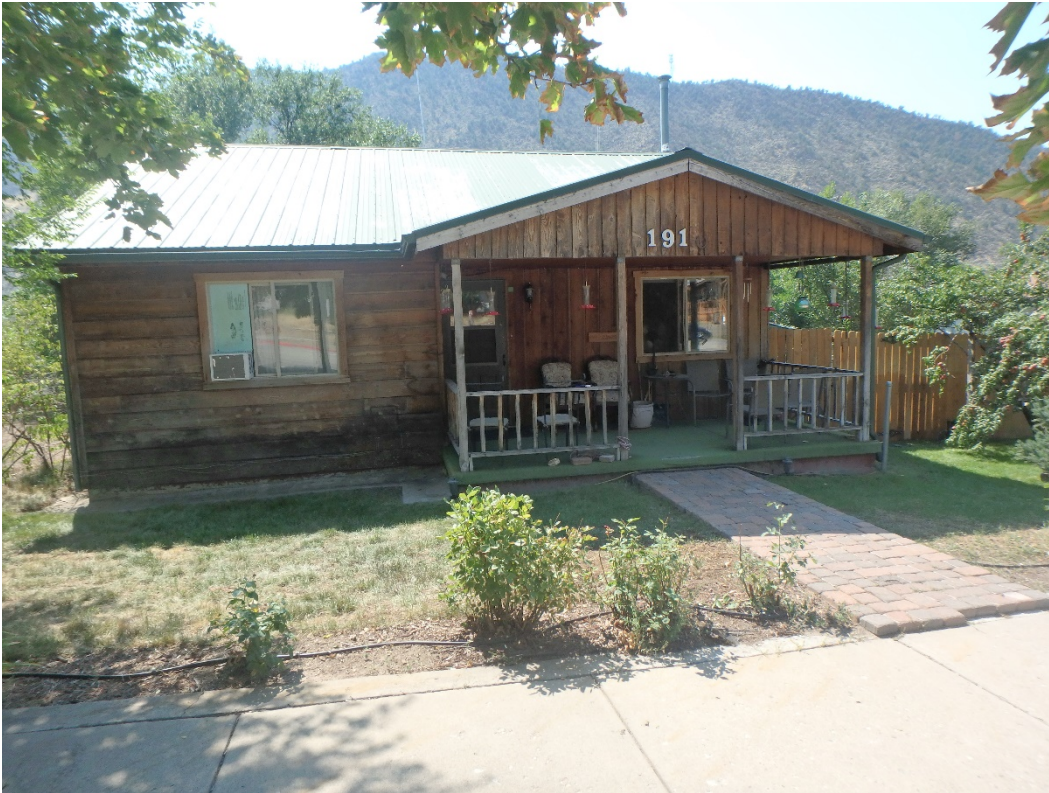
Photo Number: 5GF.5925_1
Description: Looking at the primary (north) elevation of the building.
Date: 9/6/2022
View: South

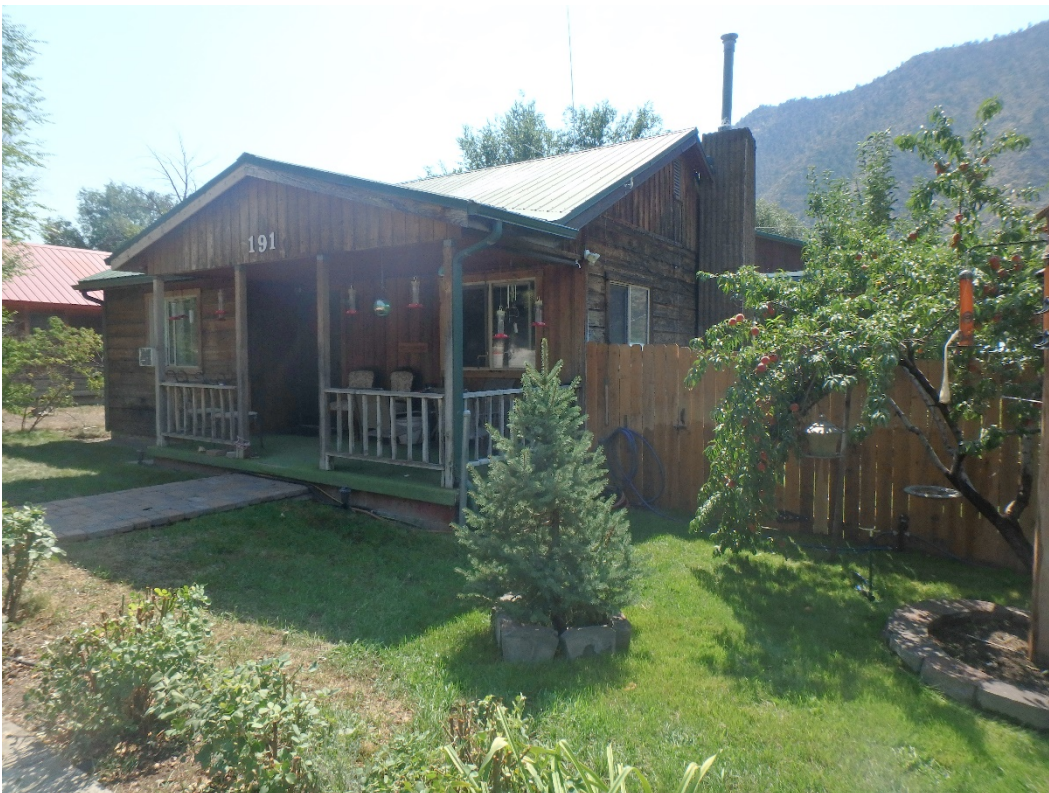
Photo Number: 5GF.5925_2
Description: Looking at the primary (north) and west elevations of the residence.
Date: 9/6/2022
View: Southeast

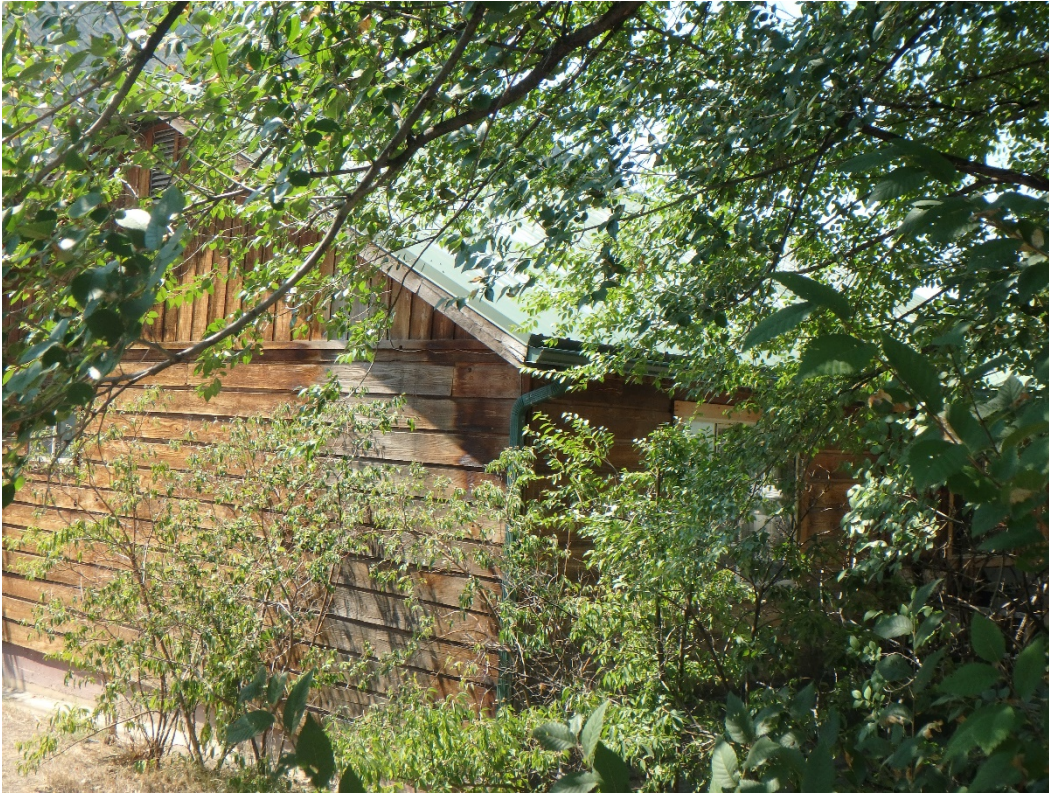
Photo Number: 5GF.5925_3

Description: Looking at the east and primary (north) elevations of the building.
