COLORADO CULTURAL RESOURCES INVENTORY

Historical and Architectural Reconnaissance

i. Property Name. <u>Pete Mattivi P</u>	10use		△ nisto		u 🗆 Other.
2. Resource Classification: $\ \ \ \ \ \ \ \ \ \ \ \ \ $	Building	Structure	□ Object	☐ Sites/Landso	cape

3. Ownership: ☐ Federal	☐ State	☐ Local	☐ Non-profit	□ Private	□ Unknown
LOCATION 4. Street Address: 202 West Mail	n Street				
5. Municipality: New Castle, CO			☐ Vicinity:

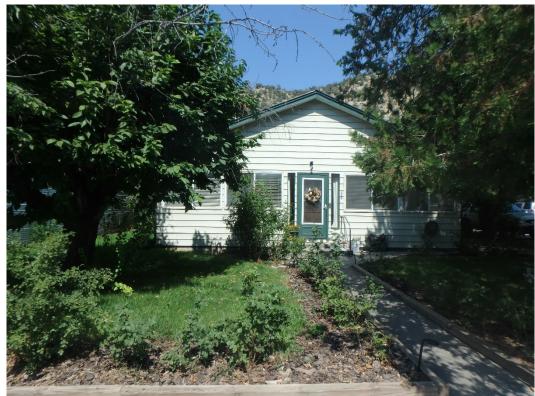
Photo Number: 5GF.5918_1

Description: Looking at the primary (south) elevation of the building.

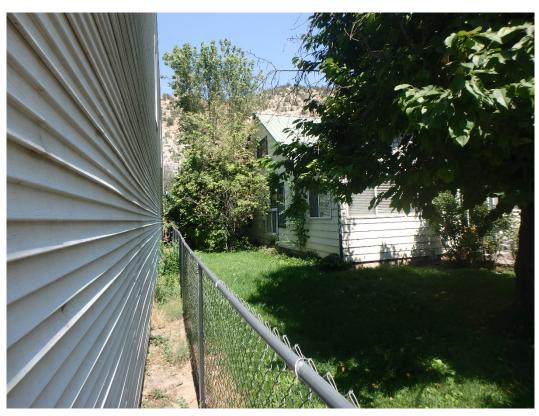
Photo Number: 5GF.5918_2

Description: Looking at the west and primary (south) elevation of the building. Note that the wall to the left is not a part of the

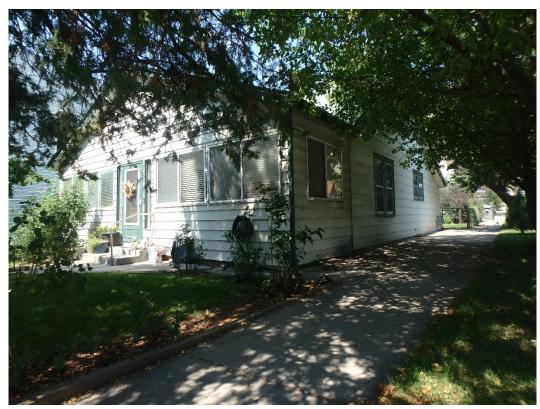
Photo Number: 5GF.5918_3

Description: Looking at the primary (south) and east elevations of the building. Note the composite siding on the exterior of the front gable projection while the side gable is clad with asbestos siding.

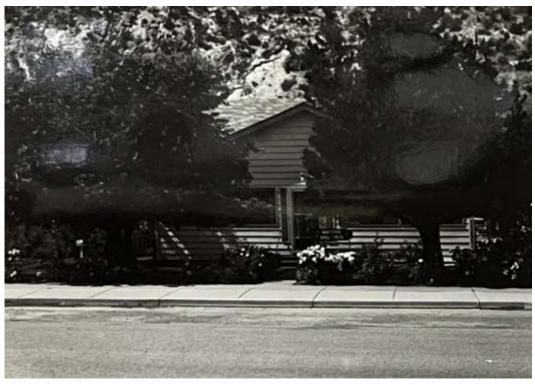
Historic Photo 1

Description: Looking at the primary (south) elevation of the building. The photo description states, "Pete Mattivi House/built by Peter Dow."
