## COLORADO CULTURAL RESOURCES INVENTORY

### Historical and Architectural Reconnaissance

1. Property Name: H.R. Kamm Store  Historic  Current  Other:  
 2. Resource Classification:  Building  Structure  Object  Sites/Landscape  
 3. Ownership:  Federal  State  Local  Non-profit  Private  Unknown

4. Street Address: 275 West Main Street  
 5. Municipality: New Castle, CO  Vicinity:  
 6. County: Garfield  
 \*\*7. USGS Quad: New Castle, CO Year: 2022  7.5'  
 \*\*8. Parcel Number: 212331408011  
 \*\*9. Parcel Information: Lot(s): 15, 16 Block: 3 Addition: ORIGINAL TWNSTE NEW CASTLE  
 \*\*10. Acreage: 0.11  Actual  Estimated  
 11. PLSS information: Principal Meridian: 6<sup>th</sup> Township: 5S Range: 90W  
NE ¼ of NW ¼ of NW ¼ of SE ¼ of section: 31

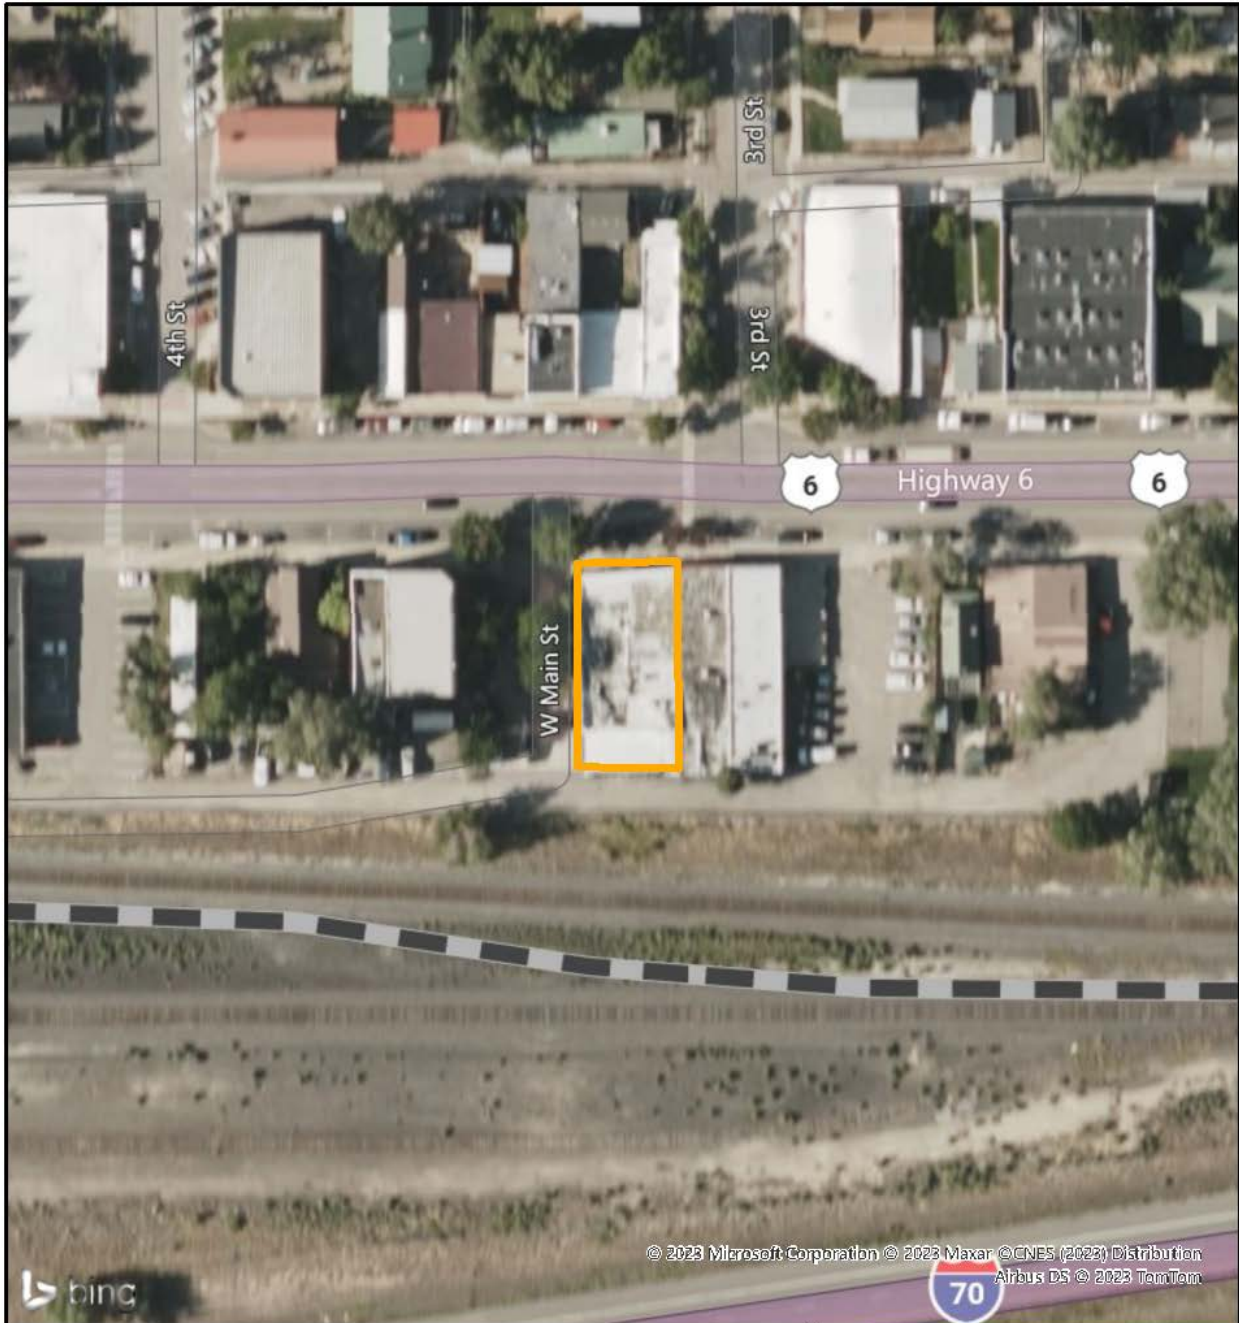
### Sketch Map

</div>	<p><b>Pinyon</b> Environmental, Inc.</p> <p><b>Sketch Map</b> 275 West Main Street (5GF.2374) New Castle, Colorado Garfield County</p>				
<p>Pinyon Project Number: I 22156.001</p>	<table border="1" style="width: 100%;"> <tr> <td style="width: 50%;">Drawn By: CJB</td> <td style="width: 50%;">Figure: 2</td> </tr> <tr> <td>Reviewed By: CMW</td> <td>Date: 4/10/2023</td> </tr> </table>	Drawn By: CJB	Figure: 2	Reviewed By: CMW	Date: 4/10/2023
Drawn By: CJB	Figure: 2				
Reviewed By: CMW	Date: 4/10/2023

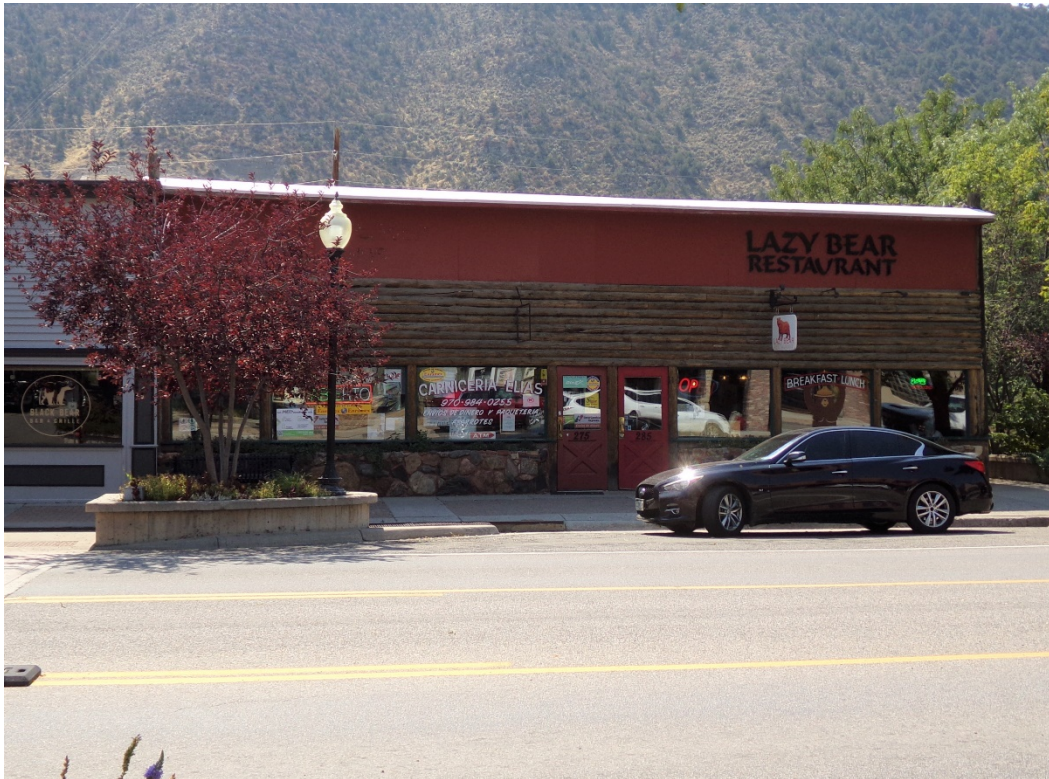
**Photo Number:** 5GF.2374\_1  
**Description:** Looking at the primary (north) elevation of the building.  
**Date:** 9/6/2022  
**View:** South

The one-story, rectangular shaped building was constructed circa 1888. The approximately 100' by 50' building is representative of a Nineteenth Century Commercial style of architecture. Architectural elements of the building include a stacked stone foundation; a flat roof with stepped parapets; a brick structural system clad in stucco; novelty siding along the primary (north) elevation; several decorative brackets under the cornice; and several convex awnings. The typical window consists of a wood framed, rectangular picture window with a wood sill. There are two entryways located in the center of the primary (north) elevation. The left side door is labeled with "275" while the right-side door is labeled "285." The numbers coincide with their addresses on Main Street. The main entryway doors consist of a wood panel door with a single lite. The doors are flanked on both sides by several typical window units that extend to each end of the façade. Stone masonry can be noticed between the window sills and the foundation. Above the typical windows are log features that transition to stucco below the cornice. Signage titled "Lazy Bear Restaurant" can be seen on the far-right side of the primary (north) elevation below the cornice. The west elevation consists of stucco exterior envelope although horizontal weatherboard can be noticed on the right side of the elevation. A recessed entryway is located in the center of the elevation. Another entryway and a typical window are located on the far-right side of the elevation.

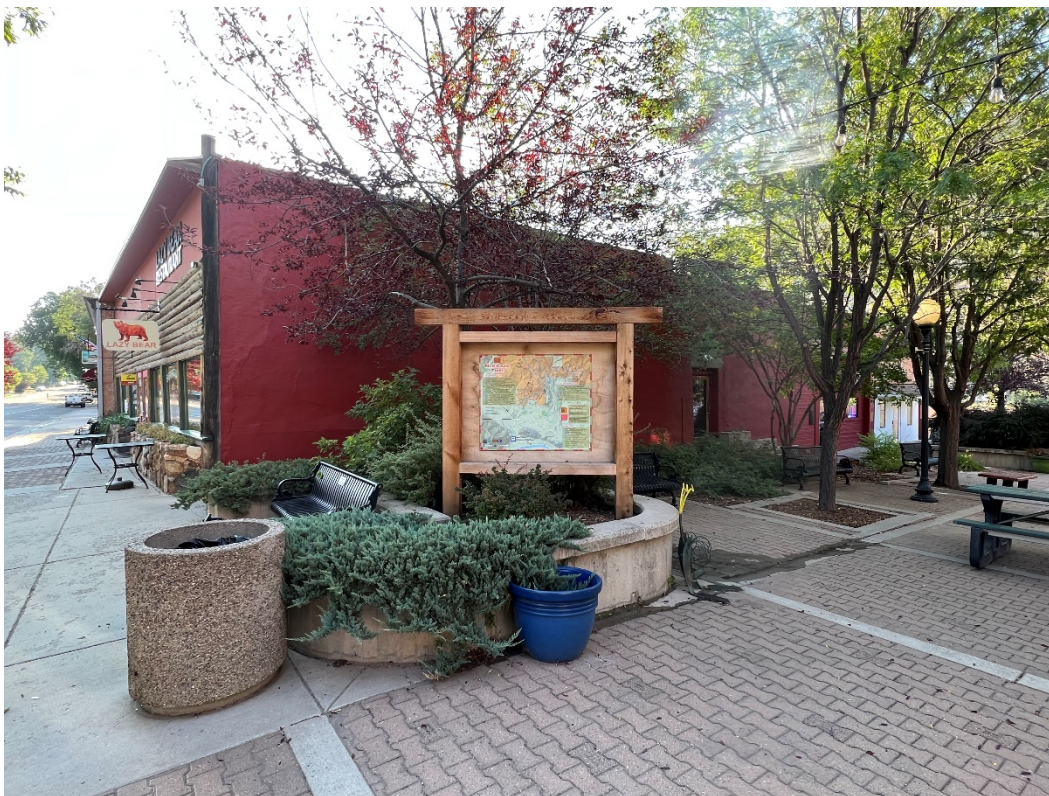
**Photo Number:** 5GF.2374\_2  
**Description:** Looking at the primary (north) and west elevations of the building.  
**Date:** 9/6/2022  
**View:** Southeast

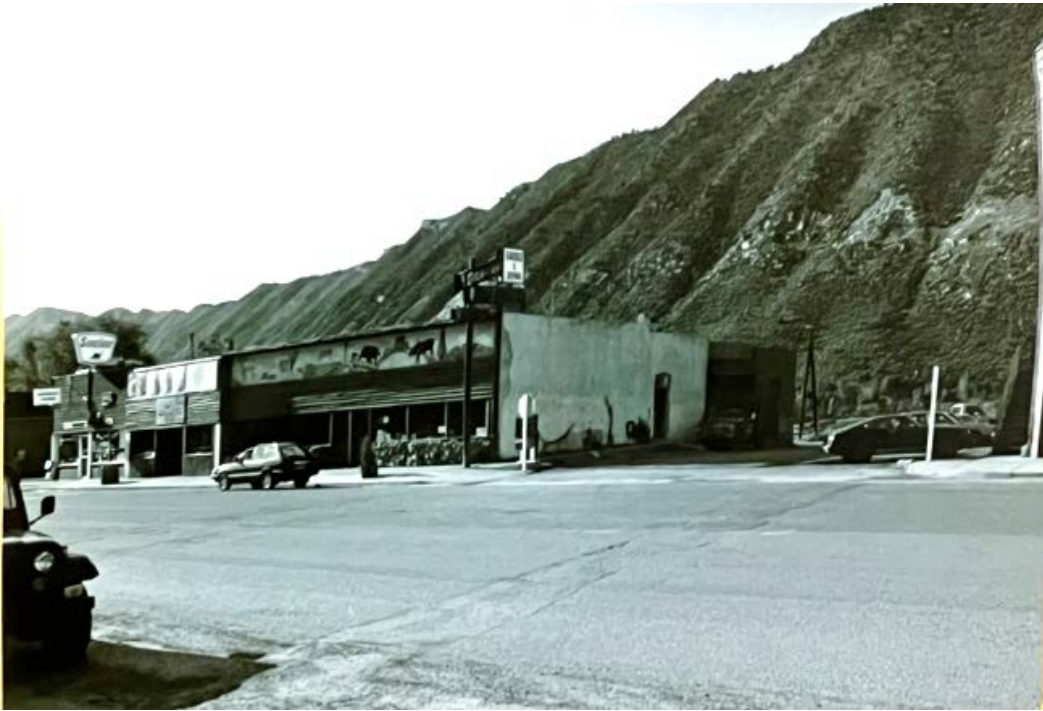
**Reference Photo 1**

**Description:** Looking at the primary (north) and west elevations of the building.

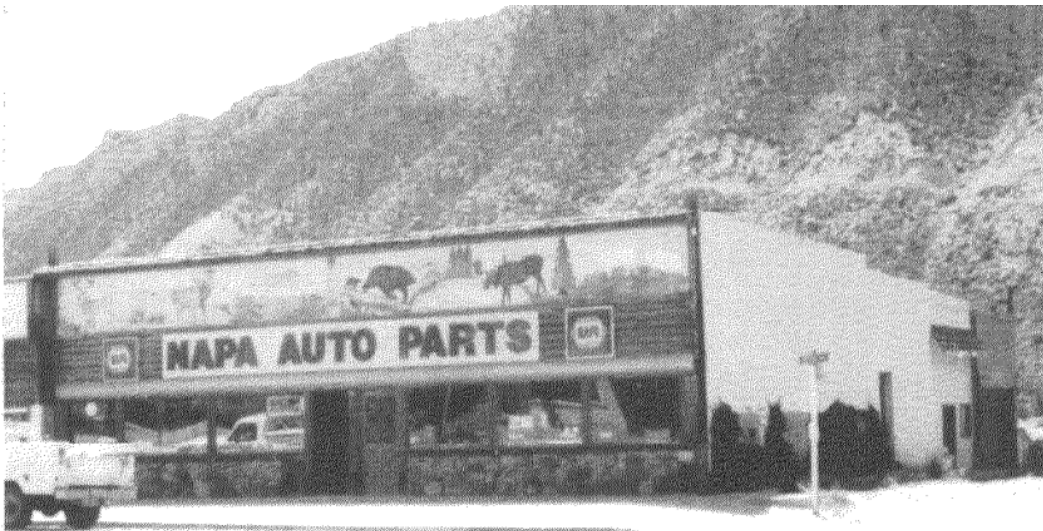
**Reference Photo 2**

**Description:** Looking at the primary (north) and west elevations of the building. Note that the building has transitioned from a guide and taxidermy business to a NAPA Auto Parts store.

Historic records indicate that the building was altered by the late Twentieth Century. Sanborn Fire Insurance maps between 1883 and 1899 reveal that an addition was construction along the south elevation. During the building's use as a guide and taxidermy business in the mid to late Twentieth Century, a mural depicting an alpine vista was painted under the cornice of the primary (north) elevation. Log and stone masonry features were also incorporated into the façade by this time and the windows were replaced. By 1996, historic imagery demonstrates that the building transitioned into a NAPA Auto Parts store with wall mounted signage on the façade of the primary (north) elevation. By 2012, historic street imagery demonstrates that the building was converted into a restaurant and that the alpine vista mural had been removed.

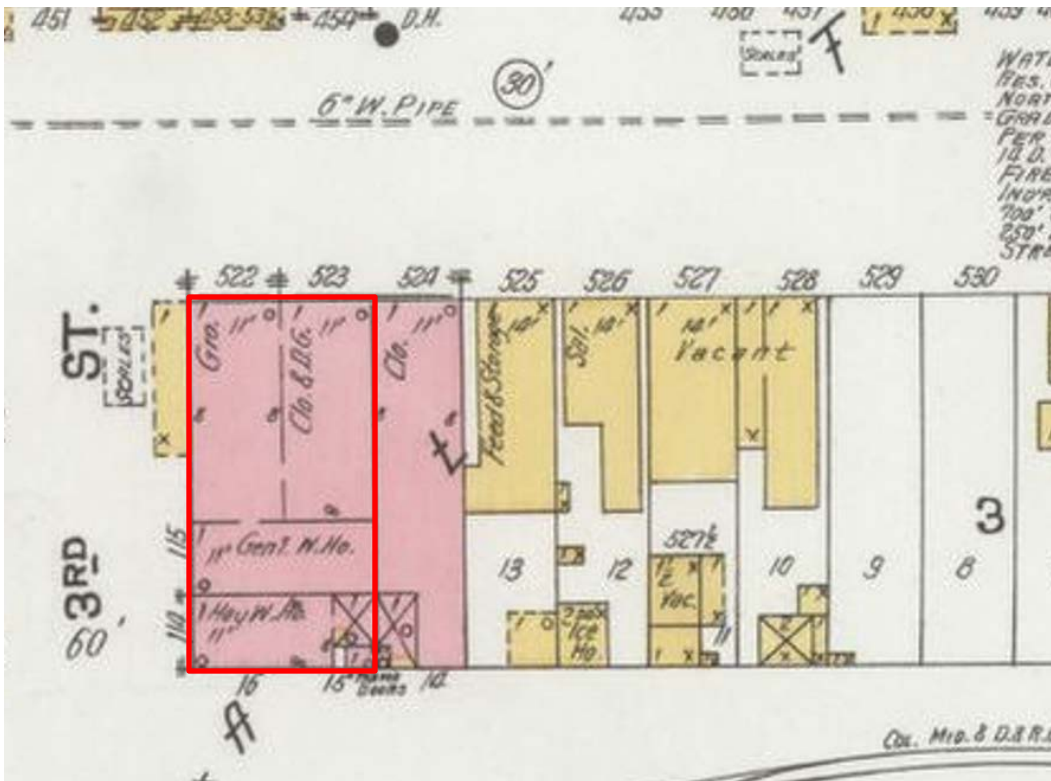
**Reference Photo 5**

**Description:** 1904 Sanborn Fire Insurance map of the resource. The property is outlined in red.

The 1893 Sanborn map shows a masonry store building, with a grocery in the western part and dry goods on the east. Associated with the building was a detached warehouse to the rear of the lot. The 1899 map indicates that the western part of the building still housed a grocery store. A second warehouse had been added behind the store building, connecting it to the other warehouse. The 1904 map indicates the same uses of the building. A covered overhang and scales had been added to the west of the building."
