## COLORADO CULTURAL RESOURCES INVENTORY

### Historical and Architectural Reconnaissance

1. Property Name: Emily & Nathaniel Hodge Residence       Historic     Current     Other:
2. Resource Classification:     Building     Structure     Object     Sites/Landscape
3. Ownership:     Federal     State     Local     Non-profit     Private     Unknown

4. Street Address: 281 East Main Street
5. Municipality: New Castle, CO       Vicinity:
6. County: Garfield
- \*\*7. USGS Quad: New Castle, CO      Year: 2022     7.5'
- \*\*8. Parcel Number: 212331405001
- \*\*9. Parcel Information: Lot(s): 1-4      Block: P      Addition: Spencer's 2<sup>nd</sup>
- \*\*10. Acreage: 0.24       Actual     Estimated
11. PLSS information: Principal Meridian: 6<sup>th</sup>      Township: 5S      Range: 90W  
    NW ¼ of NW ¼ of NE ¼ of SE ¼ of section: 31
- \*\*12. Location Coordinates:  
    UTM reference: Zone 13      ;mE 282746      ;mN 4383017     NAD 1927       NAD 1983  
    or  
    Lat/Long: Latitude \_\_\_\_\_ ; Longitude \_\_\_\_\_     WGS84     Other:

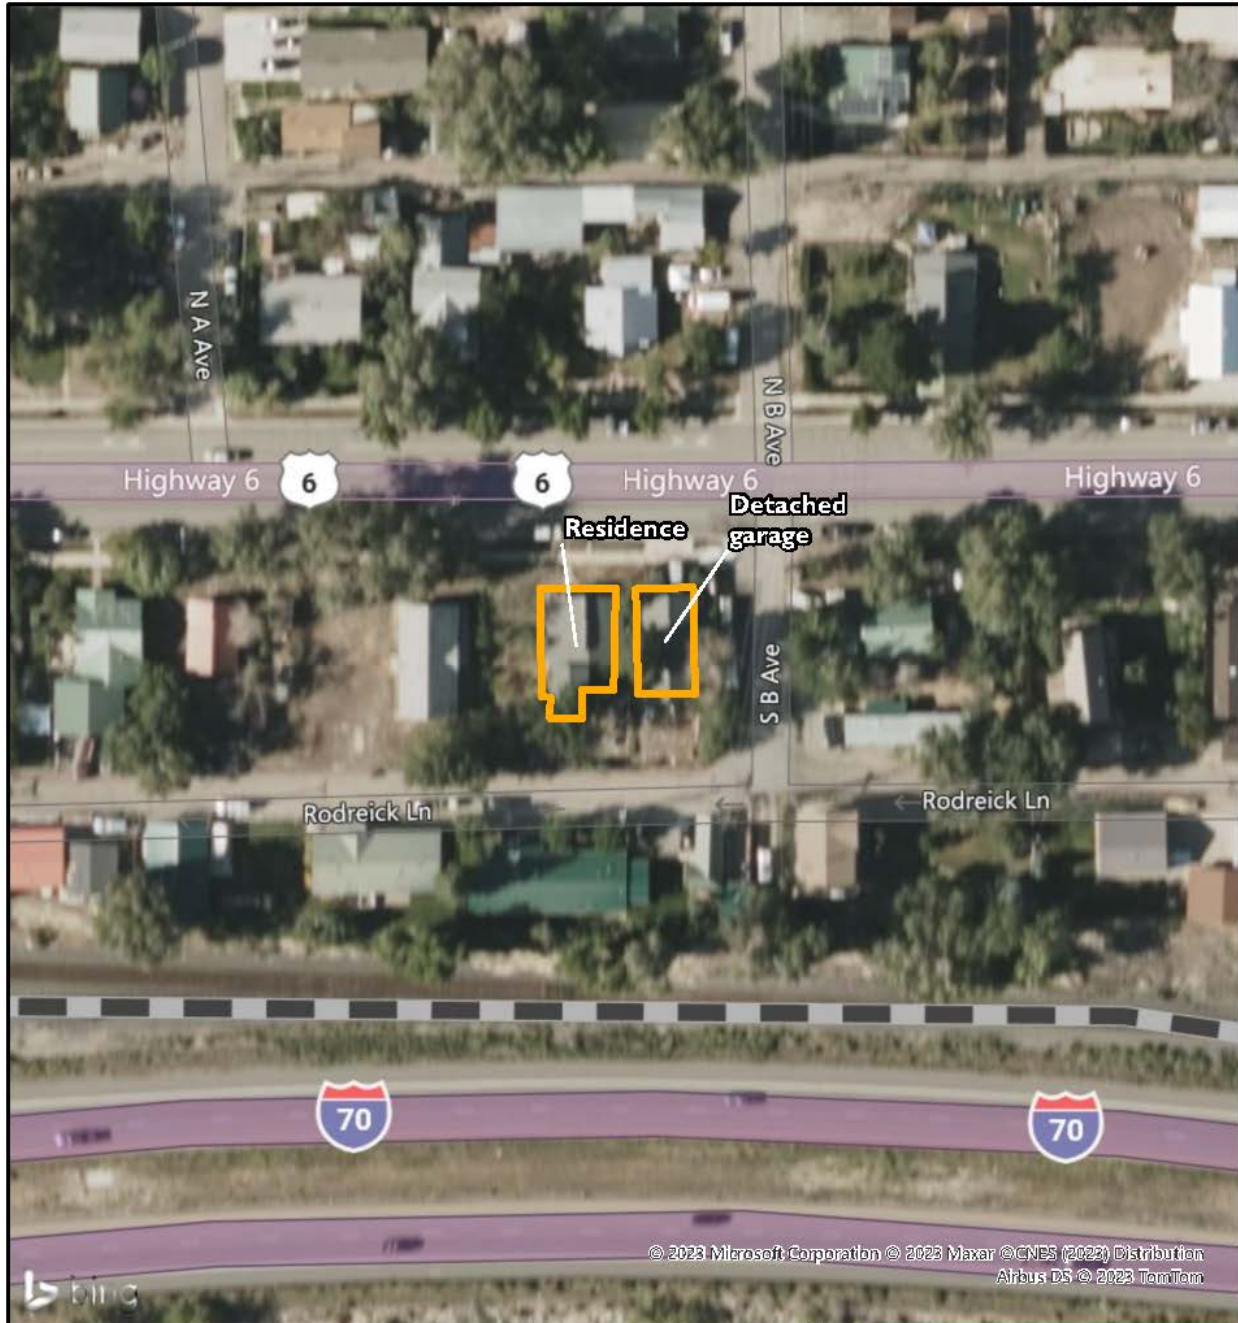
### Sketch Map

<p><b>Sketch Map</b>        281 East Main Street (5GF.5928)        New Castle, Colorado        Garfield County</p>				
<p>Pinyon Project Number: I 22156.001</p>	<table border="1"> <tr> <td>Drawn By: CJB</td> <td>Figure: 2</td> </tr> <tr> <td>Reviewed By: CMW</td> <td>Date: 4/10/2023</td> </tr> </table>	Drawn By: CJB	Figure: 2	Reviewed By: CMW	Date: 4/10/2023
Drawn By: CJB	Figure: 2				
Reviewed By: CMW	Date: 4/10/2023

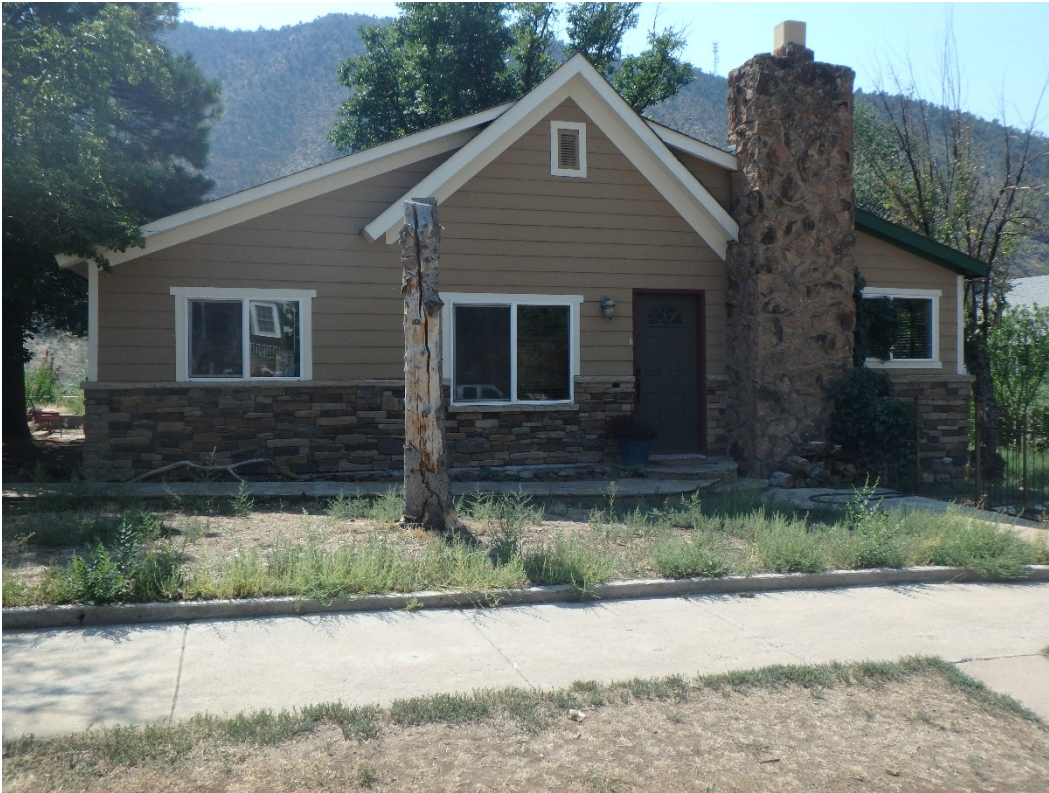
**Photo Number:** 5GF.5928\_1  
**Description:** Looking at the primary (north) elevation of the residence.  
**Date:** 9/6/2022  
**View:** South

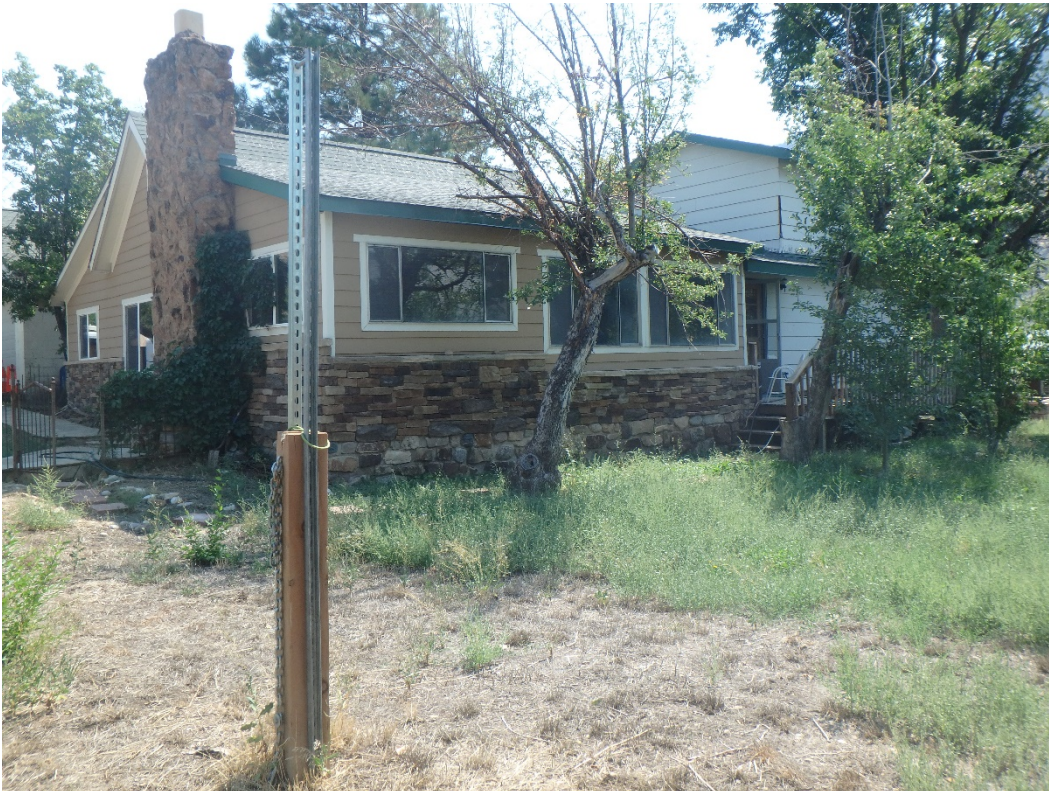
**Photo Number:** 5GF.5928\_2  
**Description:** Looking at the primary (north) and west elevations of the building.  
**Date:** 9/6/2022  
**View:** Southeast

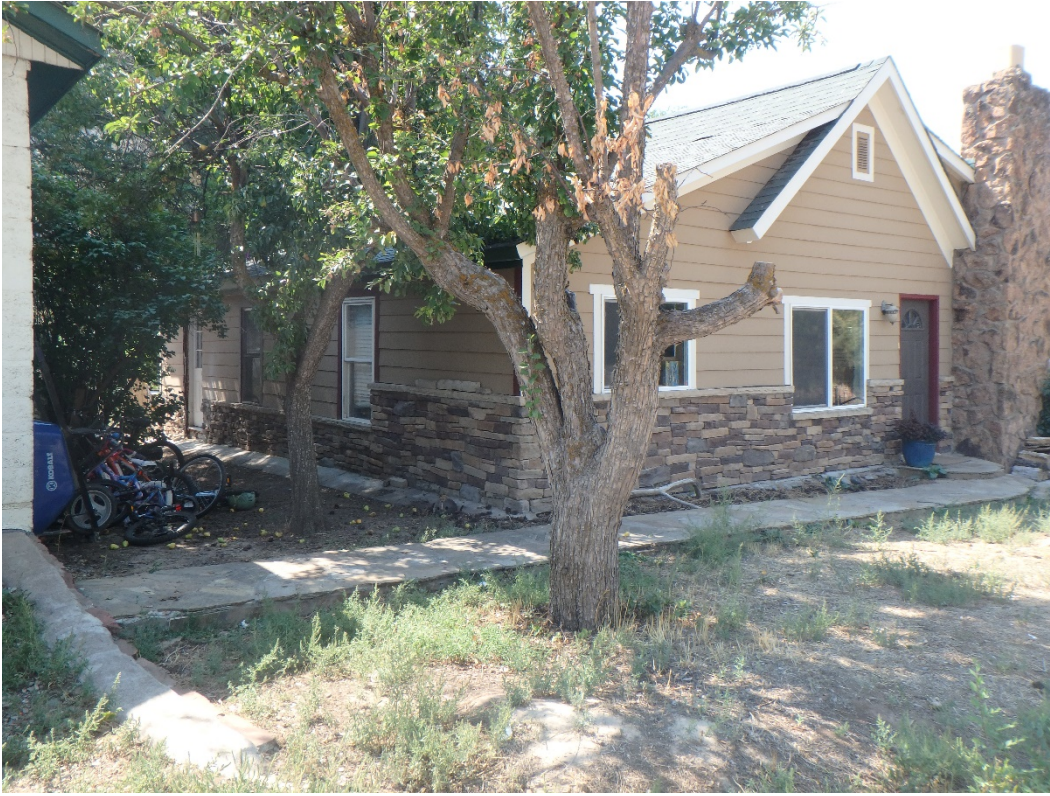
**Photo Number:** 5GF.5928\_3  
**Description:** Looking at the west and primary (north) elevations of the building.  
**Date:** 9/6/2022  
**View:** Southwest
