COLORADO CULTURAL RESOURCES INVENTORY

Historical and Architectural Reconnaissance

1. Property Name: Shannon Poland & Carmel Walden Residence Historic Current Other:
2. Resource Classification: Building Structure Object Sites/Landscape
3. Ownership: Federal State Local Non-profit Private Unknown

4. Street Address: 296 East Main Street
5. Municipality: New Castle, CO Vicinity:
6. County: Garfield
- **7. USGS Quad: New Castle, CO Year: 2022 7.5'
- **8. Parcel Number: 212331105011
- **9. Parcel Information: Lot(s): 1-4 Block: F Addition: Spencer's Addition
- **10. Acreage: 0.22 Actual Estimated
11. PLSS information: Principal Meridian: 6th Township: 5S Range: 90W
SW ¼ of SW ¼ of SE ¼ of NE ¼ of section: 31

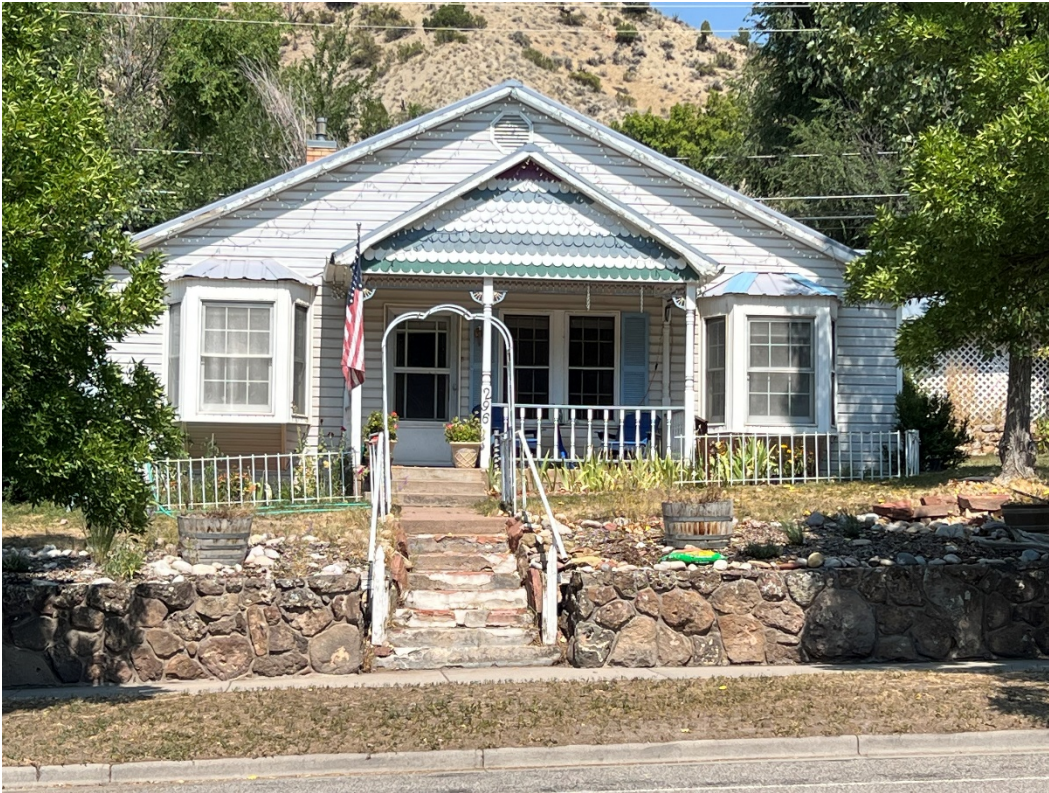
Photo Number: 5GF.5929_1
Description: Looking at the primary (south) elevation of the primary building. Note the decorative wood spindlework and brackets under the gable ceiling of the porch overhang.
Date: 9/6/2022
View: North

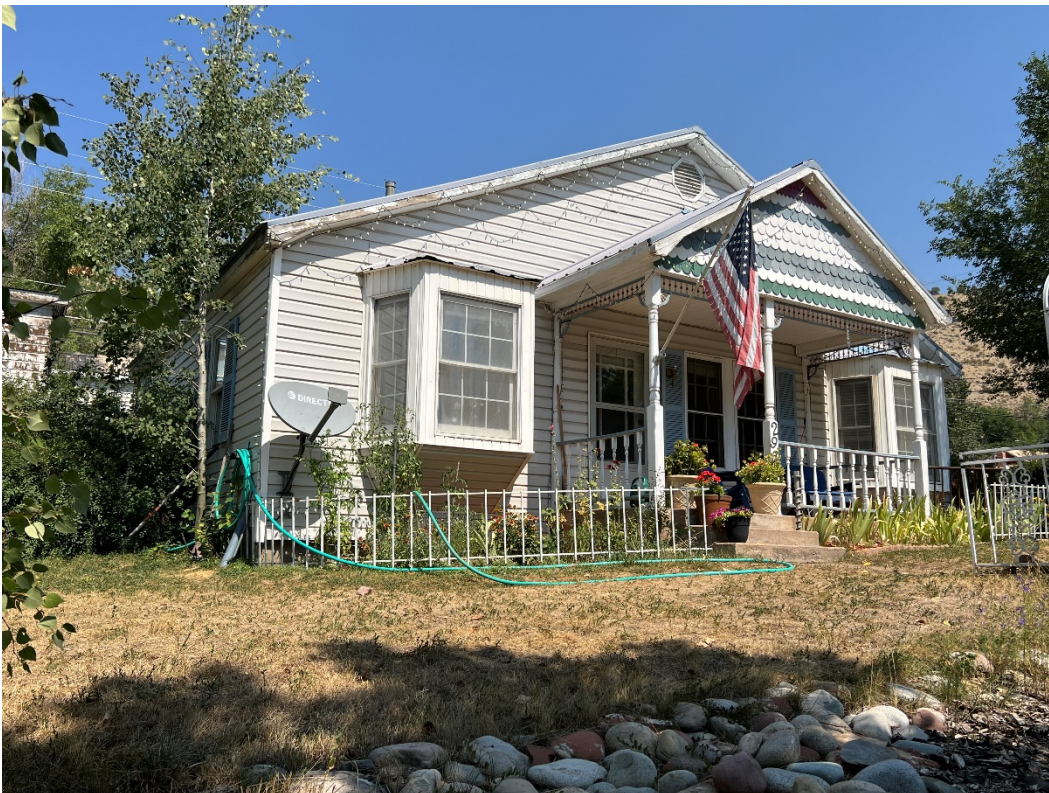
Photo Number: 5GF.5929_2
Description: Looking at the west and primary (south) elevations of the primary residence.
Date: 9/6/2022
View: Northeast

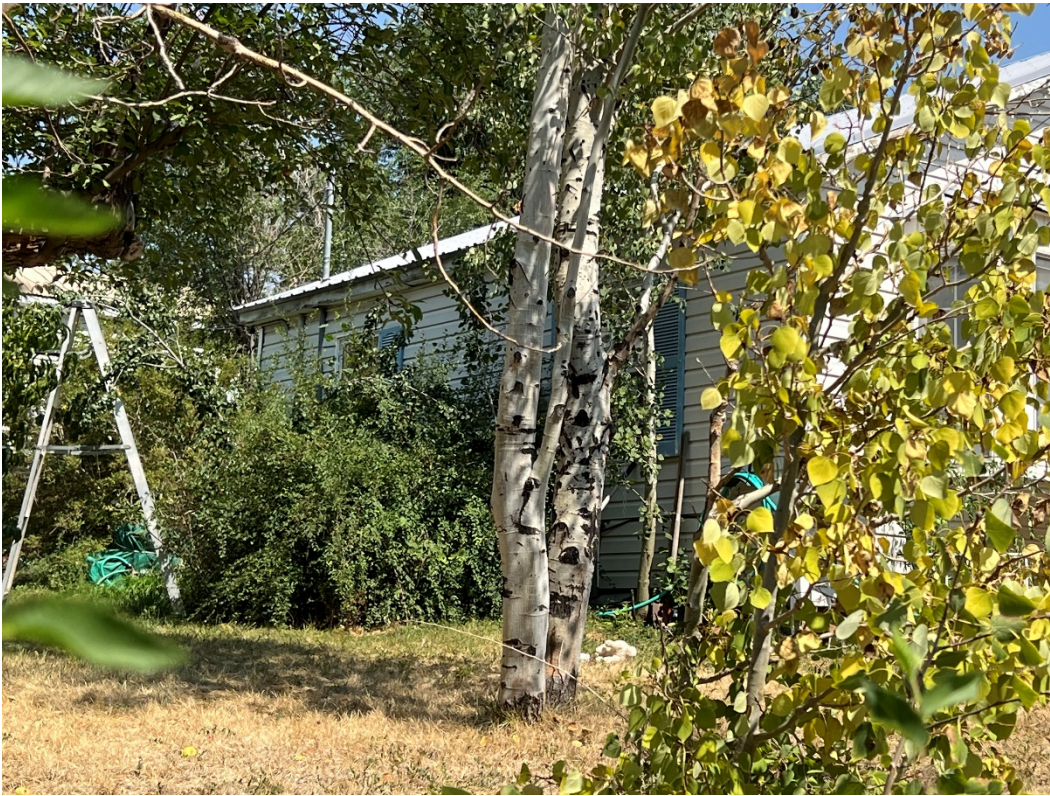
Photo Number: 5GF.5929_3
Description: Looking at the west elevation of the primary building. A majority of the elevation is obscured by vegetation.
Date: 9/6/2022
View: Northeast

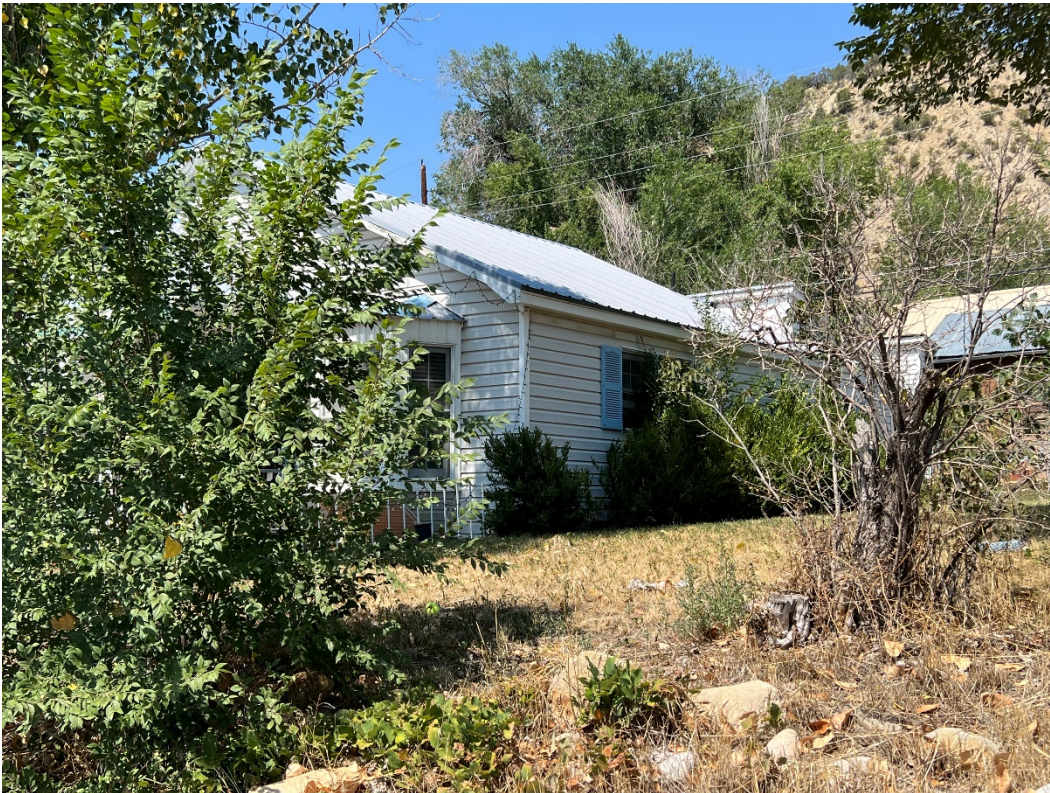
Photo Number: 5GF.5929_4
Description: Looking at the east elevation of the primary building.
Date: 9/6/2022
View: Northwest

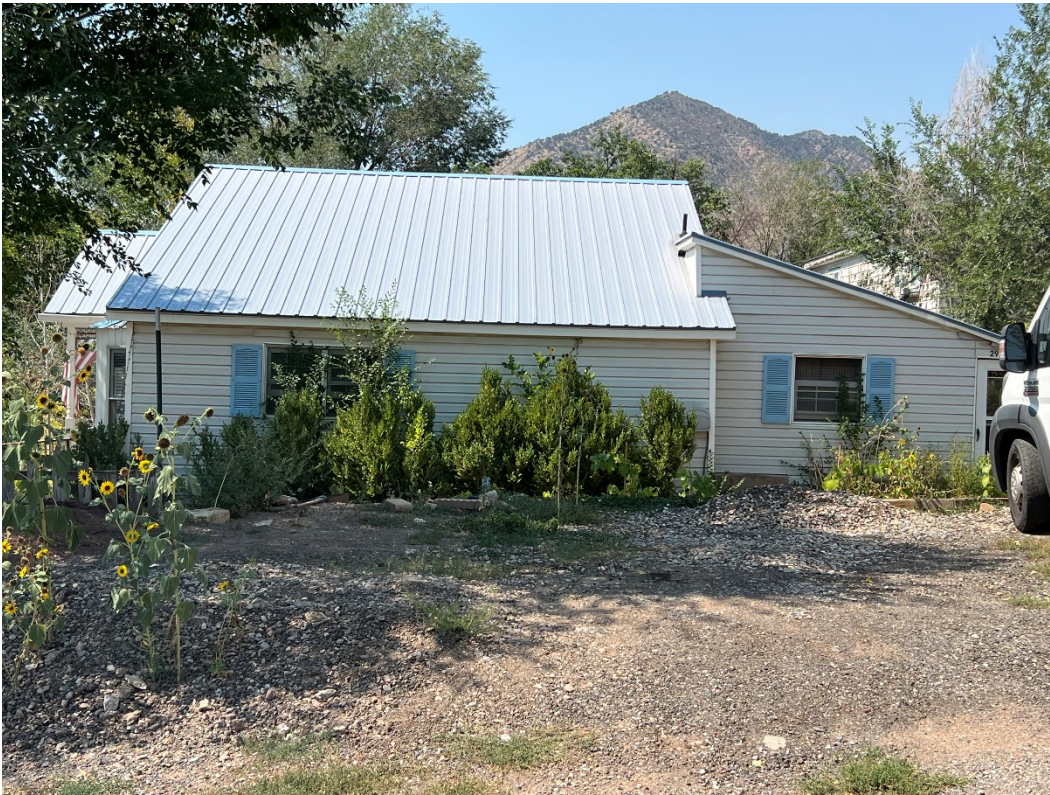
Photo Number: 5GF.5929_5

Description: Looking at the east elevation of the primary building. Note the shed roof addition to the north elevation (right side of photo).

window incorporates a typical window consisting of a six-over-six double hung sash unit. The center window of the bay unit is flanked on both sides by a four-over-four double hung sash unit. A shed roof addition was constructed along the north elevation of the building at some point. Additionally, the metal roof likely replaced a prior asphalt shingle roof.
