## COLORADO CULTURAL RESOURCES INVENTORY

### Historical and Architectural Reconnaissance

1. Property Name: Mattivi Motor Co./Phillips 66       Historic     Current     Other:
2. Resource Classification:     Building     Structure     Object     Sites/Landscape
3. Ownership:     Federal     State     Local     Non-profit     Private     Unknown

4. Street Address: 298 West Main Street
5. Municipality: New Castle, CO       Vicinity:
6. County: Garfield
- \*\*7. USGS Quad: New Castle, CO      Year: 2022     7.5'
- \*\*8. Parcel Number: 212331108013
- \*\*9. Parcel Information: Lot(s): 8-9      Block: C      Addition: ORIGINAL TWNSTE NEW CASTLE
- \*\*10. Acreage: 0.11       Actual     Estimated
11. PLSS information: Principal Meridian: 6<sup>th</sup>      Township: 5S      Range: 90W  
SE ¼ of SW ¼ of SW ¼ of NE ¼ of section: 31
- \*\*12. Location Coordinates:  
 UTM reference: Zone 13      ;mE 282454      ;mN 4383083     NAD 1927       NAD 1983  
 or  
 Lat/Long: Latitude \_\_\_\_\_ ; Longitude \_\_\_\_\_     WGS84     Other:

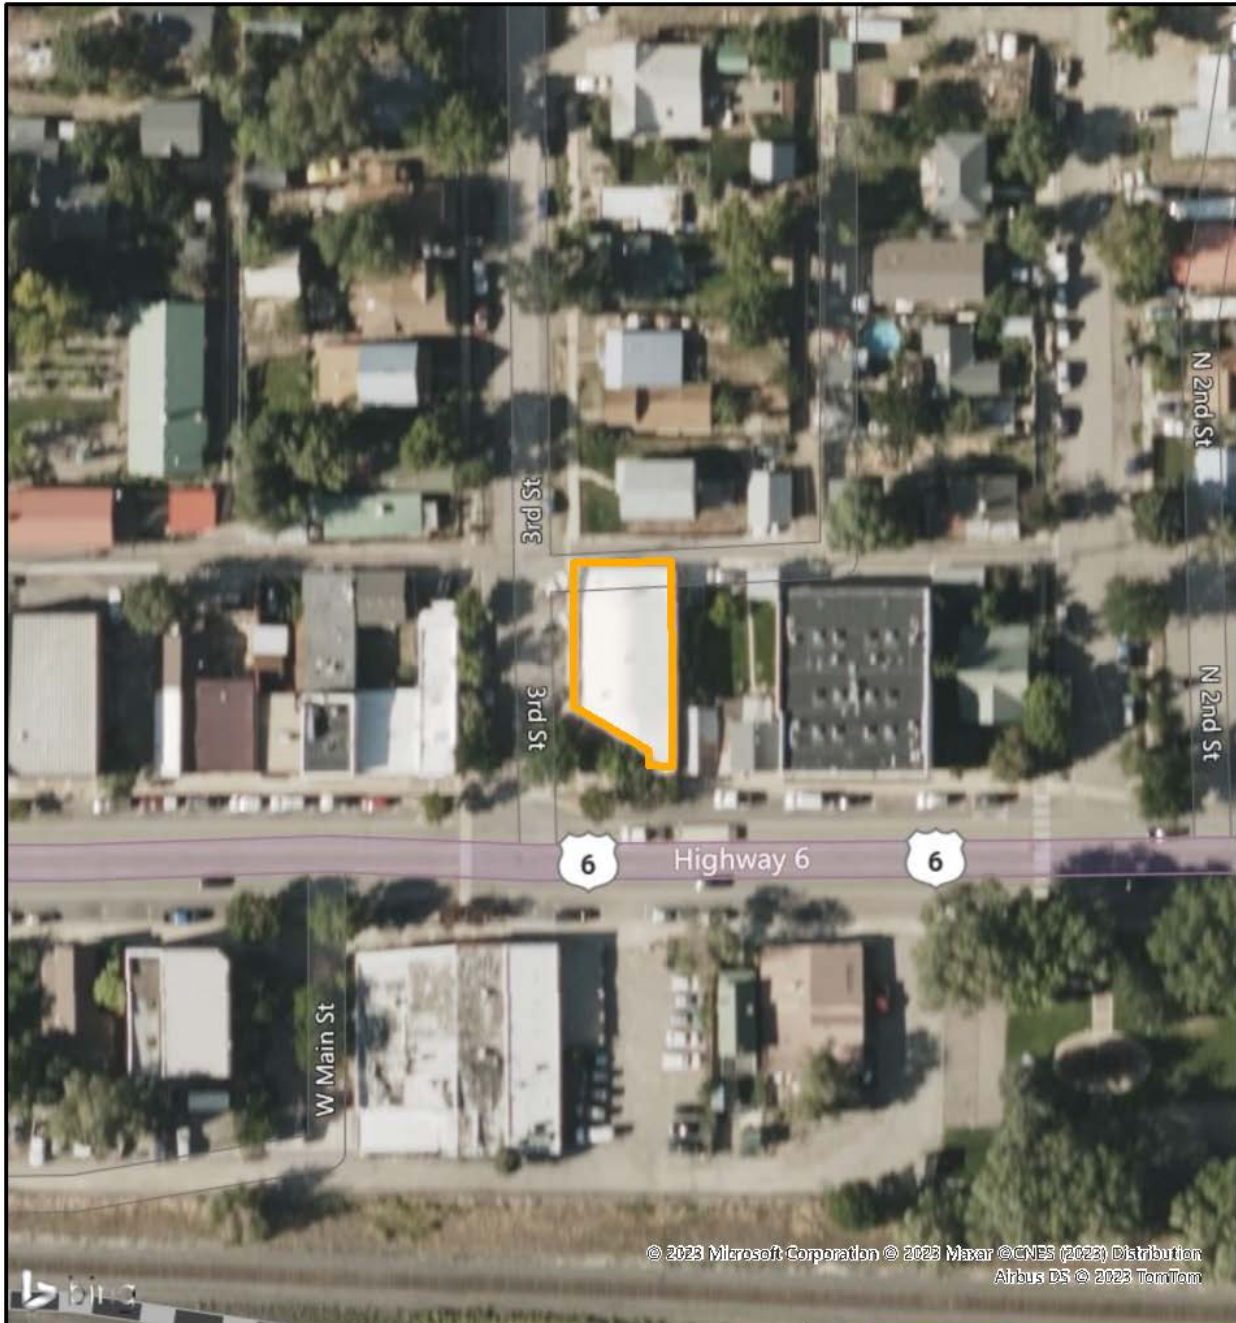
### Sketch Map

<p><b>Sketch Map</b>          298 West Main Street (5GF.2373)          New Castle, Colorado          Garfield County</p>				
<p>Pinyon Project Number: I 22156.001</p>	<table border="1"> <tr> <td>Drawn By: CJB</td> <td>Figure: 2</td> </tr> <tr> <td>Reviewed By: CMW</td> <td>Date: 4/10/2023</td> </tr> </table>	Drawn By: CJB	Figure: 2	Reviewed By: CMW	Date: 4/10/2023
Drawn By: CJB	Figure: 2				
Reviewed By: CMW	Date: 4/10/2023

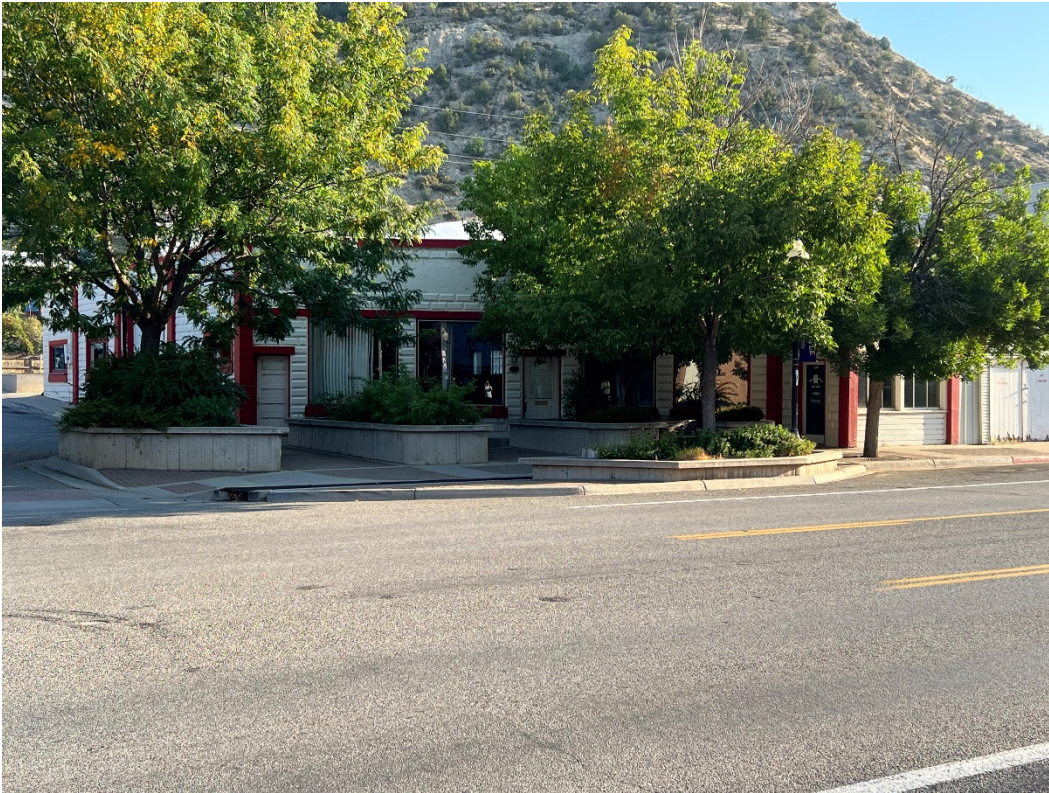
**Photo Number:** 5GF.2373\_1  
**Description:** Looking at the west and primary (south) elevations of the building. Note that a majority of the primary (south) elevation is obscured by mature deciduous trees.  
**Date:** 9/6/2022  
**View:** Northeast

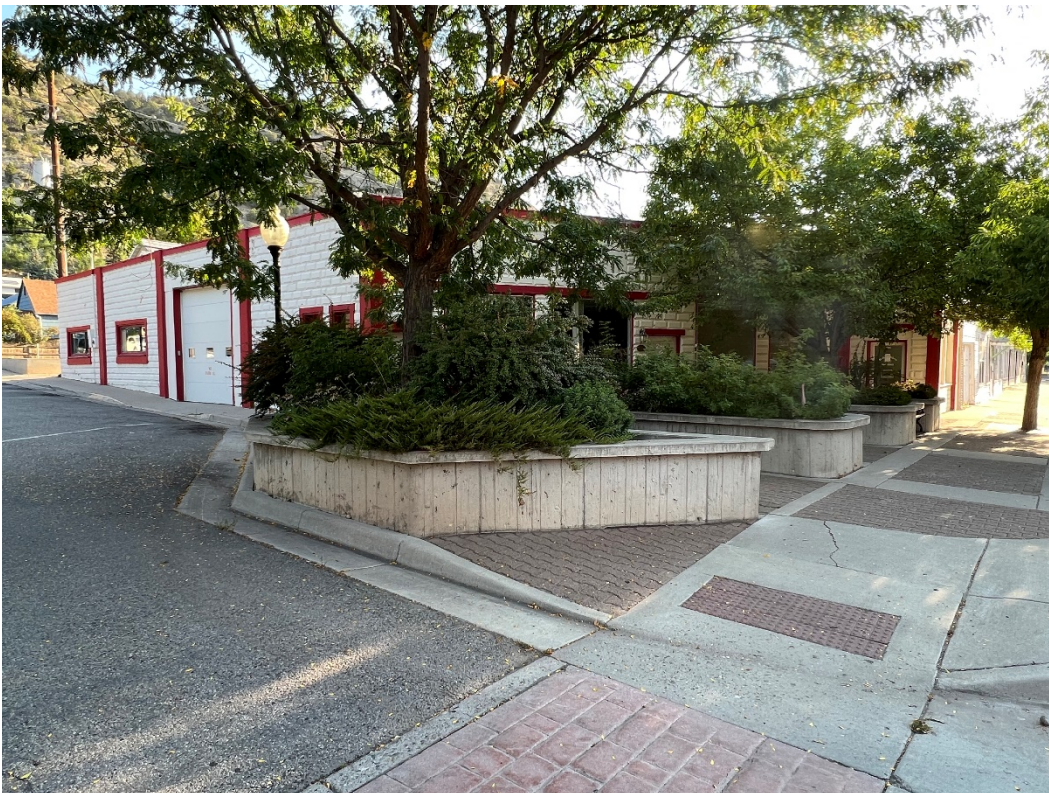
**Photo Number:** 5GF.2373\_2  
**Description:** Close up view of the west and primary (south) elevation of the building.  
**Date:** 9/6/2022  
**View:** Northeast

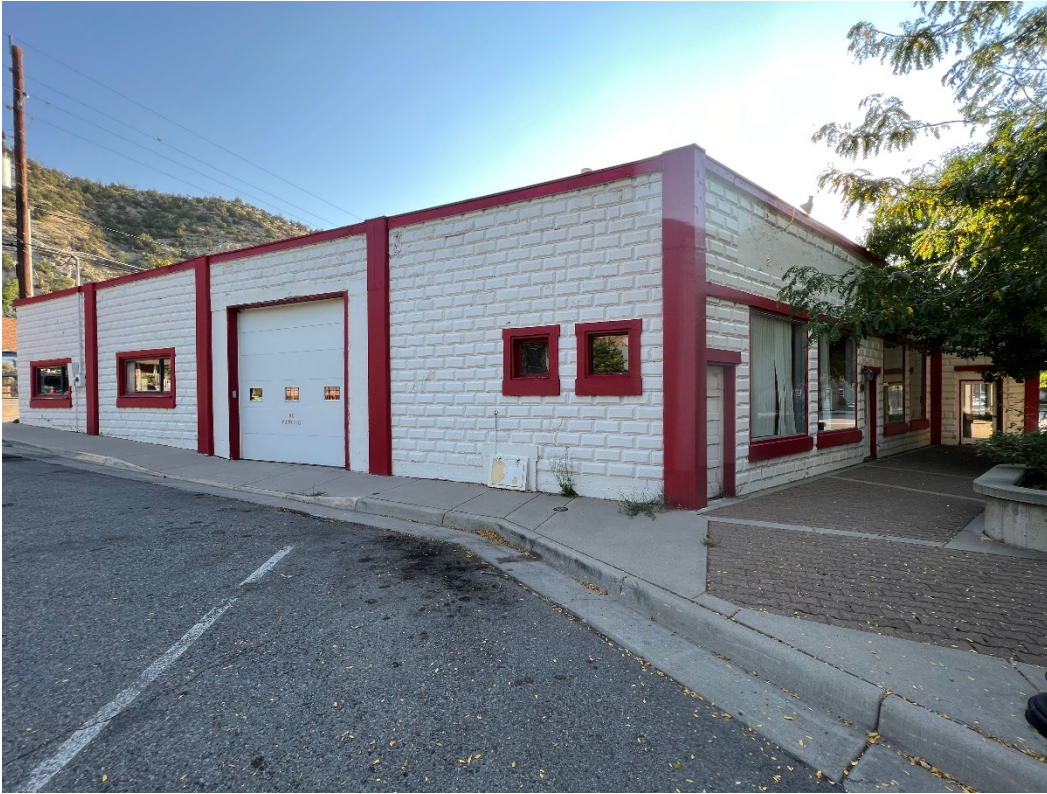
**Photo Number:** 5GF.2373\_3  
**Description:** Looking at the west and primary (south) elevation of the building.  
**Date:** 9/6/2022  
**View:** Northeast

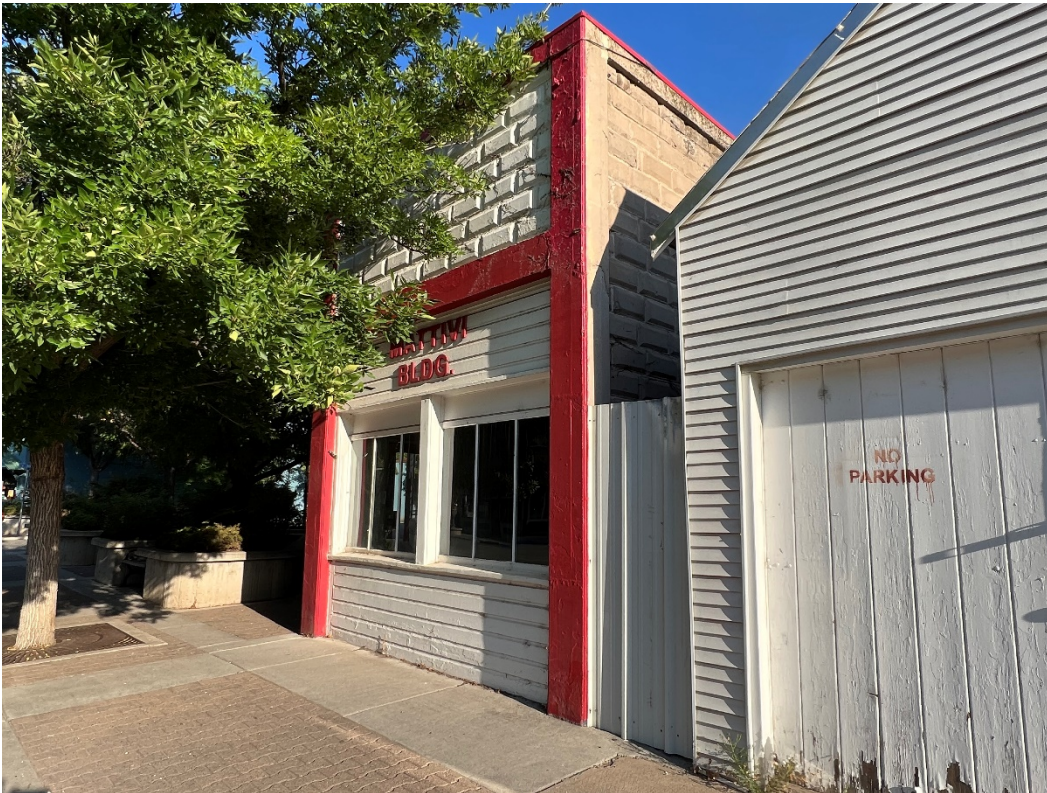
**Photo Number:** 5GF.2373\_4  
**Description:** Looking at the far-right side of the primary (south) and a portion of the east elevations. Note the former garage door opening that was covered by the mid to late Twentieth Century.  
**Date:** 9/6/2022  
**View:** Northwest

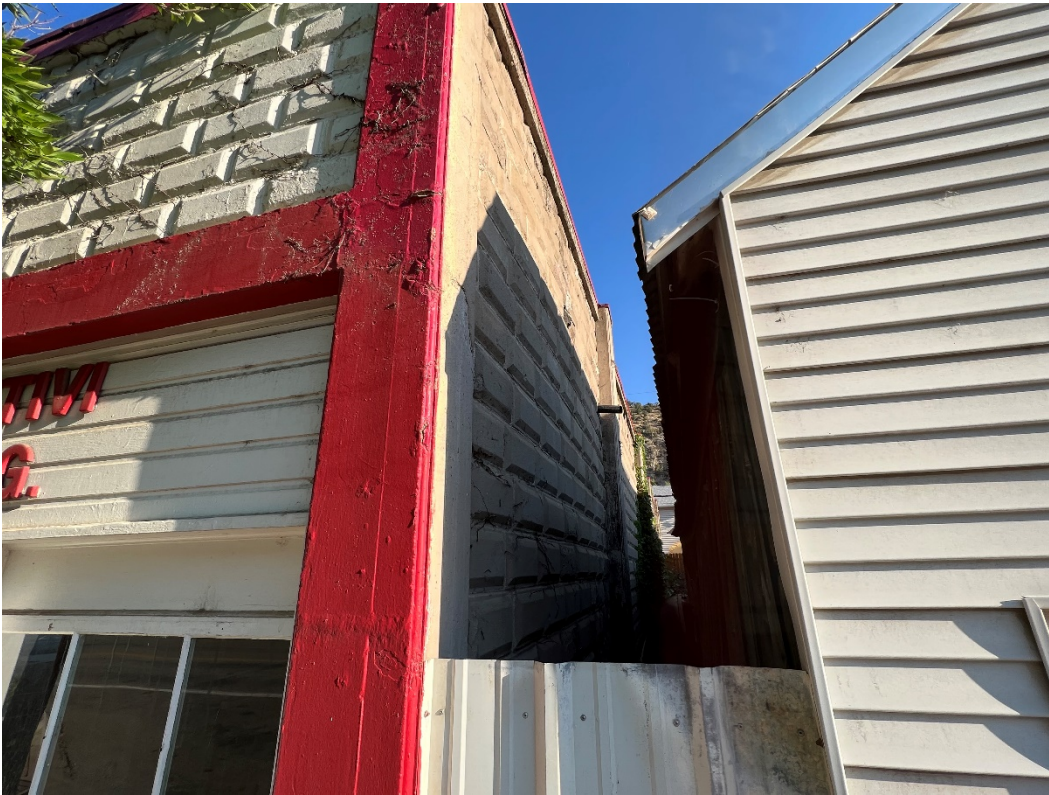
**Photo Number:** 5GF.2373\_5

**Description:** Looking at the east elevation of the building.

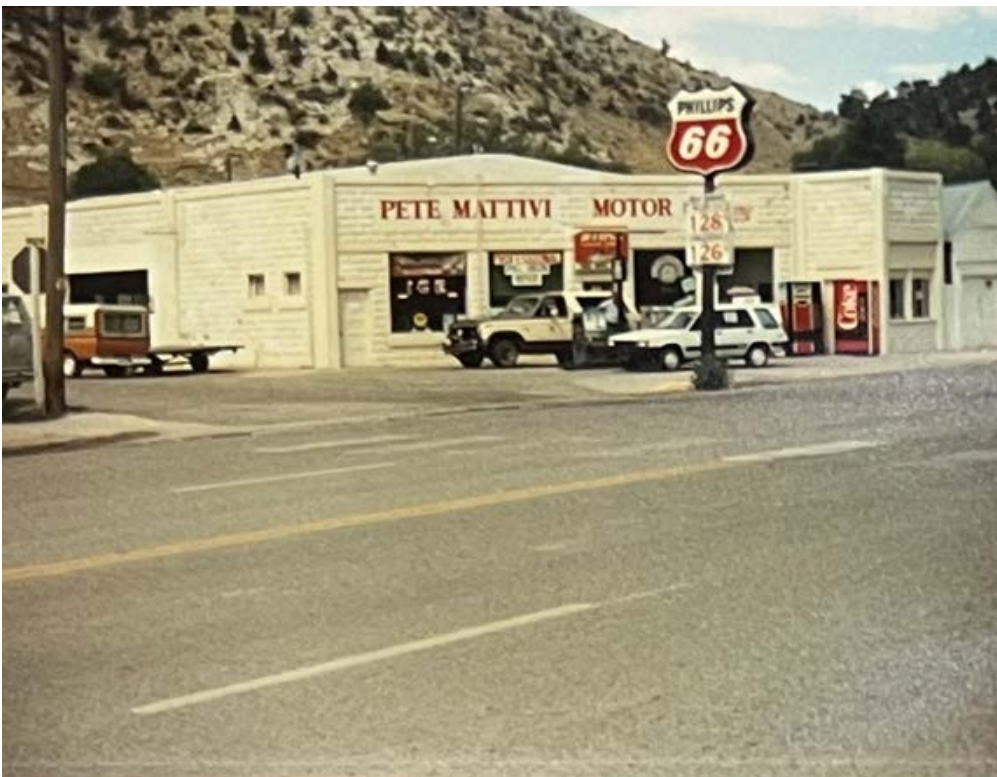
**Historic Photo 1**

**Description:** Looking at the west and primary (south) elevations of the building. Note that the garage opening on the far right of the primary (south) elevation was covered by this time.

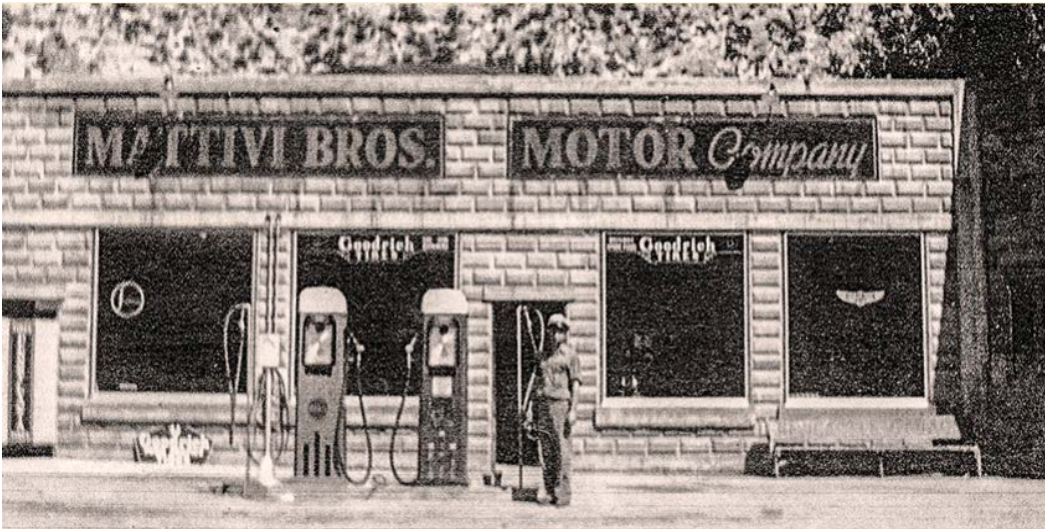
**Historic Photo 2**

**Description:** Looking at the primary (south) elevation of the building.

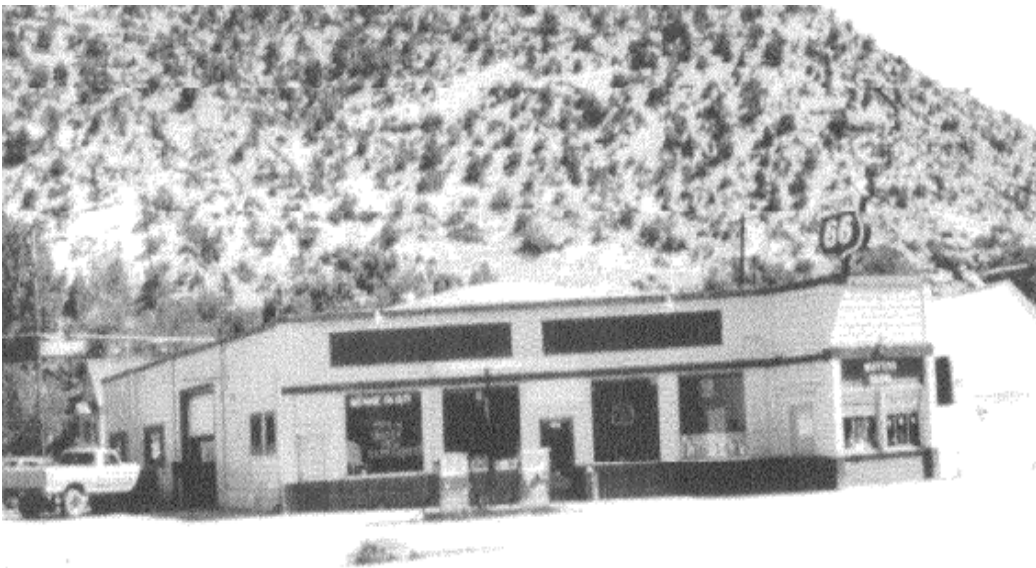
**Reference Photo 1**

**Description:** Looking at the west and primary (south) elevations of the building. Note the extant fuel island and Phillips 66 sign on the roof of the building.

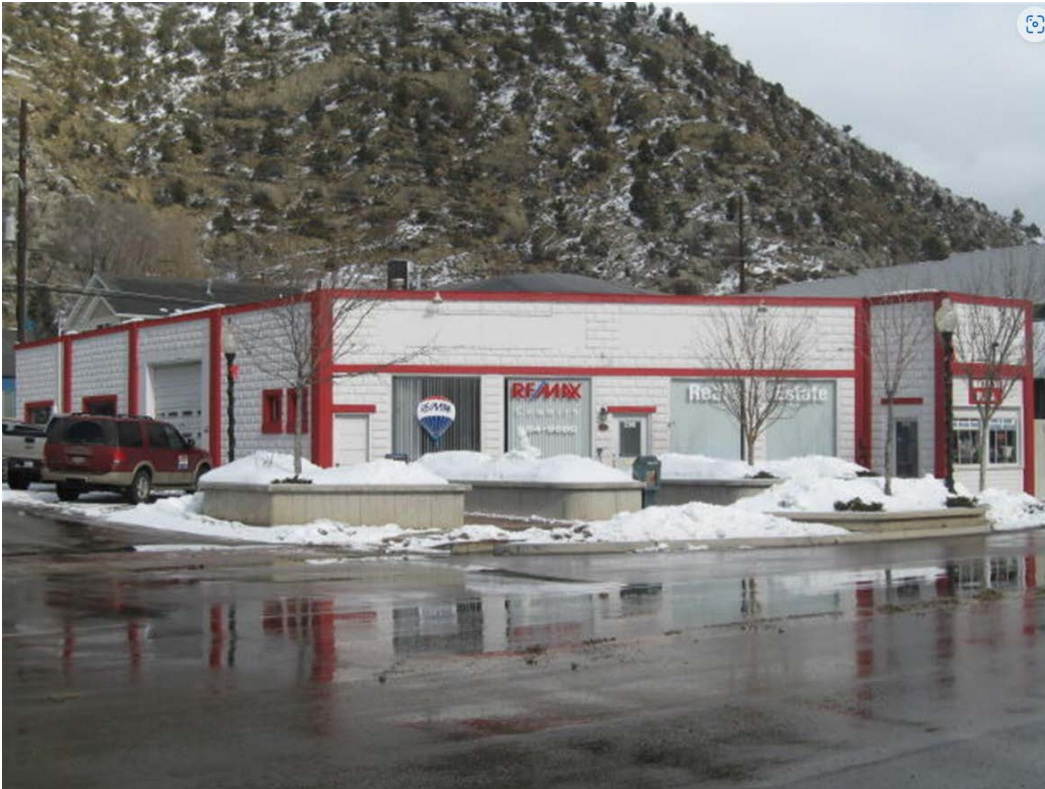
**Reference Photo 2**

**Description:** Looking at the west and primary (south) elevations of the building. Note that the fuel island and pumps have been removed by this time.
