COLORADO CULTURAL RESOURCES INVENTORY

Historical and Architectural Reconnaissance

1. Property Name: Bank of New Castle Historic Current Other:
2. Resource Classification: Building Structure Object Sites/Landscape
3. Ownership: Federal State Local Non-profit Private Unknown

4. Street Address: 302 West Main Street
5. Municipality: New Castle, CO Vicinity:
6. County: Garfield
- **7. USGS Quad: New Castle, CO Year: 2022 7.5'
- **8. Parcel Number: 212331109022
- **9. Parcel Information: Lot(s): 1 Block: B Addition: ORIGINAL TWNSTE NEW CASTLE
- **10. Acreage: 0.05 Actual Estimated
11. PLSS information: Principal Meridian: 6th Township: 5S Range: 90W
SE ¼ of SW ¼ of SW ¼ of NE ¼ of section: 31

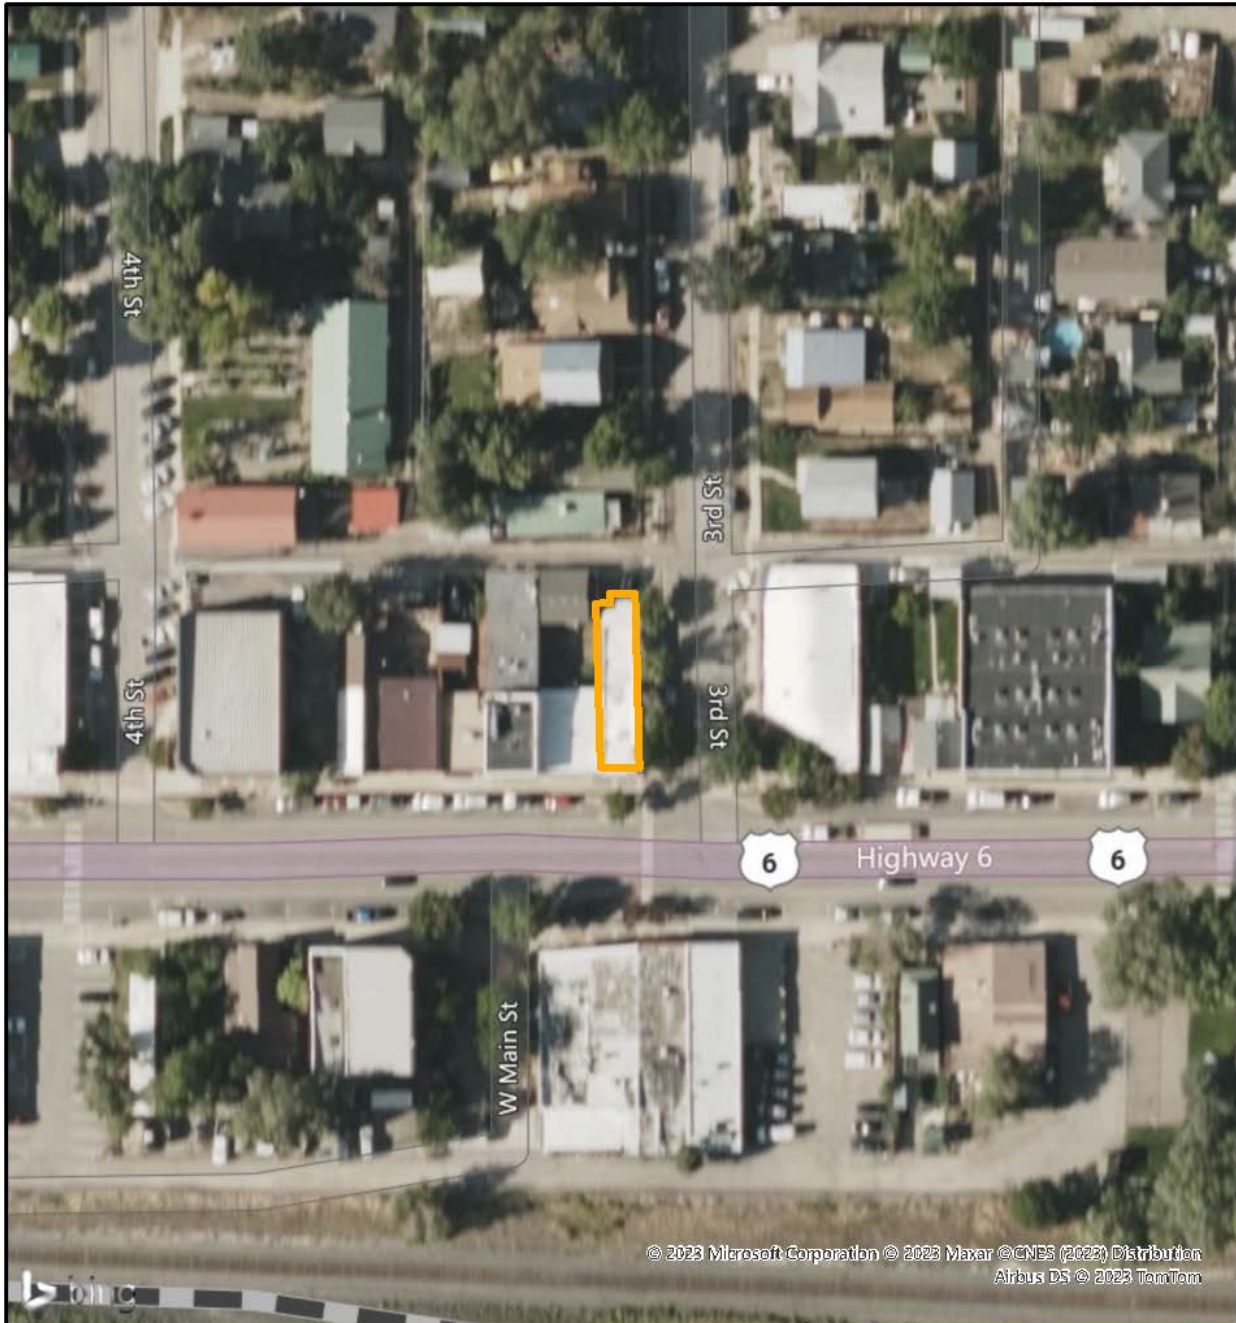
Sketch Map

Feet </div>	<p>Pinyon Professional, Inc.</p> <p>Sketch Map 302 West Main Street (5GF.2375) New Castle, Colorado Garfield County</p>				
<p>Pinyon Project Number: I 22156.001</p>	<table border="1"> <tr> <td>Drawn By: CJB</td> <td>Figure: 2</td> </tr> <tr> <td>Reviewed By: CMW</td> <td>Date: 4/10/2023</td> </tr> </table>	Drawn By: CJB	Figure: 2	Reviewed By: CMW	Date: 4/10/2023
Drawn By: CJB	Figure: 2				
Reviewed By: CMW	Date: 4/10/2023

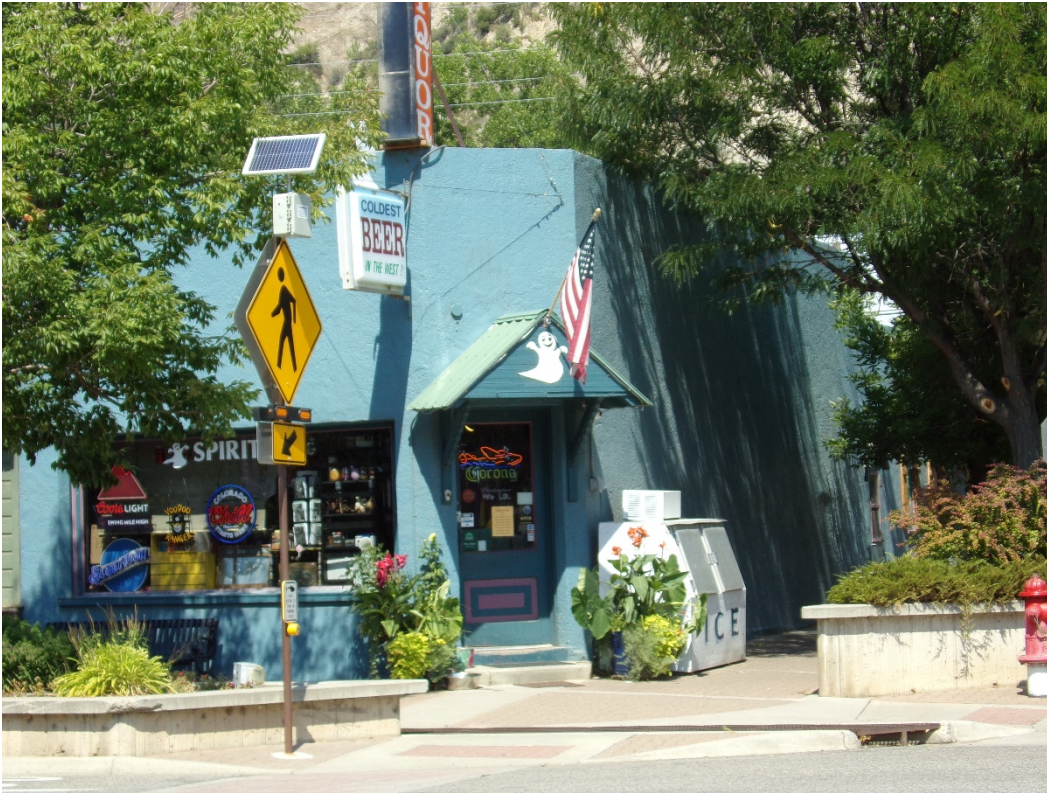
Photo Number: 5GF.2375_1
Description: Looking at the primary (south) and east elevations of the building.
Date: 9/6/2022
View: Northwest

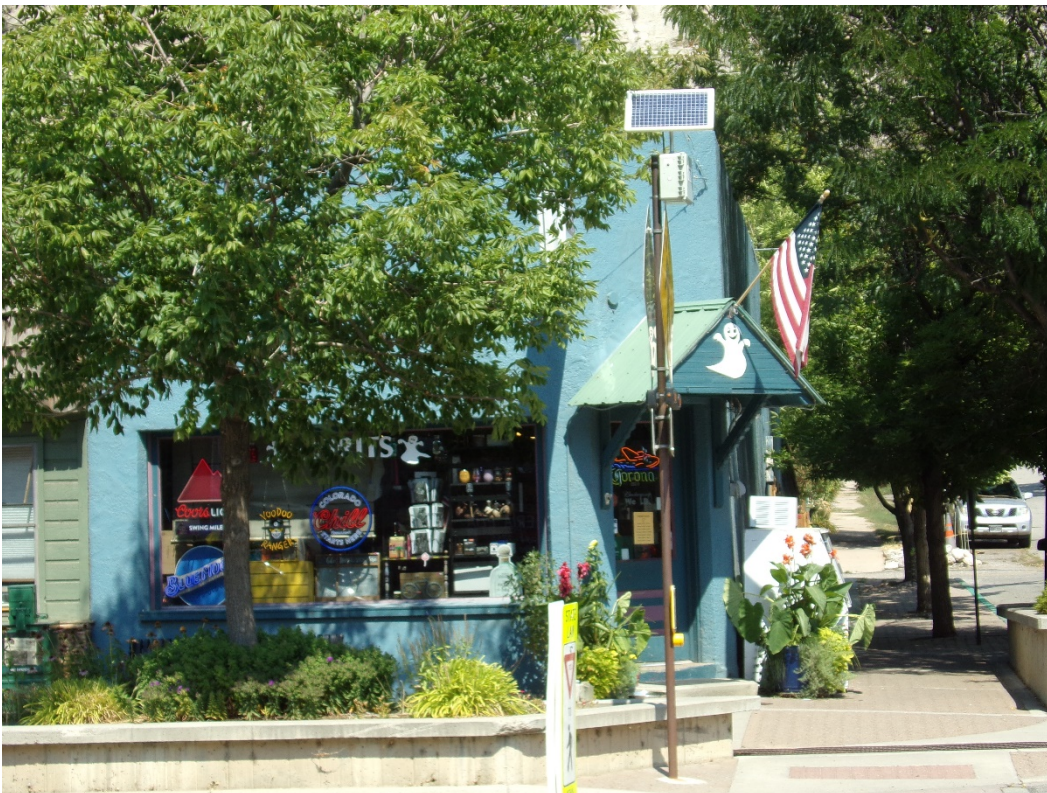
Photo Number: 5GF.2375_2
Description: Looking at the primary (south) elevation of the building.
Date: 9/6/2022
View: North

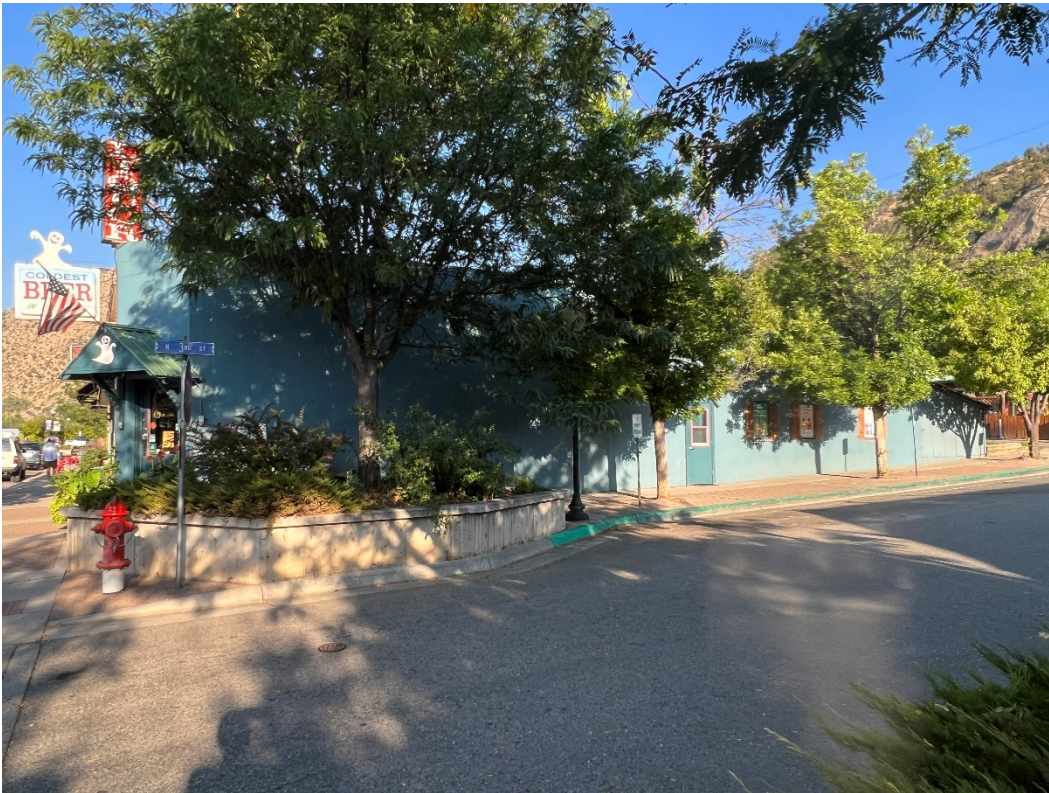
Photo Number: 5GF.2375_3
Description: Looking at the east elevation of the building. Note that a majority of the elevation is observed by landscaping features added between 1996 and 2005.
Date: 9/6/2022
View: Northwest

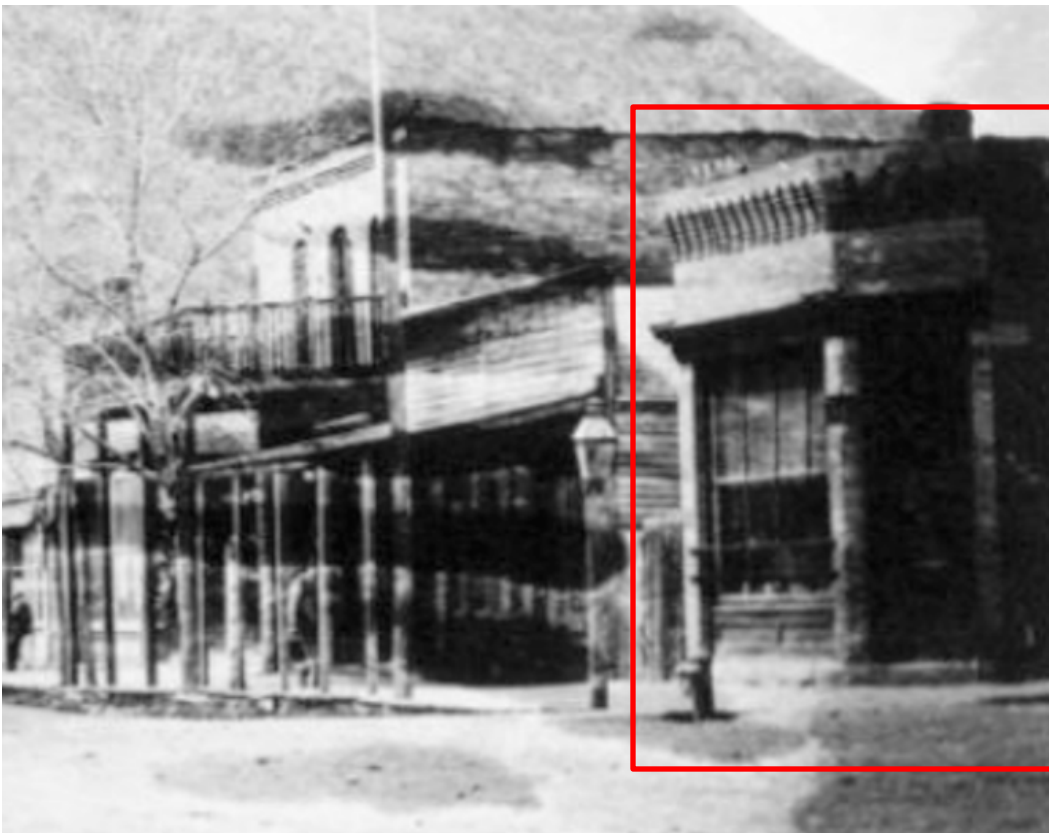
Historical imagery of the building in 1905 demonstrates that the building has undergone a high degree of modification. By the late Twentieth Century, the decorative corbelled brick cornice had been removed as well as pilasters along the primary (south) and far left side of the east elevation. In addition, the fenestration pattern was altered due to the multi-lite window along the façade having been replaced with a smaller picture window. The brick masonry exterior envelope had been clad in stucco as well. A front gable overhang was added above the main entryway, and wall mounted signage was also added to the primary (south) elevation. Historical aerial imagery between 1996 and 2005 demonstrates that several trees and curb features were added along the primary (south) and east elevations of the building.

Historic Photo 1
Description: Image of downtown New Castle between North 3rd Street and North 4th Street. Note that the resource is outline in red. The decorative corbelled brick cornice was removed by the mid to late Twenty Century.
Date: 1905
Source: Denver Public Library – Digital Collections [Not for publication]

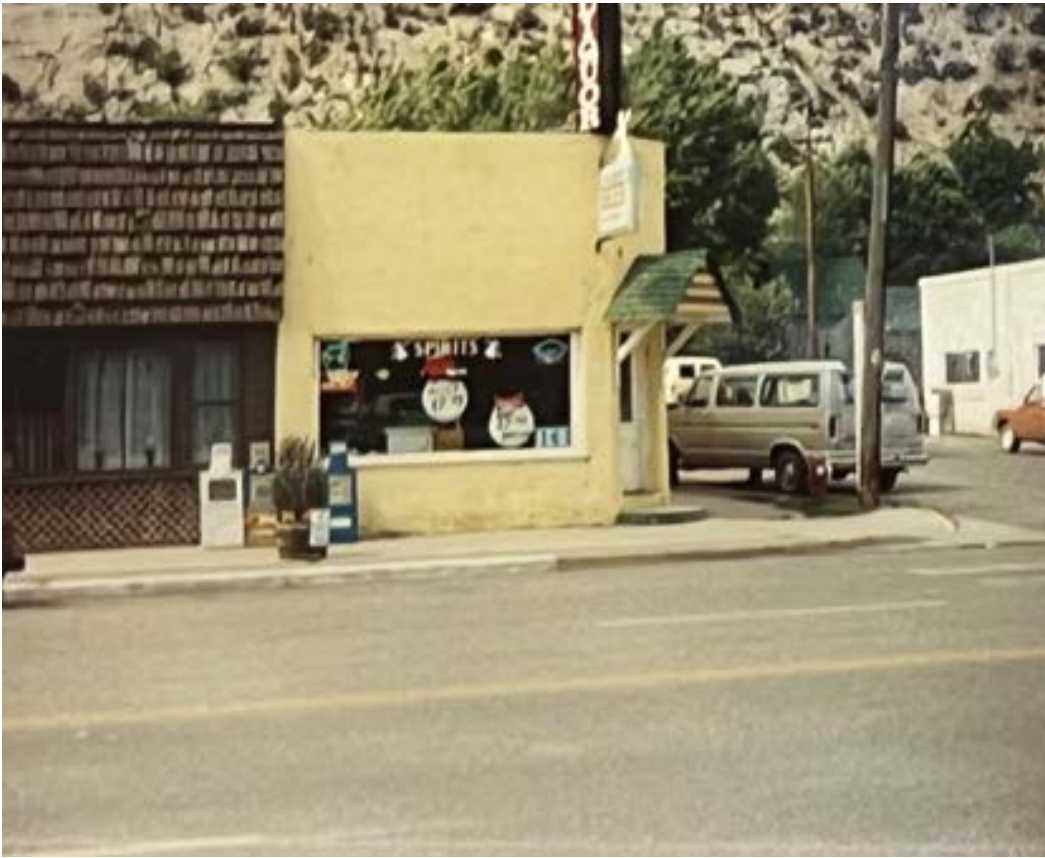
Reference Photo 1

Description: Image of the south elevation of the resource with the label stating, "Office building/ has been home of many businesses. New Castle State Bank 1909-1939. Now a liquor store."

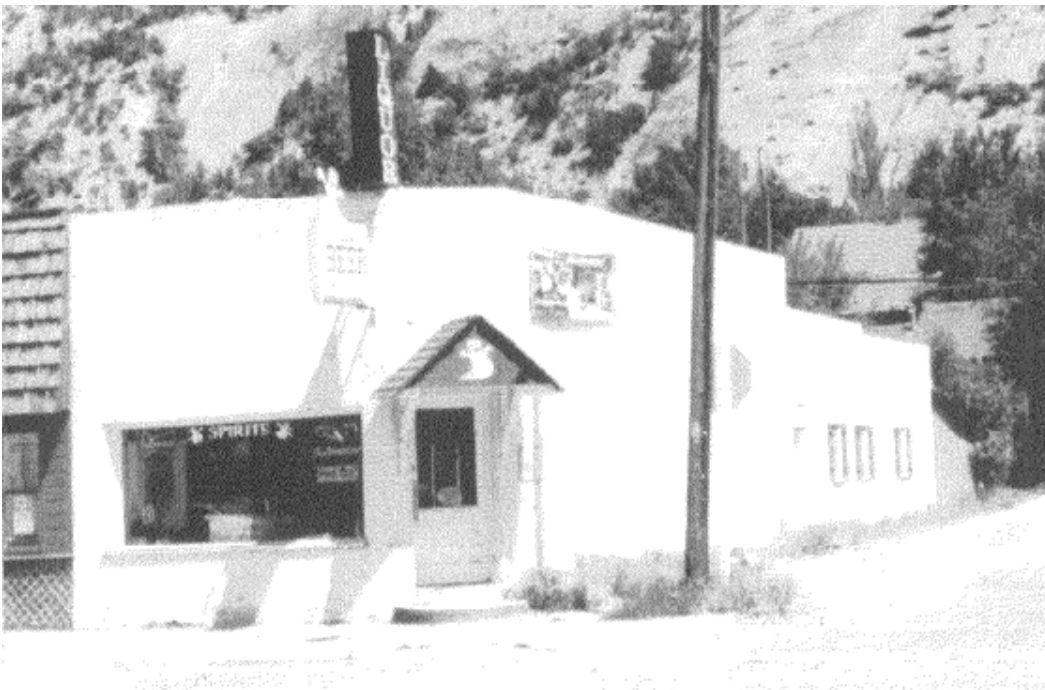
Reference Photo 2

Description: Looking at the primary (south) and east elevations of the building.

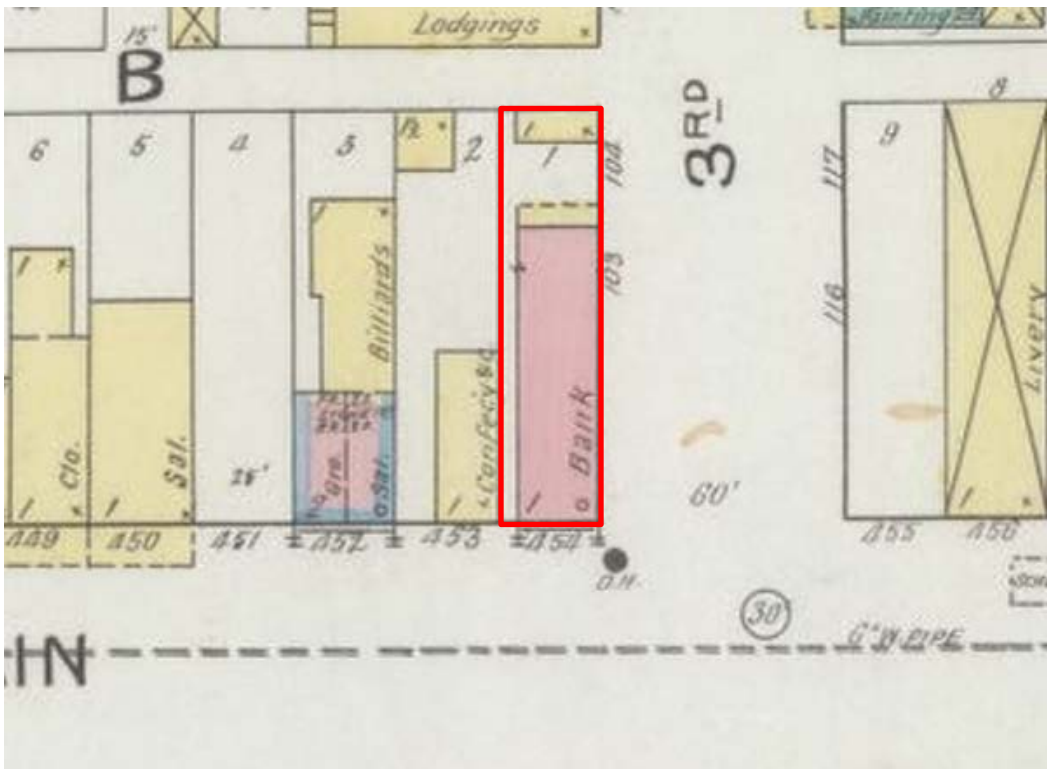
Reference Photo 3

Description: 1893 Sanborn Fire Insurance map of the resource located on lot 1 of block B. The property is outlined in red.

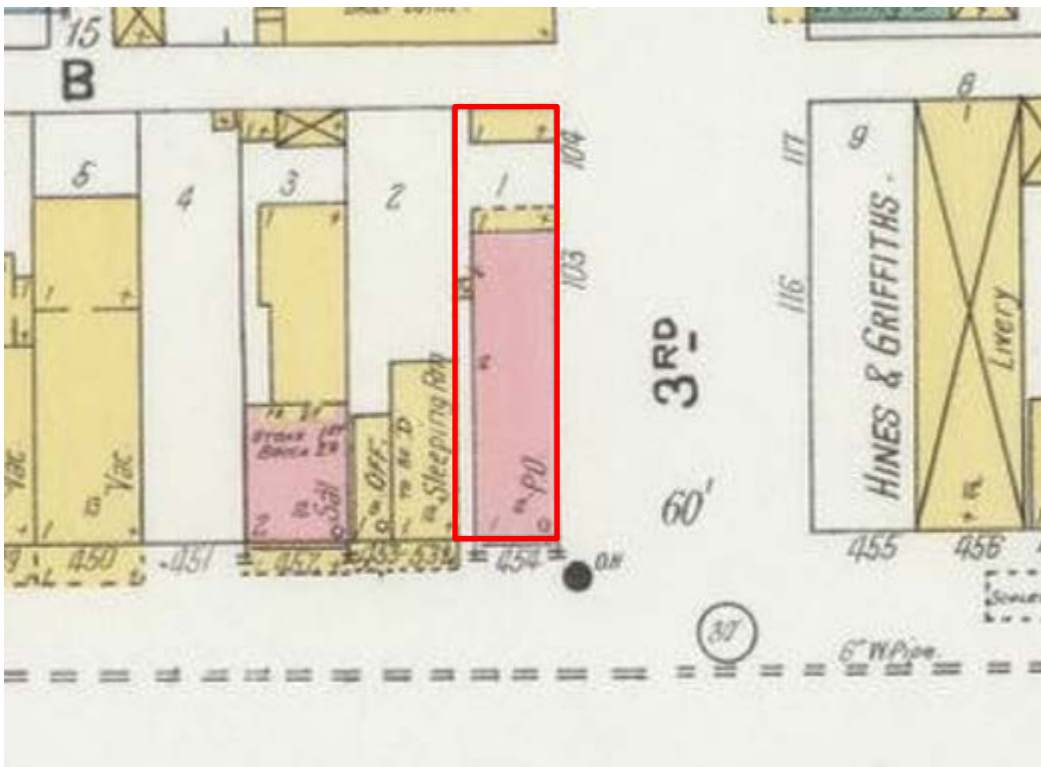
Reference Photo 4

Description: 1899 Sanborn Fire Insurance map of the resource. The property is outlined in red.
