COLORADO CULTURAL RESOURCES INVENTORY

Historical and Architectural Reconnaissance

1. Property Name: Trimble Block Historic Current Other:
2. Resource Classification: Building Structure Object Sites/Landscape
3. Ownership: Federal State Local Non-profit Private Unknown

4. Street Address: 303 West Main Street
5. Municipality: New Castle, CO Vicinity:
6. County: Garfield
- **7. USGS Quad: New Castle, CO Year: 2022 7.5'
- **8. Parcel Number: 212331409001
- **9. Parcel Information: Lot(s): 1, 2 Block: 7 Addition: ORIGINAL TWNSTE NEW CASTLE
- **10. Acreage: 0.07 Actual Estimated
11. PLSS information: Principal Meridian: 6th Township: 5S Range: 90W
NE ¼ of NW ¼ of NW ¼ of SE ¼ of section: 31
- **12. Location Coordinates:
 UTM reference: Zone 13 ;mE 282390 ;mN 4383026 NAD 1927 NAD 1983
 or
 Lat/Long: Latitude _____ ; Longitude _____ WGS84 Other:

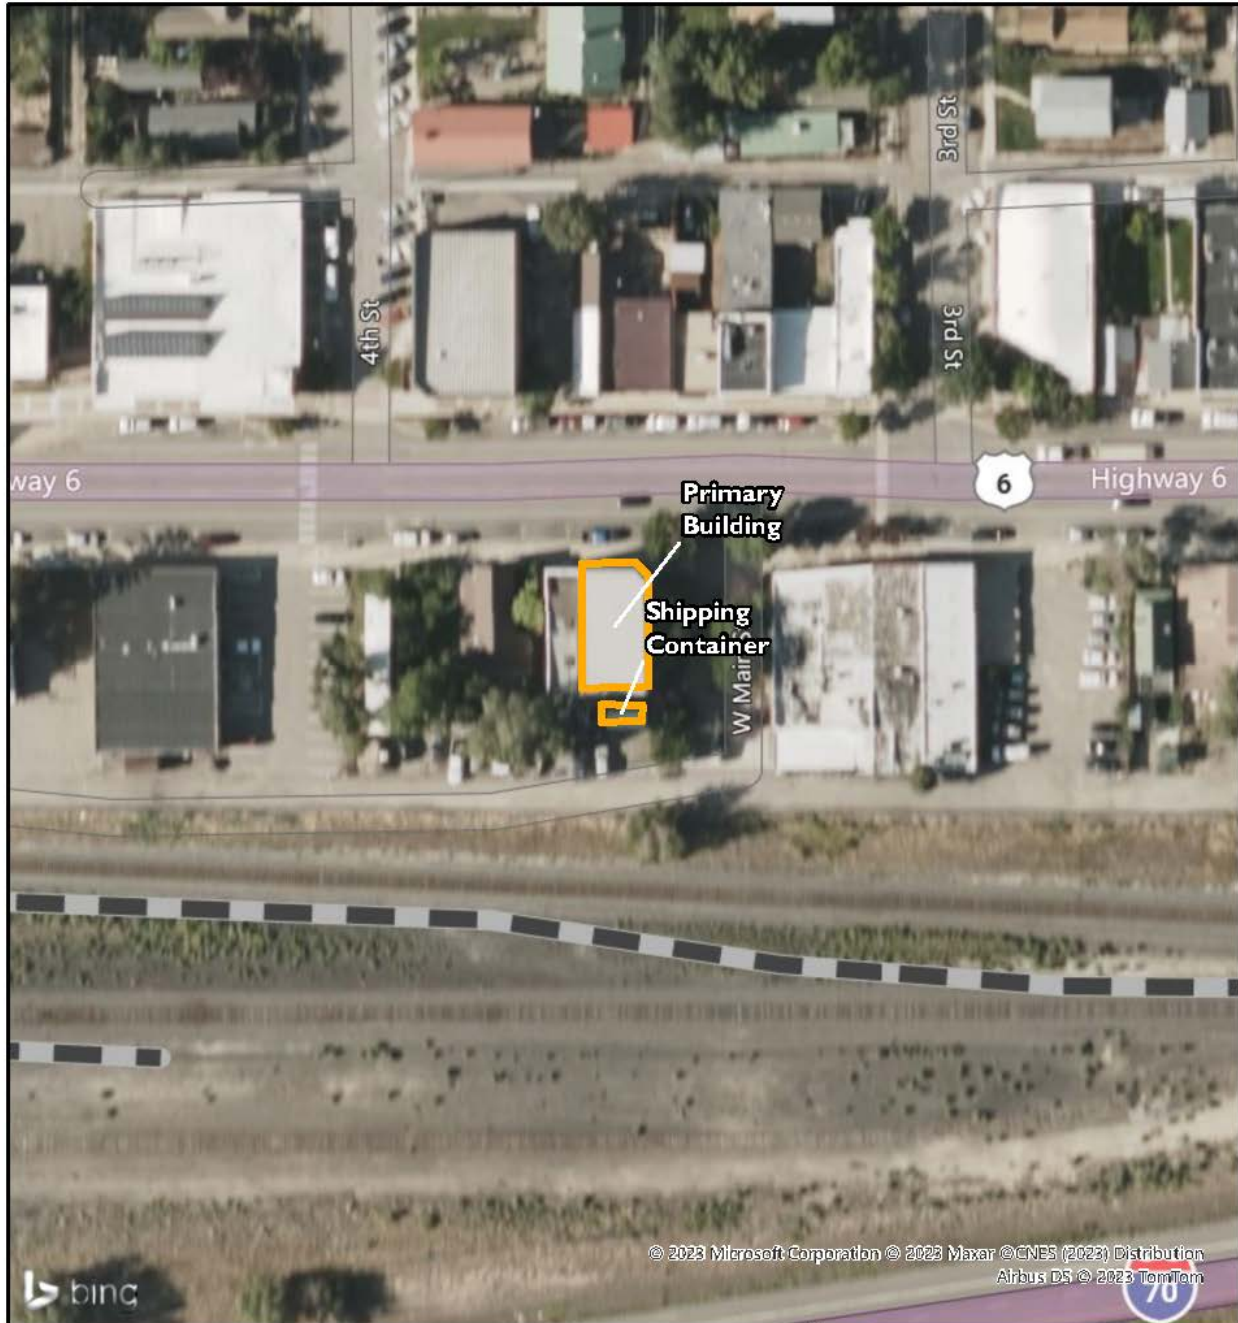
Sketch Map

</div>	<p>Pinyon Professional, Inc.</p> <p>Sketch Map 303 West Main Street (5GF.2376) New Castle, Colorado Garfield County</p>				
<p>Pinyon Project Number: I 22156.001</p>	<table border="1"> <tr> <td>Drawn By: CJB</td> <td>Figure: 2</td> </tr> <tr> <td>Reviewed By: CMW</td> <td>Date: 4/10/2023</td> </tr> </table>	Drawn By: CJB	Figure: 2	Reviewed By: CMW	Date: 4/10/2023
Drawn By: CJB	Figure: 2				
Reviewed By: CMW	Date: 4/10/2023

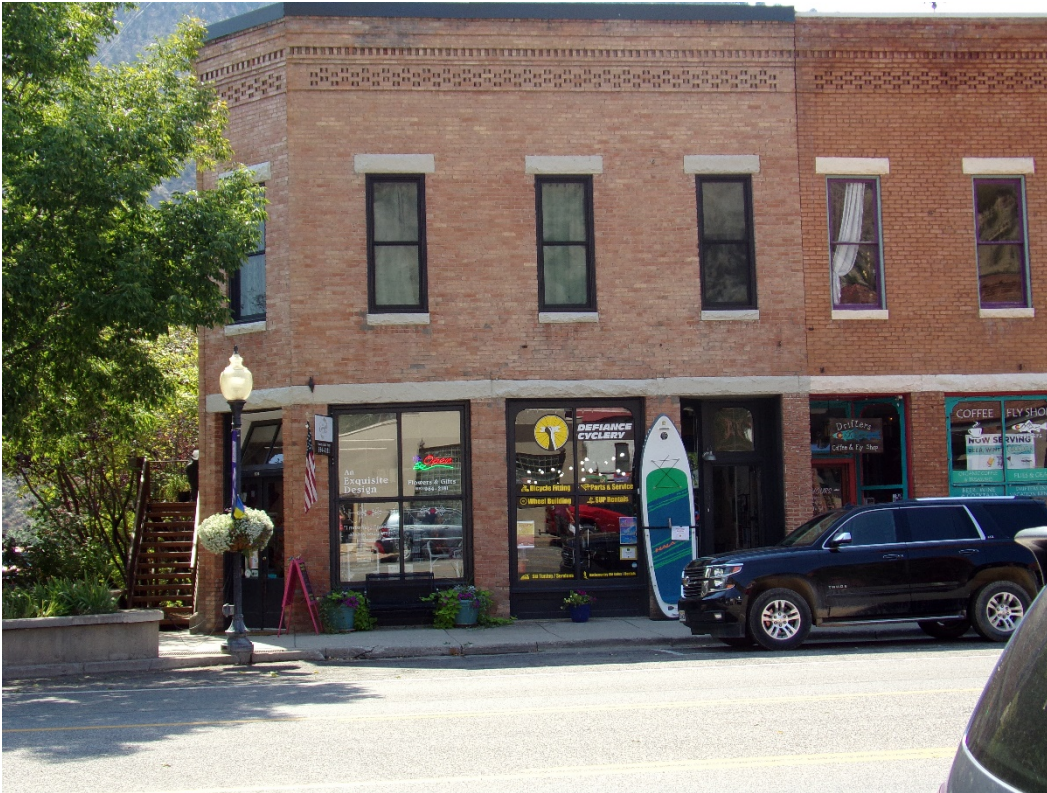
Photo Number: 5GF.2376_1
Description: Looking at the primary (north) elevation of the building. Note the decorative brickwork underneath the cornice.
Date: 9/6/2022
View: South

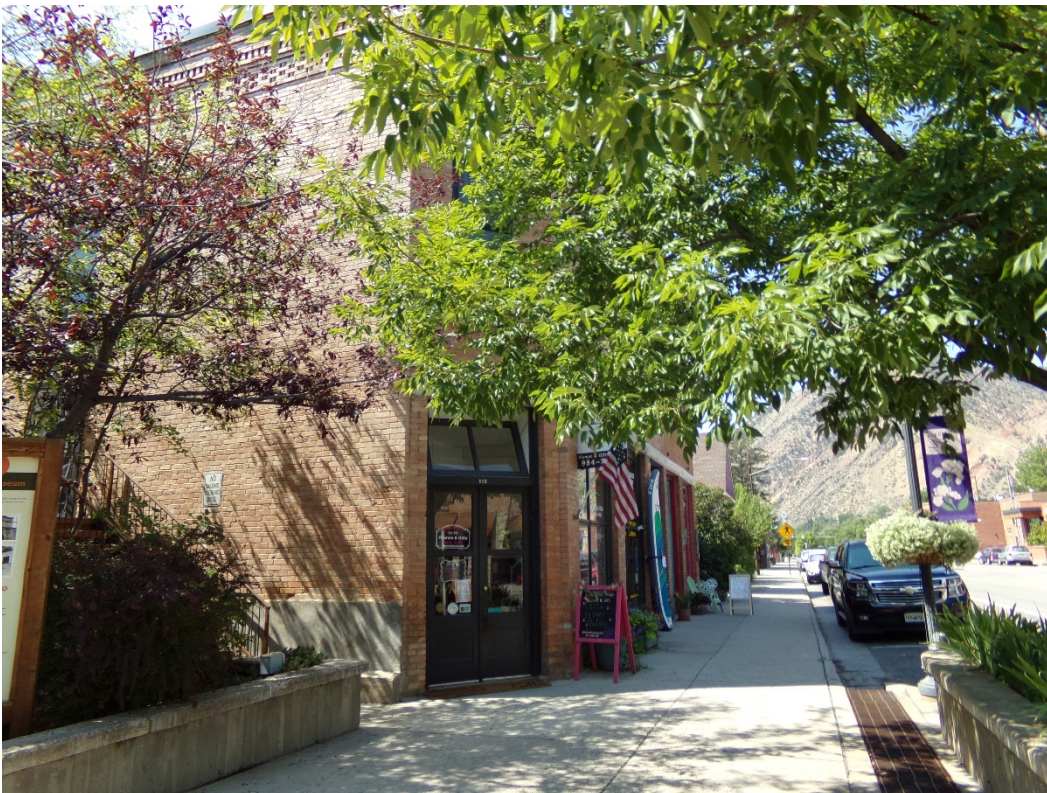
Photo Number: 5GF.2376_2
Description: Looking at the east and angled main entryway along the primary (north) elevation of the building.
Date: 9/6/2022
View: West

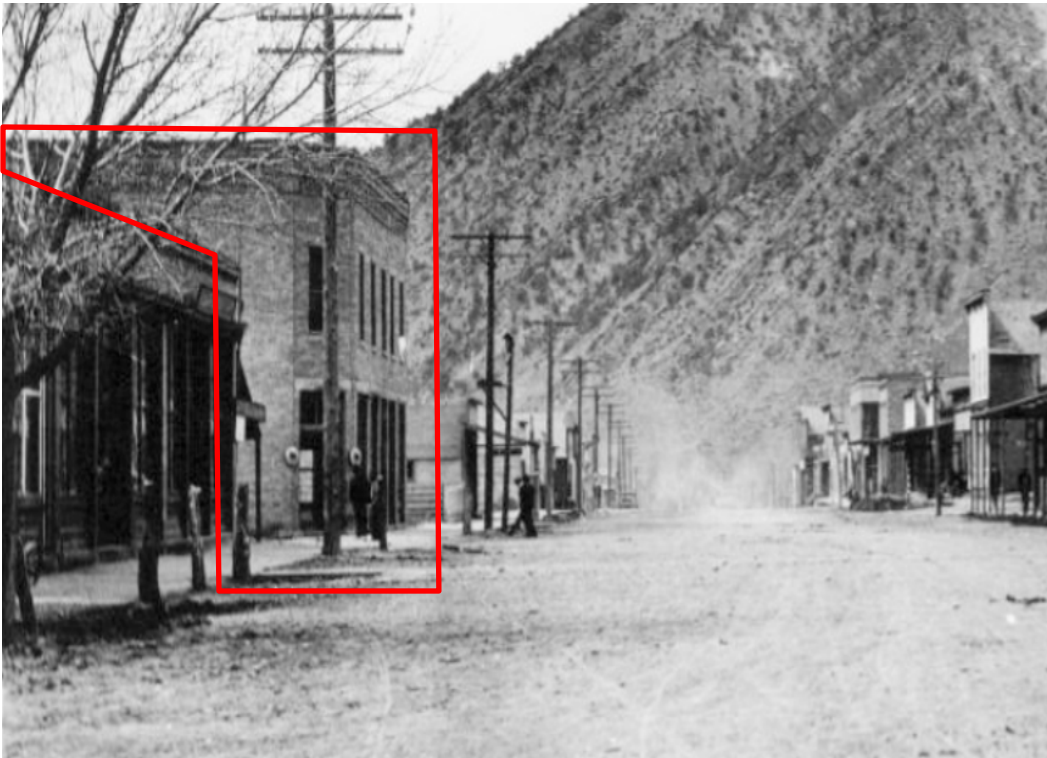
Historic Photo 1

Description: Image of downtown New Castle between North 3rd Street and North 4th Street. Note that the resource is outlined in red.

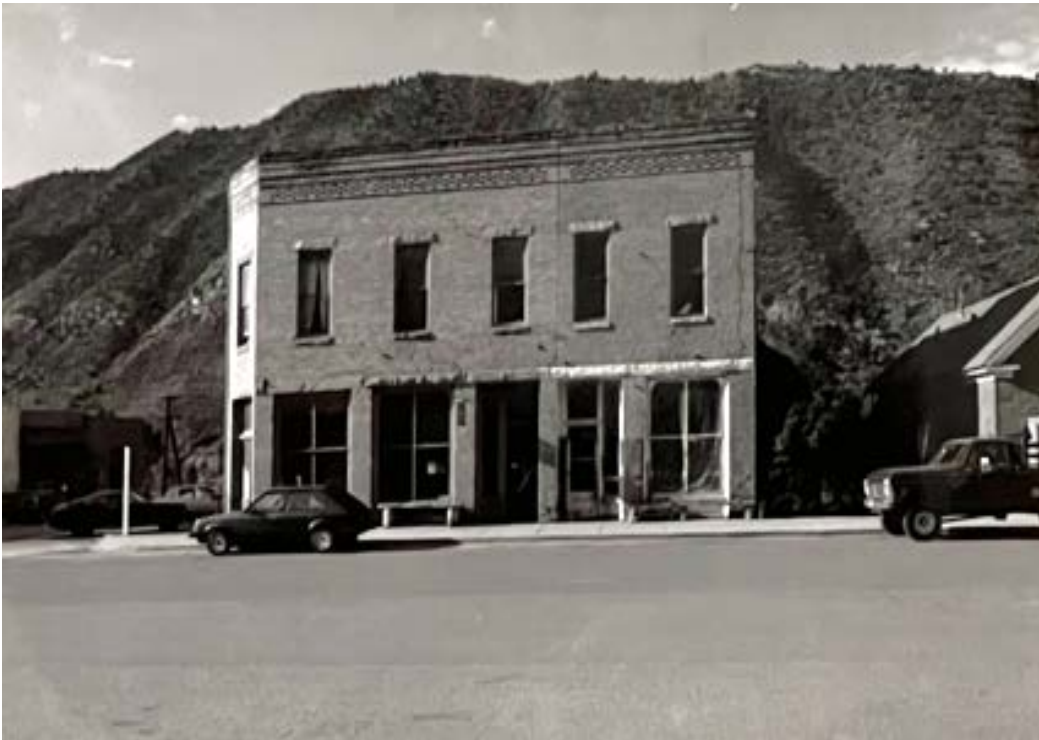
Reference Photo 1

Description: Photo states, that the “‘Trimble Building’ was a dance hall and saloon. Later housed Hall’s Barber shop, Schmueser’s Grocery Store, Bomer’s Meat Market, and Garfield County Telephone.”

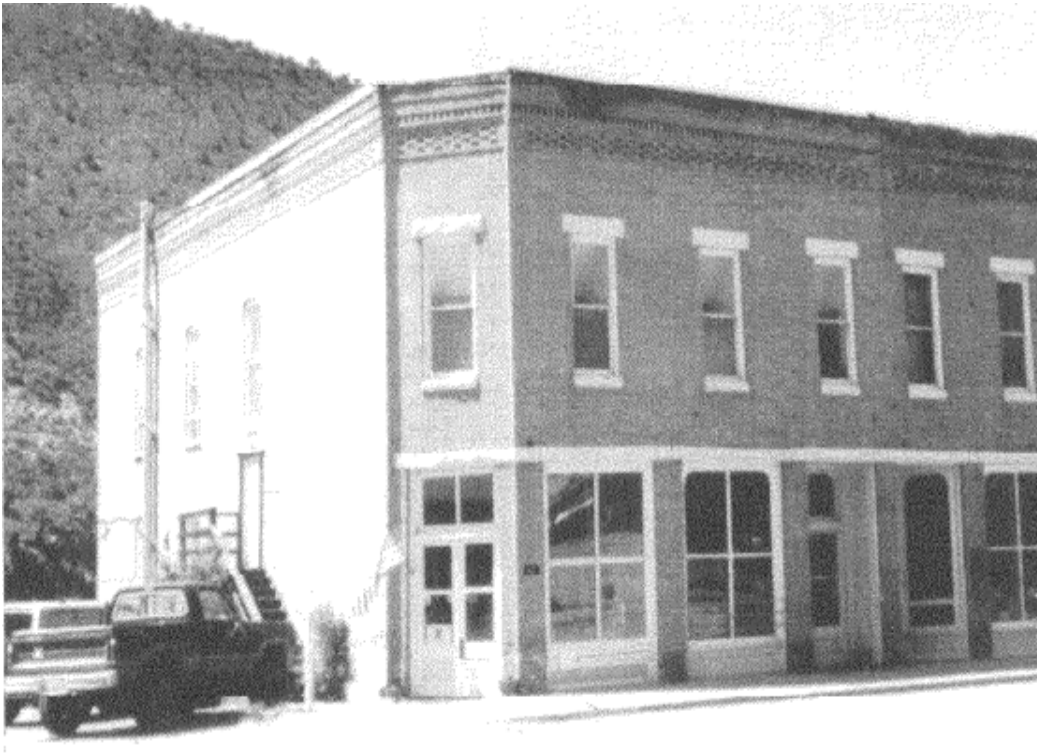
Reference Photo 2

Description: Looking at the east and (primary) north elevation of the building.

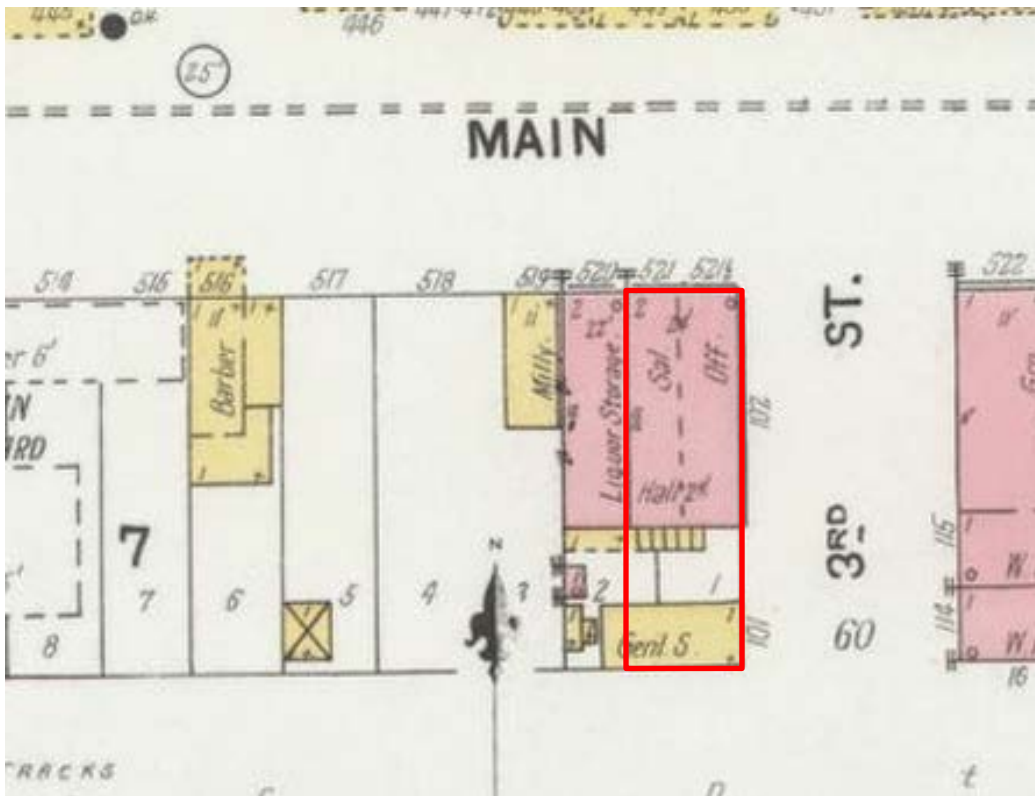
Reference Photo 4

Description: 1899 Sanborn Fire Insurance map of the resource. The property is outlined in red.

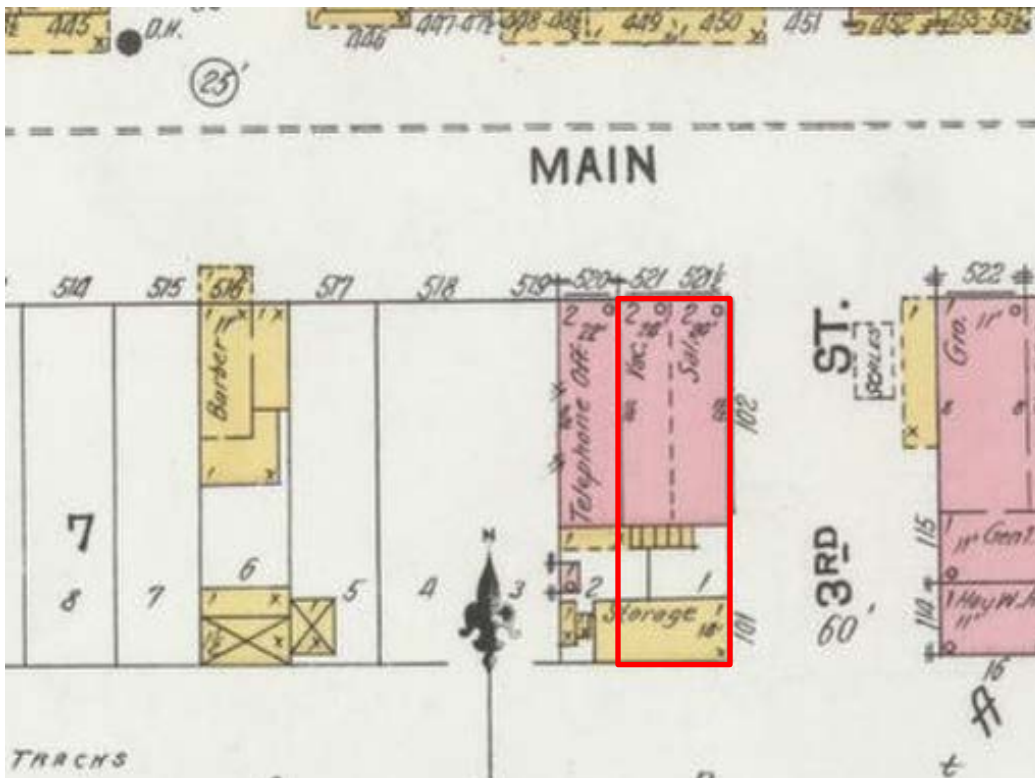
Reference Photo 5

Description: 1904 Sanborn Fire Insurance map of the resource. The property is outlined in red.
