COLORADO CULTURAL RESOURCES INVENTORY

Historical and Architectural Reconnaissance

1. Property Name: Salvador Vargas Residence Historic Current Other:
2. Resource Classification: Building Structure Object Sites/Landscape
3. Ownership: Federal State Local Non-profit Private Unknown

4. Street Address: 311 East Main Street
5. Municipality: New Castle, CO Vicinity:
6. County: Garfield
- **7. USGS Quad: New Castle, CO Year: 2022 7.5'
- **8. Parcel Number: 212331404003
- **9. Parcel Information: Lot(s): 5-9 Block: Q Addition: Spencer's 2nd
- **10. Acreage: 0.12 Actual Estimated
11. PLSS information: Principal Meridian: 6th Township: 5S Range: 90W
NW ¼ of NW ¼ of NE ¼ of SE ¼ of section: 31
- **12. Location Coordinates:
 UTM reference: Zone 13 ;mE 282791 ;mN 4383024 NAD 1927 NAD 1983
 or
 Lat/Long: Latitude _____ ; Longitude _____ WGS84 Other:

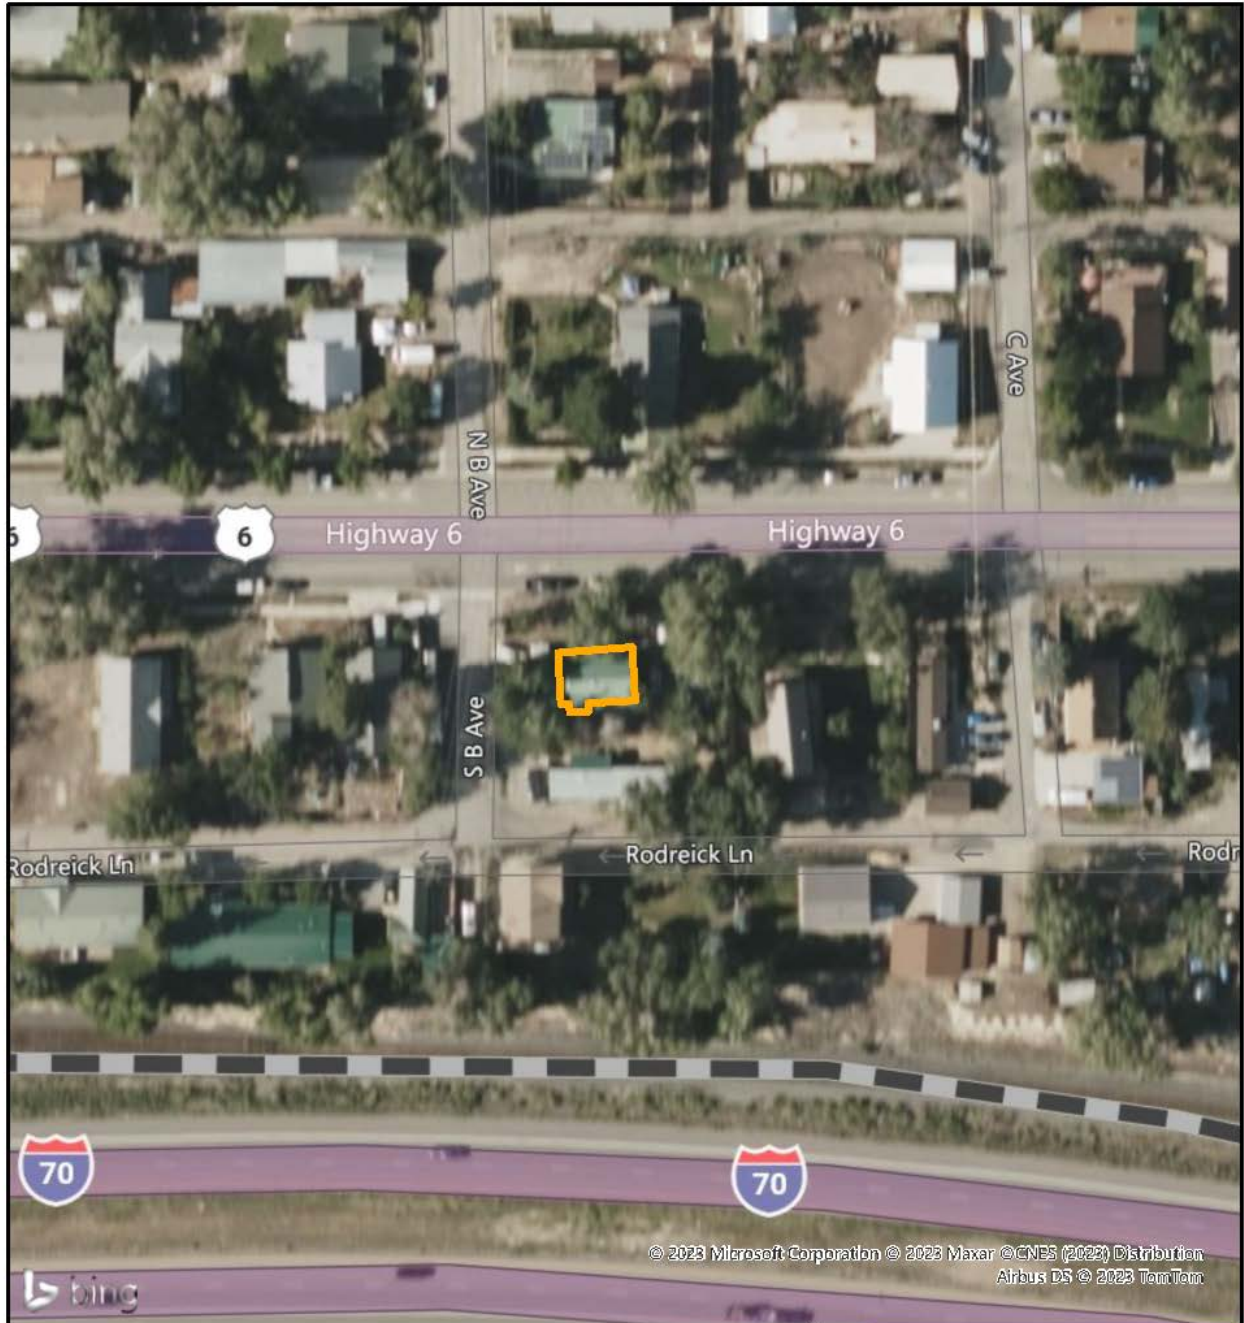
Sketch Map

</div>	<p>Pinyon Environmental, Inc.</p> <p>Sketch Map 311 East Main Street (5GF.5930) New Castle, Colorado Garfield County</p>				
<p>Pinyon Project Number: I 22156.001</p>	<table border="1" style="width: 100%;"> <tr> <td>Drawn By: CJB</td> <td>Figure: 2</td> </tr> <tr> <td>Reviewed By: CMW</td> <td>Date: 4/10/2023</td> </tr> </table>	Drawn By: CJB	Figure: 2	Reviewed By: CMW	Date: 4/10/2023
Drawn By: CJB	Figure: 2				
Reviewed By: CMW	Date: 4/10/2023

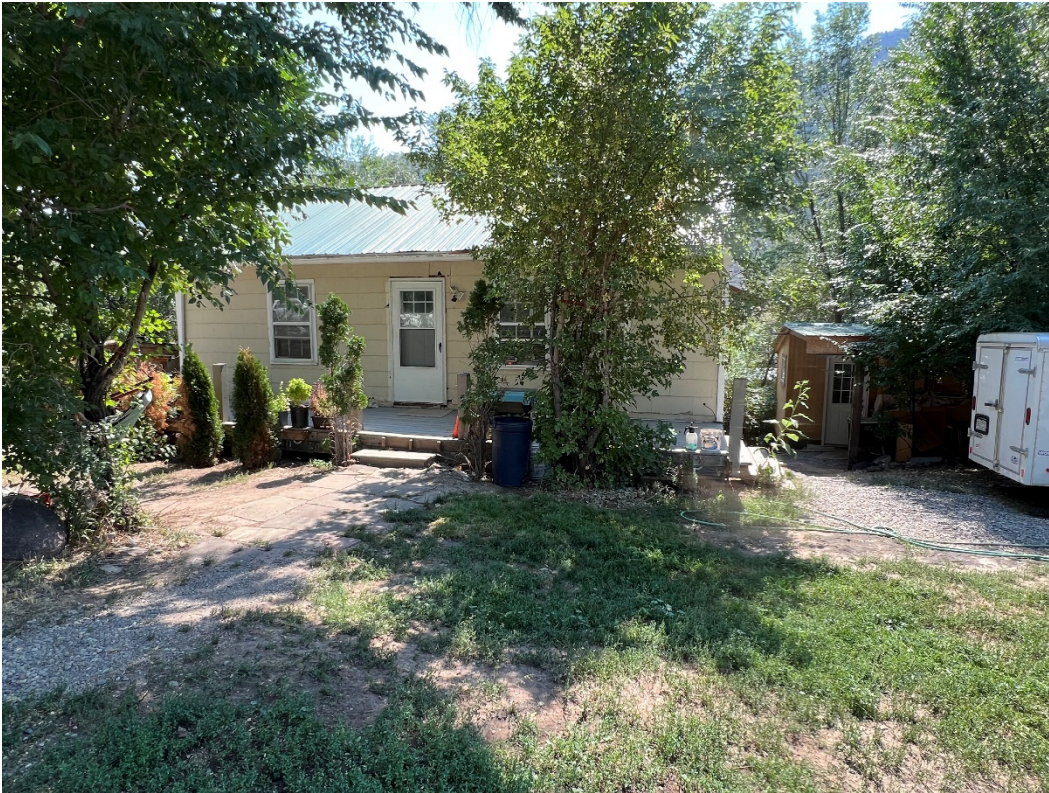
Photo Number: 5GF.5930_1
Description: Looking at the primary (north) elevation of the building.
Date: 9/6/2022
View: South

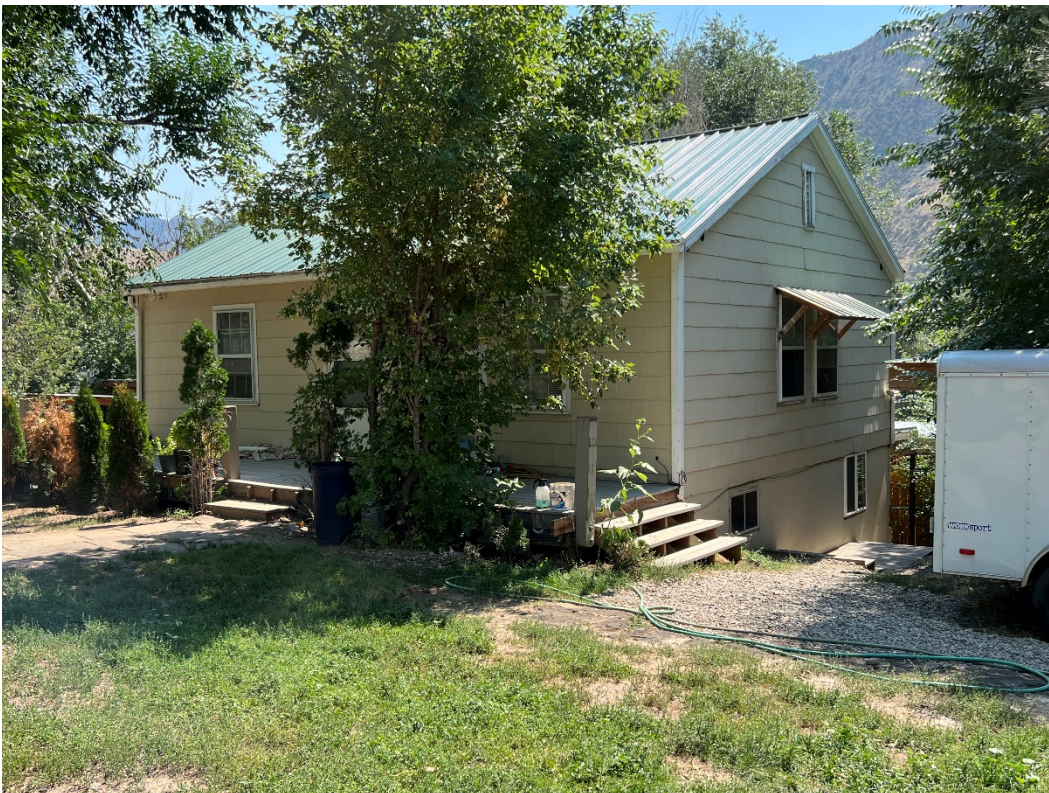
Photo Number: 5GF.5930_2
Description: Looking at the primary (north) and west elevations of the residence. Note the shed roof awning that protects the typical windows.
Date: 9/6/2022
View: Southeast

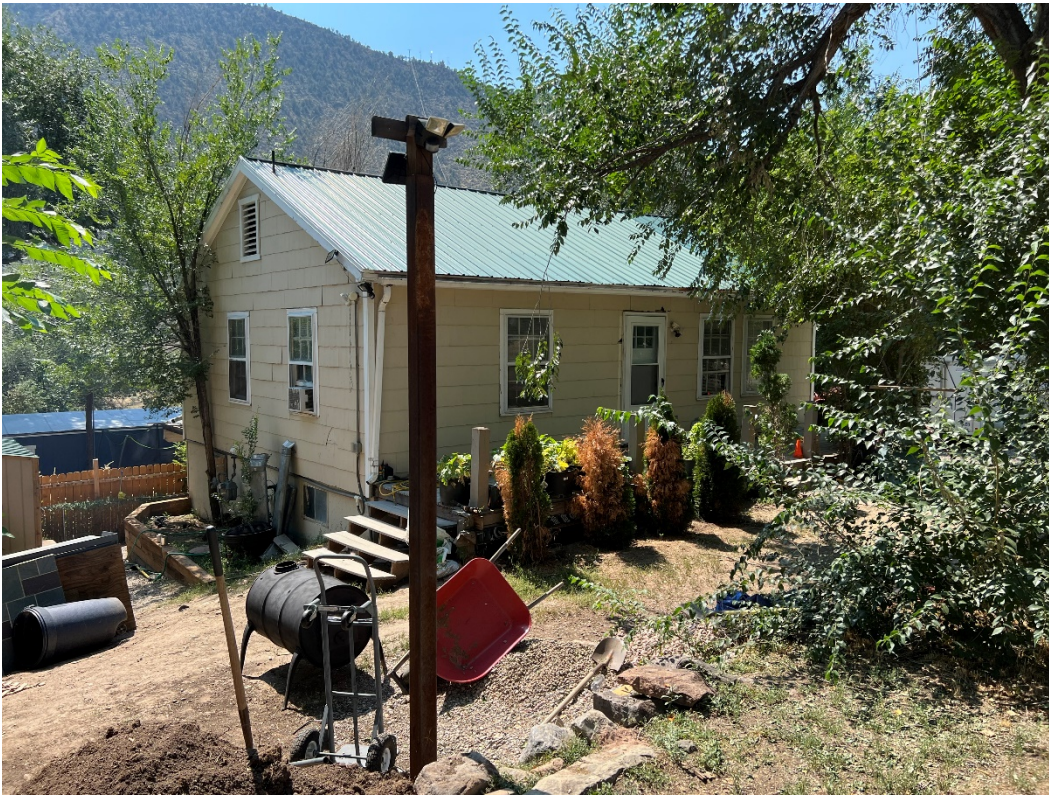
Photo Number: 5GF.5930_3
Description: Looking at the west and primary (north) elevations of the building.
Date: 9/6/2022
View: Southwest
