COLORADO CULTURAL RESOURCES INVENTORY

Historical and Architectural Reconnaissance

1. Property Name: Sassy Cutz Salon Historic Current Other:
2. Resource Classification: Building Structure Object Sites/Landscape
3. Ownership: Federal State Local Non-profit Private Unknown

4. Street Address: 312 West Main Street
5. Municipality: New Castle, CO Vicinity:
6. County: Garfield
- **7. USGS Quad: New Castle, CO Year: 2022 7.5'
- **8. Parcel Number: 212331109021
- **9. Parcel Information: Lot(s): 1, 2 Block: B Addition: ORIGINAL TWNSTE NEW CASTLE
- **10. Acreage: 0.06 Actual Estimated
11. PLSS information: Principal Meridian: 6th Township: 5S Range: 90W
SE ¼ of SW ¼ of SW ¼ of NE ¼ of section: 31

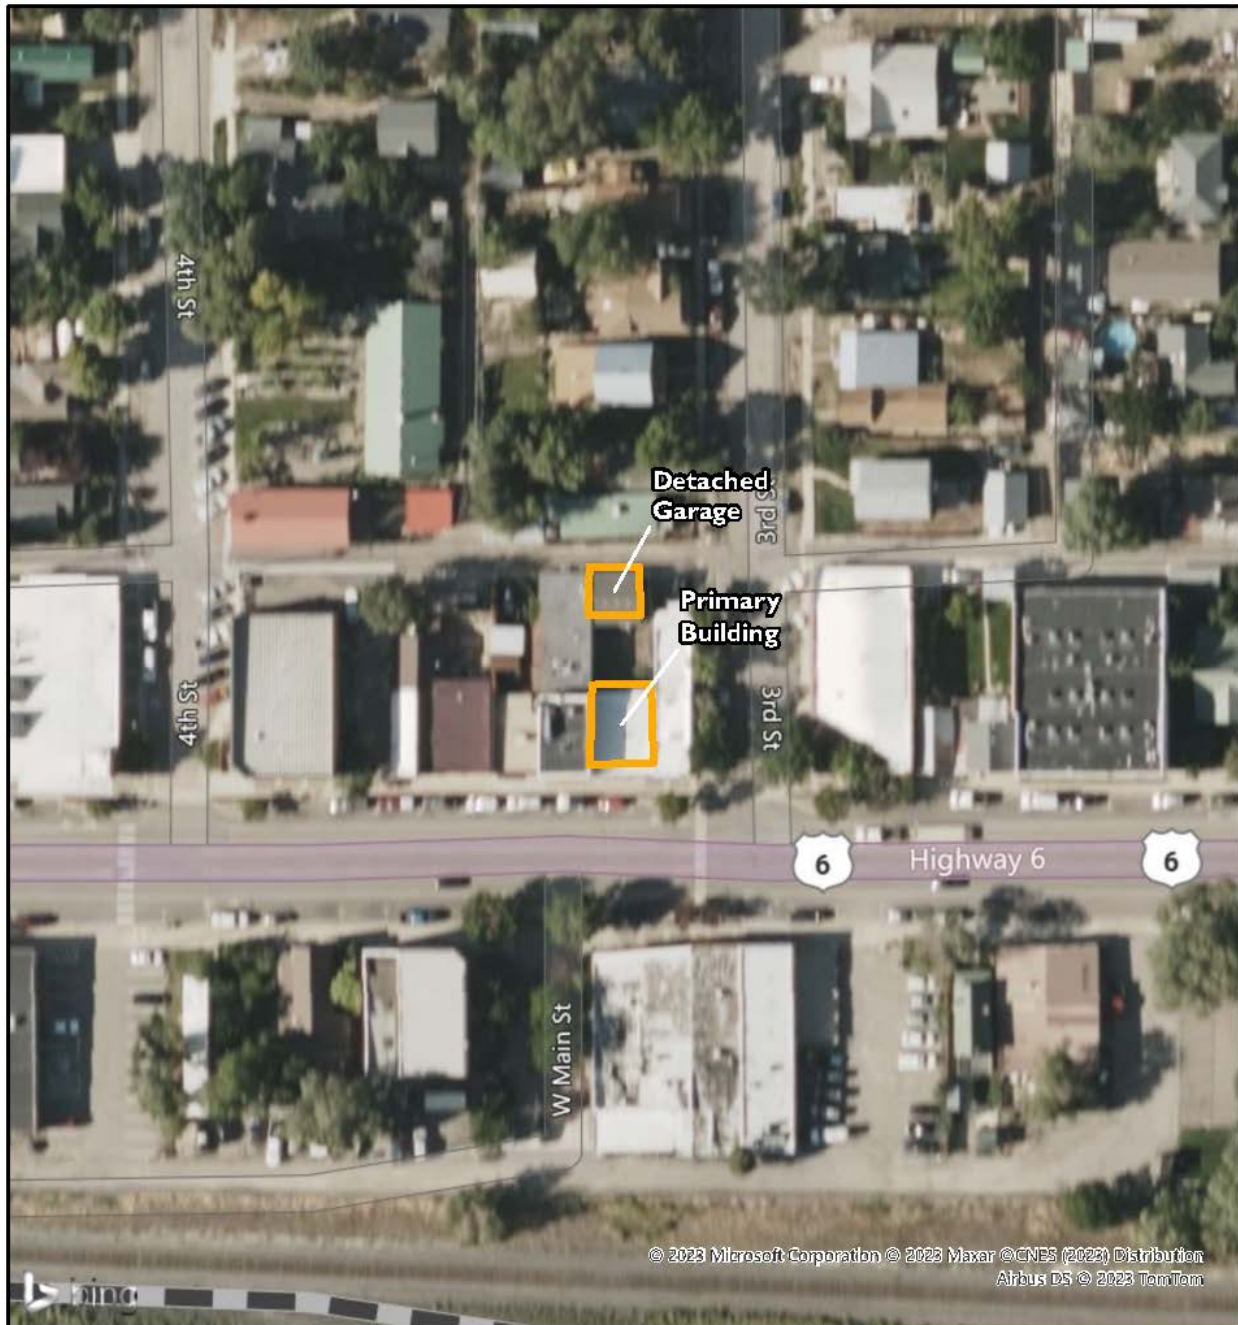
Sketch Map

<p>Sketch Map 312 West Main Street (5GF.2377) New Castle, Colorado Garfield County</p>				
<p>Pinyon Project Number: I 22156.001</p>	<table border="1"> <tr> <td>Drawn By: CJB</td> <td>Figure: 2</td> </tr> <tr> <td>Reviewed By: CMW</td> <td>Date: 4/10/2023</td> </tr> </table>	Drawn By: CJB	Figure: 2	Reviewed By: CMW	Date: 4/10/2023
Drawn By: CJB	Figure: 2				
Reviewed By: CMW	Date: 4/10/2023

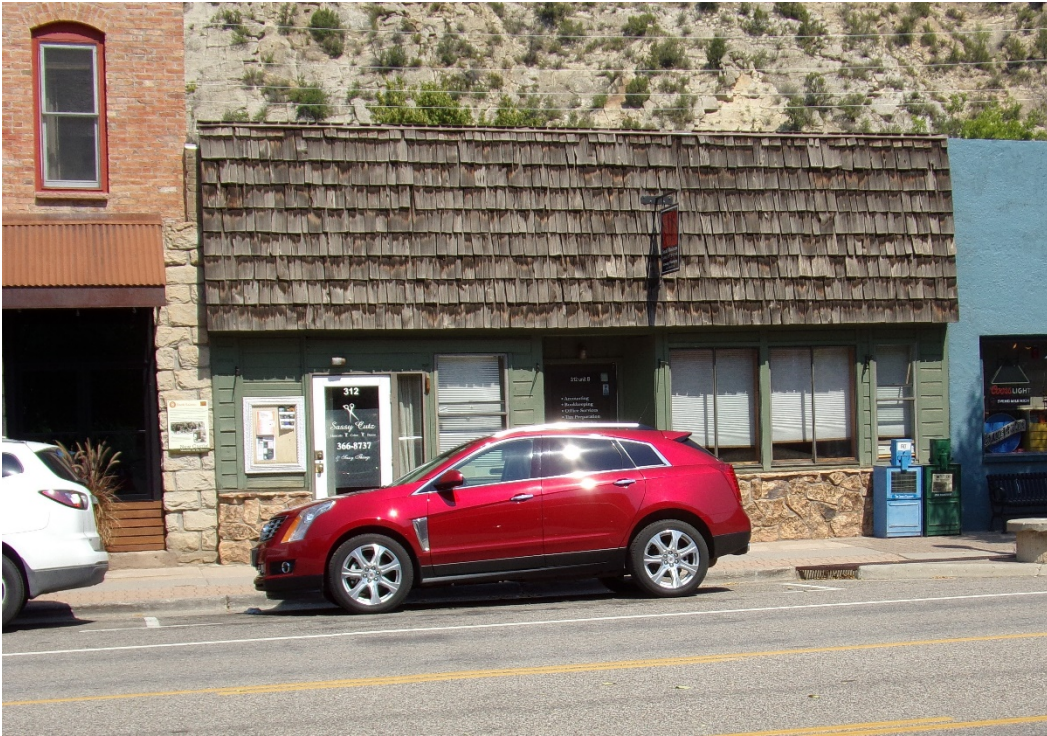
Photo Number: 5GF.2377_1
Description: Looking at the primary (south) elevation of the building.
Date: 9/6/2022
View: North

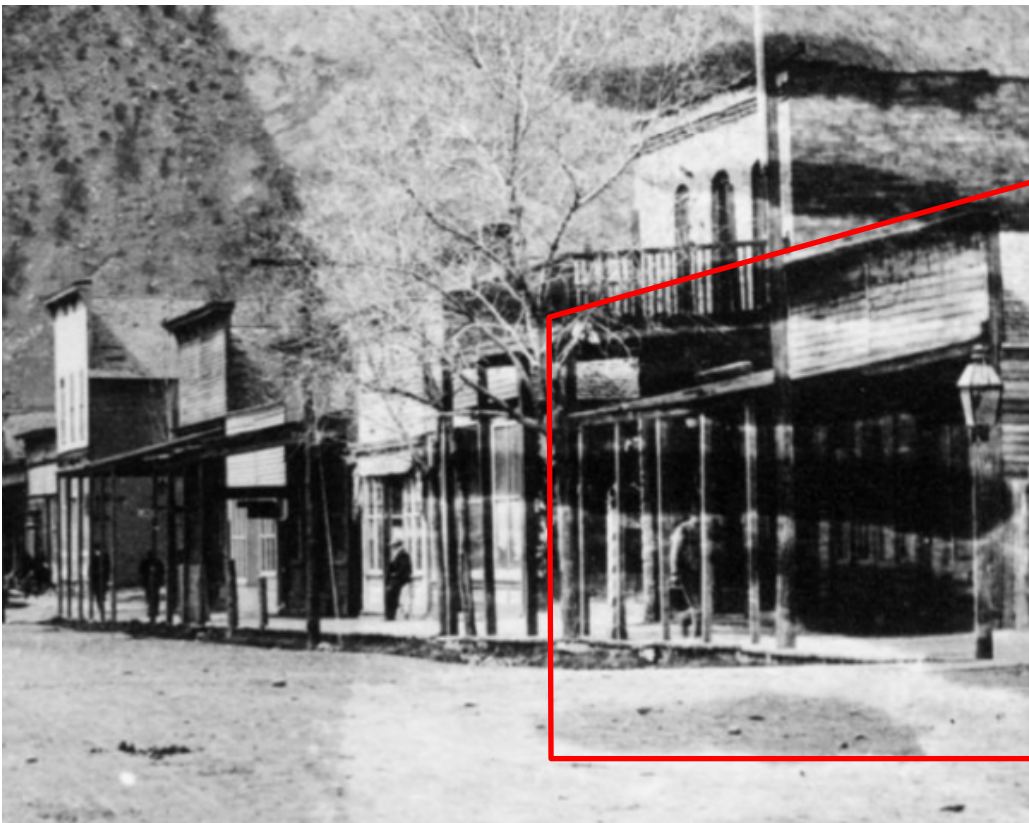
Historic Photo 1
Description: Image of downtown New Castle between North 3rd Street and North 4th Street. Note that the resource is outline in red.
Date: 1905
Source: Denver Public Library – Digital Collections [Not for publication]

Historical imagery of the building in 1905 and associated Sanborn Fire Insurance maps between 1899 and 1904 demonstrate that the building had a shed roof overhang along the primary (south) elevation. In addition, horizontal weatherboard siding can be noticed along the east elevation prior to the building's exterior wall being conjoined with the adjacent building to the east. In the late Twentieth Century, a faux mansard apron was constructed along the primary (south) elevation and the shed roof overhang was removed. Stone masonry features were also constructed along the façade. By 1996, lattice panels were present between the foundation and the window sills along the primary (south) elevation and the secondary entryway side-by-side doors had been replaced. The lattice panels were later removed by 2005 after review of historical street imagery.

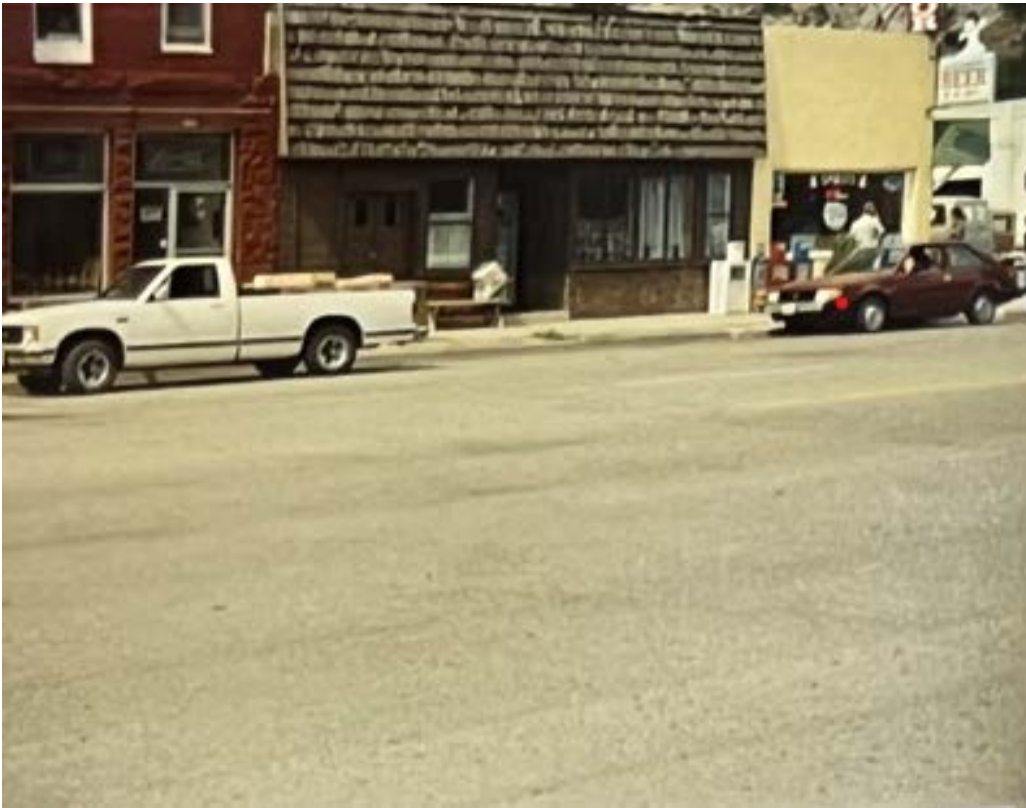
Reference Photo 1

Description: Lisa Gresock's Knitting Shop-Building has been a café, barber shop, and other businesses.

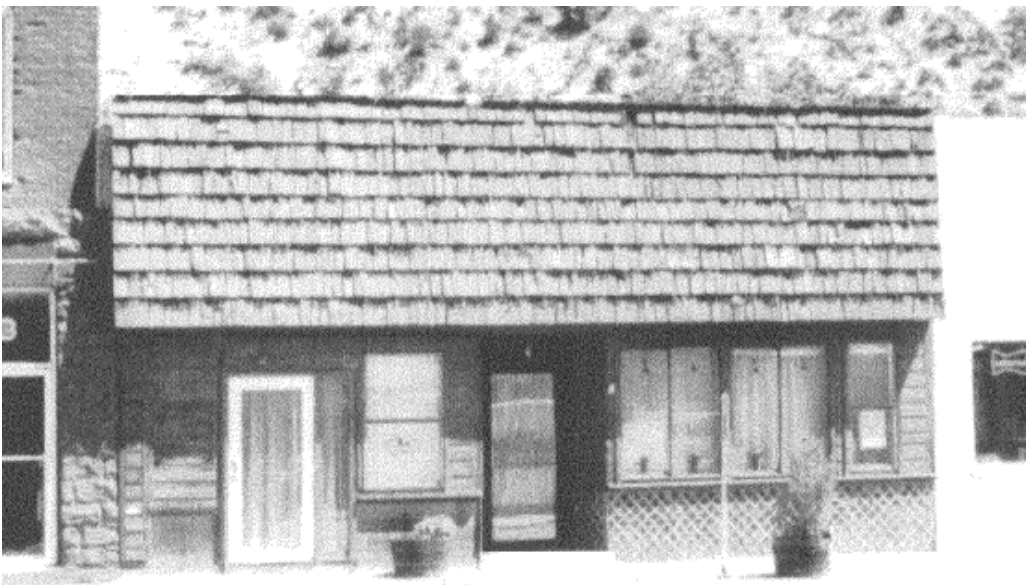
Reference Photo 2

Description: Looking at the primary (south) elevation of the building.

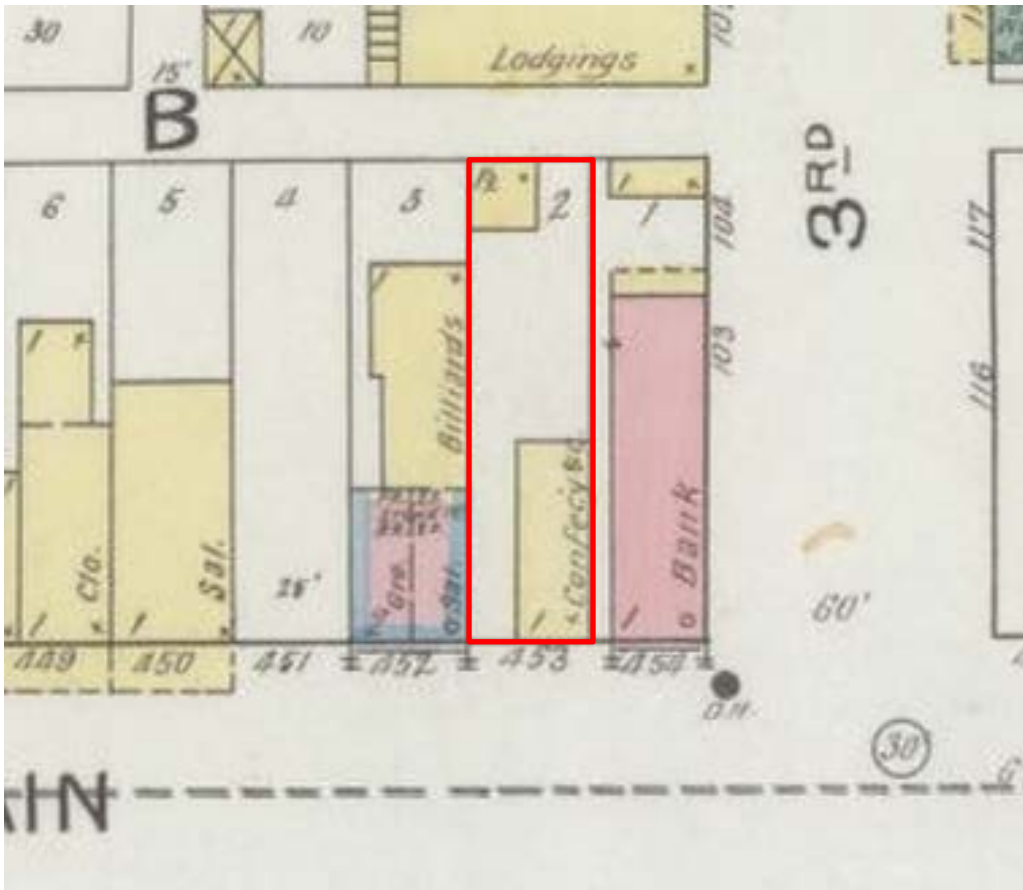
Reference Photo 3

Description: 1893 Sanborn Fire Insurance map of the resource located on lot 2 of block B. The property is outlined in red.

"The Sanborn map of 1893 shows a one-story frame building on the site labelled 'confectionary and cigars' with open space between buildings to the east and west. The 1899 Sanborn map shows the frame building in use as sleeping rooms, while a narrow office building had been added on the west. By 1904, the office portion was used as a barber shop and the eastern part was labelled 'offices.' The current building, which features a circa 1910s or 1920s brick façade behind the upper mansard, may be a refacading of the early building. In 1928, the building was purchased by the ladies group of St. John's Episcopal Church for use as a guild room... In 1937, the structure was sold to Tony Perry for \$000 and he operated a café and bar there. A photograph from the 1950s shows the building as the 'New Castle Café and Bar.' The property was purchased by Whipcheck Manufacturing Co. 1981 and by Stephen and Lisa Gresock in 1991. A wholesale sweater business now occupies the building. The detached garage was erected in 1979."

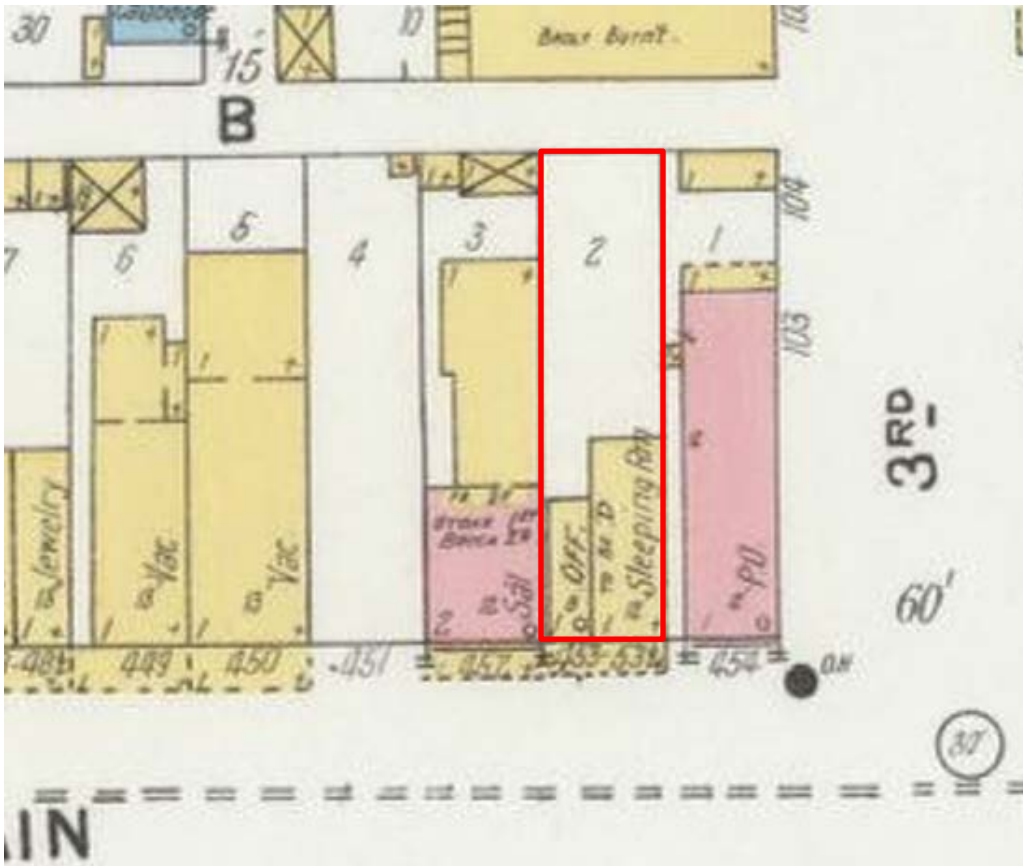
Reference Photo 4

Description: 1899 Sanborn Fire Insurance map of the resource. The property is outlined in red.

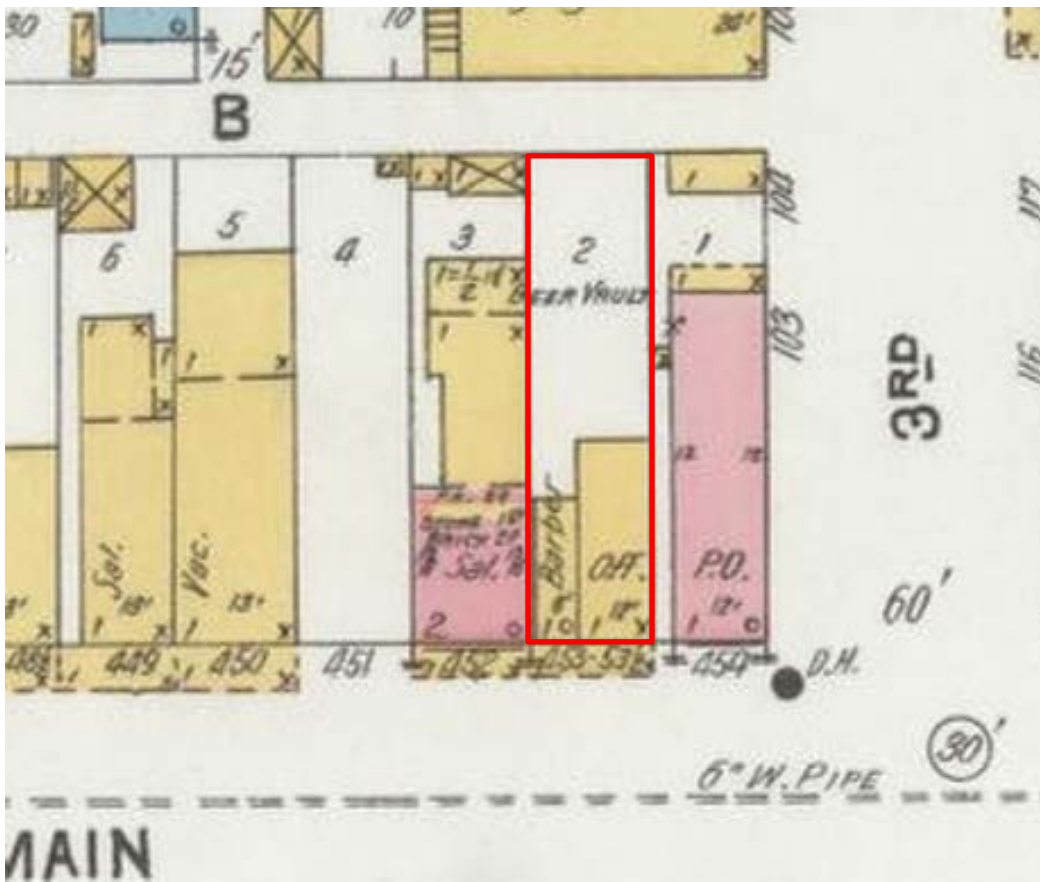
Reference Photo 5

Description: 1904 Sanborn Fire Insurance map of the resource. The property is outlined in red.
