COLORADO CULTURAL RESOURCES INVENTORY

Historical and Architectural Reconnaissance

1. Property Name: Barry & Anne Andersen Residence Historic Current Other:
2. Resource Classification: Building Structure Object Sites/Landscape
3. Ownership: Federal State Local Non-profit Private Unknown

4. Street Address: 316 East Main Street
5. Municipality: New Castle, CO Vicinity:
6. County: Garfield
- **7. USGS Quad: New Castle, CO Year: 2022 7.5'
- **8. Parcel Number: 212331104007
- **9. Parcel Information: Lot(s): 5-9 Block: G Addition: Spencer's Addition
- **10. Acreage: 0.28 Actual Estimated
11. PLSS information: Principal Meridian: 6th Township: 5S Range: 90W
SE ¼ of SW ¼ of SE ¼ of NE ¼ of section: 31

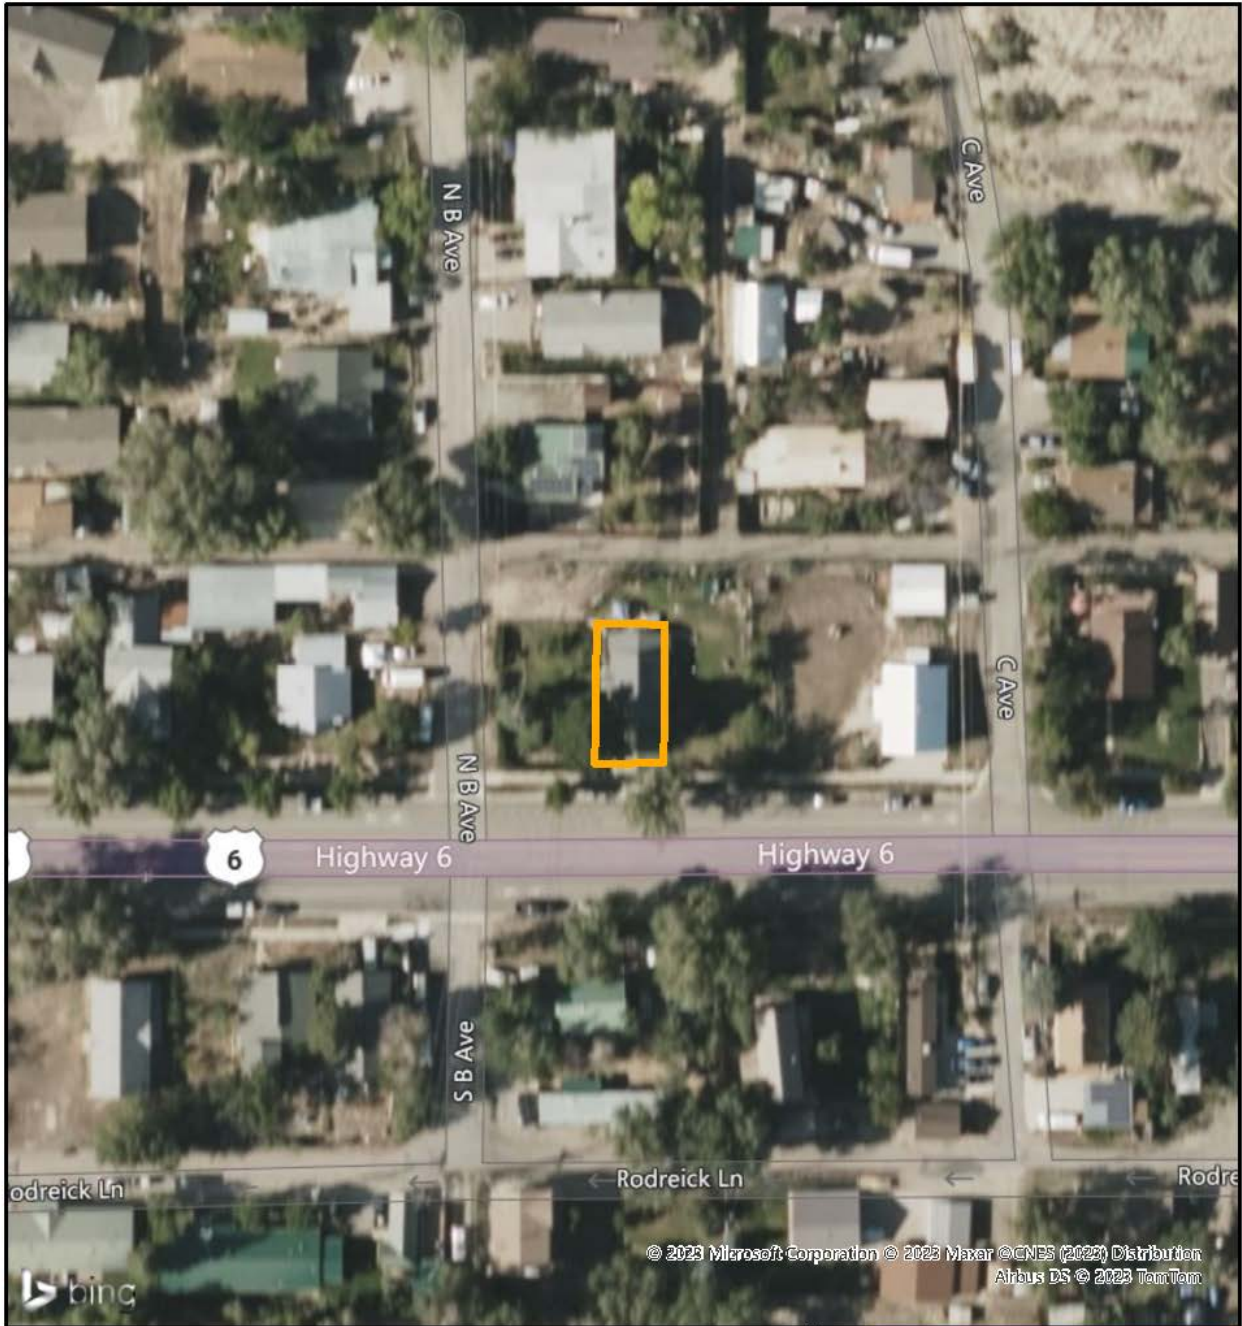
Sketch Map

<p>Sketch Map 316 East Main Street (5GF.5931) New Castle, Colorado Garfield County</p>				
<p>Pinyon Project Number: I 22156.001</p>	<table border="1"> <tr> <td>Drawn By: CJB</td> <td>Figure: 2</td> </tr> <tr> <td>Reviewed By: CMW</td> <td>Date: 4/10/2023</td> </tr> </table>	Drawn By: CJB	Figure: 2	Reviewed By: CMW	Date: 4/10/2023
Drawn By: CJB	Figure: 2				
Reviewed By: CMW	Date: 4/10/2023

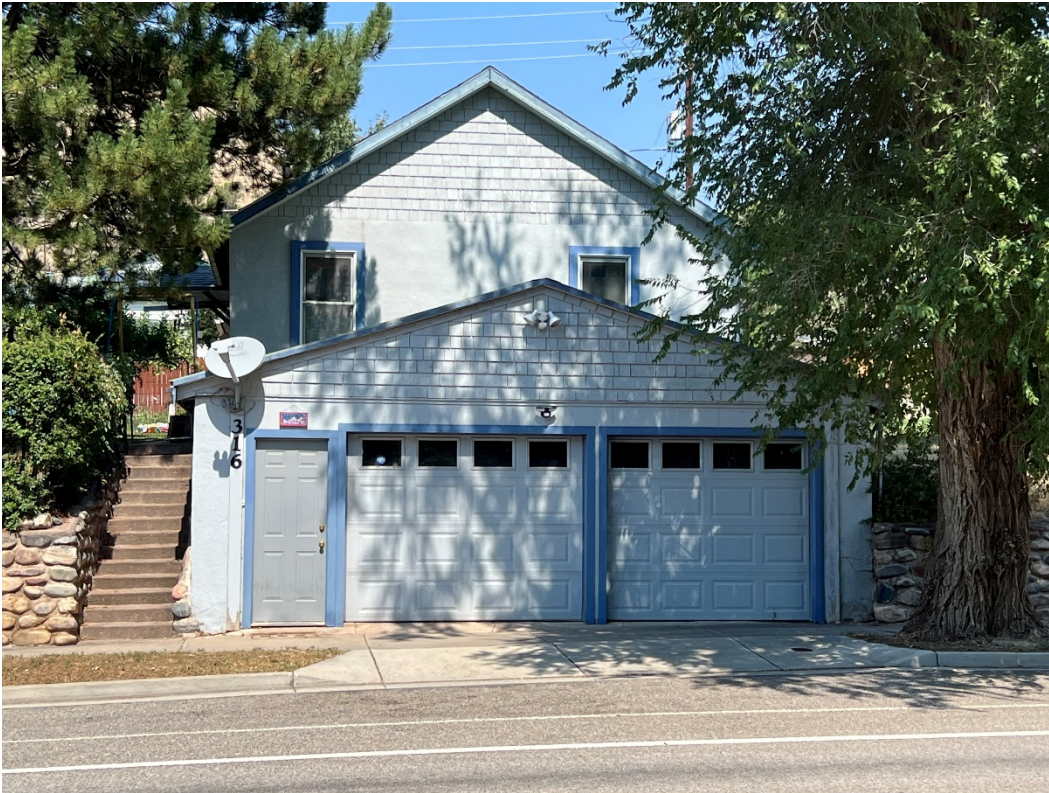
Photo Number: 5GF.5931_1
Description: Looking at the south elevation of the building.
Date: 9/6/2022
View: North

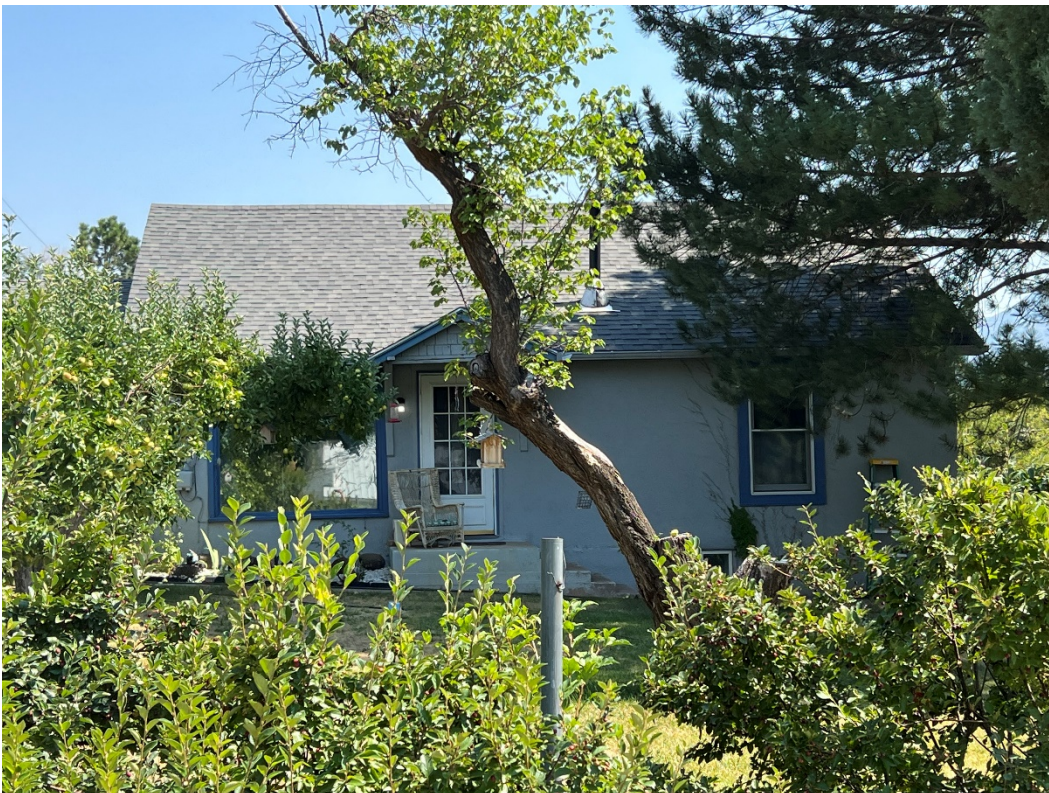
Photo Number: 5GF.5931_2
Description: Looking at the primary (west) elevation of the building.
Date: 9/6/2022
View: East

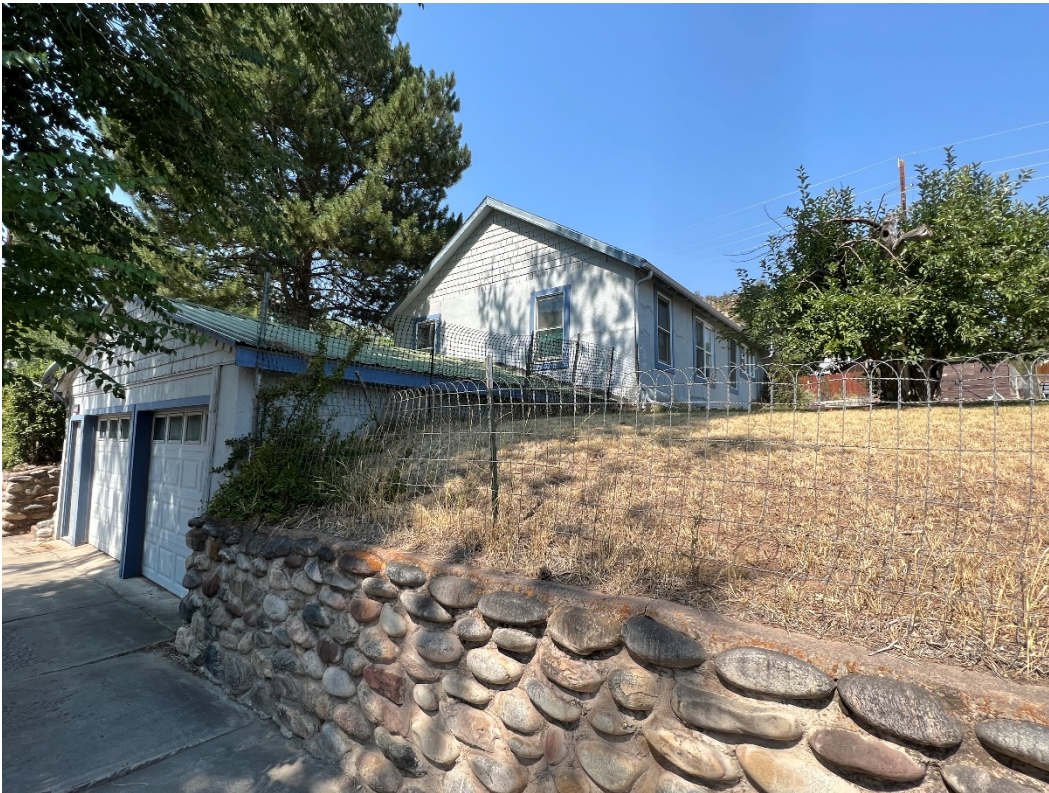
Photo Number: 5GF.5931_3
Description: Looking at the south and east elevations of the residence.
Date: 9/6/2022
View: Northwest

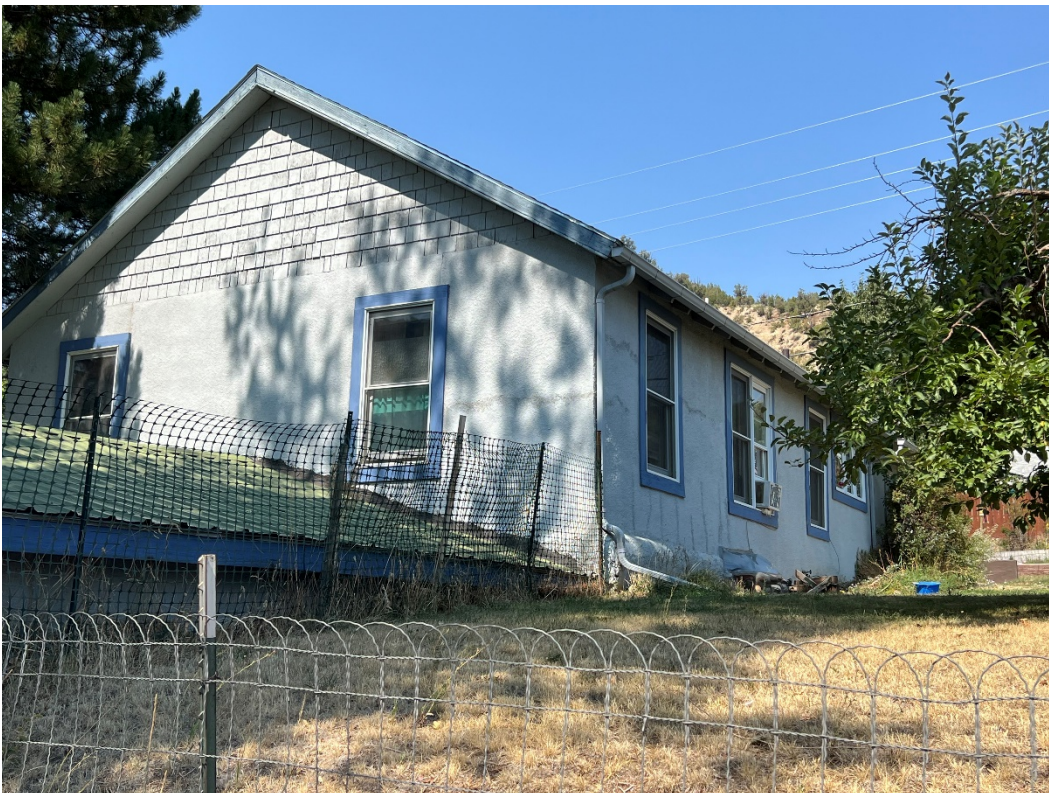
Photo Number: 5GF.5931_4
Description: Close up of the south and east elevations of the residence. Note the exposed rafter tails under the eaves that are partially obscured by the fascia board.
Date: 9/6/2022
View: Northwest
