COLORADO CULTURAL RESOURCES INVENTORY

Historical and Architectural Reconnaissance

1. Property Name: Rock Saloon Historic Current Other:
2. Resource Classification: Building Structure Object Sites/Landscape
3. Ownership: Federal State Local Non-profit Private Unknown

4. Street Address: 316 West Main Street
5. Municipality: New Castle, CO Vicinity:
6. County: Garfield
- **7. USGS Quad: New Castle, CO Year: 2022 7.5'
- **8. Parcel Number: 212331109020
- **9. Parcel Information: Lot(s): 3, 4 Block: B Addition: ORIGINAL TWNSTE NEW CASTLE
- **10. Acreage: 0.08 Actual Estimated
11. PLSS information: Principal Meridian: 6th Township: 5S Range: 90W
SE ¼ of SW ¼ of SW ¼ of NE ¼ of section: 31

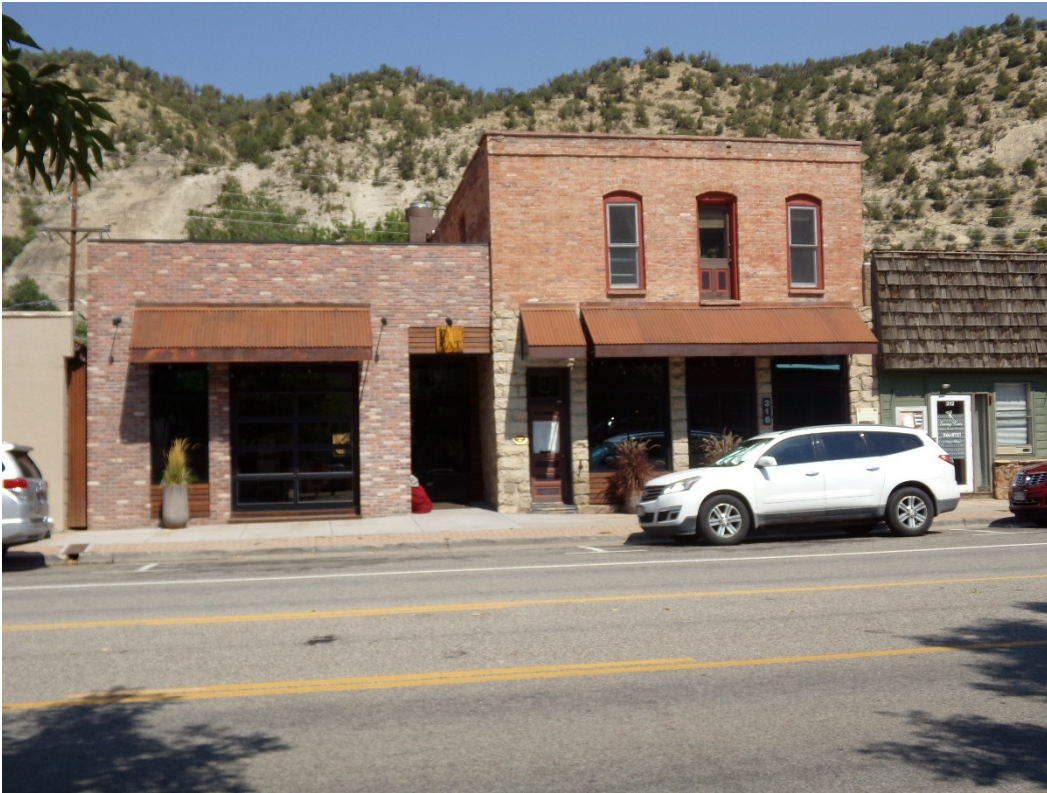
Photo Number: 5GF.2378_1
Description: Looking at the primary (south) elevation of the building. Note that the left half of the building consists of the addition constructed between 2017 and 2019.
Date: 9/6/2022
View: North

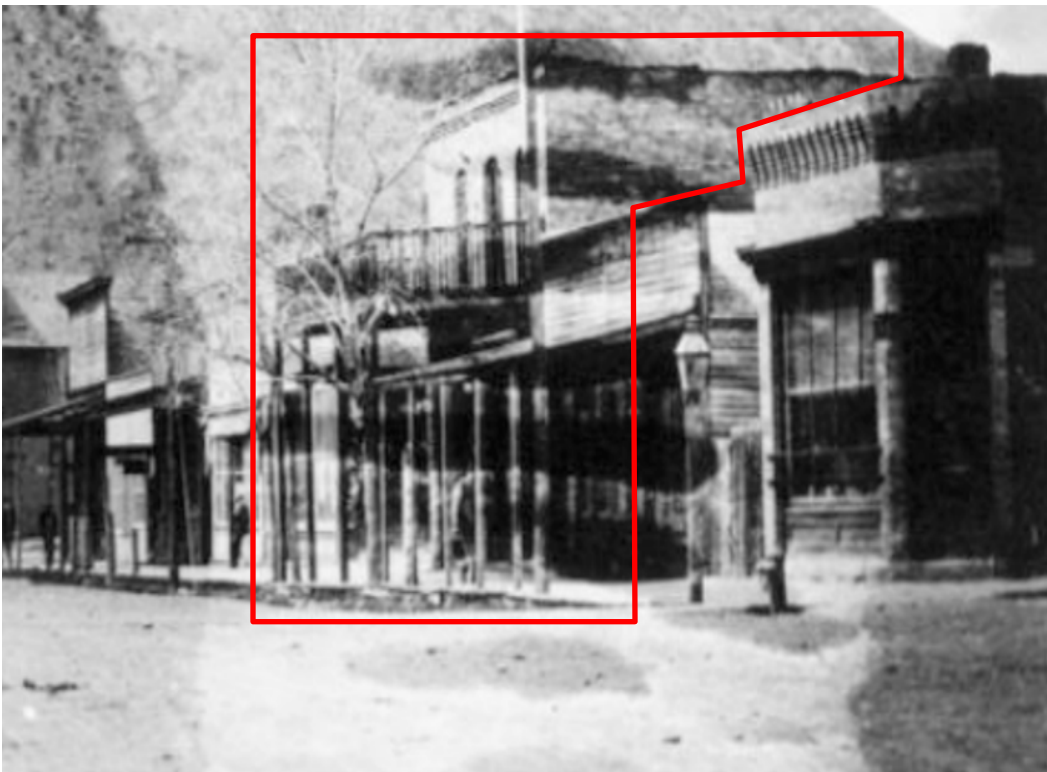
Historic Photo 1
Description: Image of downtown New Castle between North 3rd Street and North 4th Street. Note that the resource is outlined in red.
Date: 1905
Source: Denver Public Library – Digital Collections [Not for publication]

Sanborn Fire Insurance maps between 1893 and 1904 demonstrate that an addition was made to the north elevation of the building. Historical imagery of the building in 1905 demonstrates that the building had a full length wood deck on the second floor of the primary (south) elevation. In addition, a corbelled brick cornice was present at the time. Around two and a half decades later, another historic image of the building circa 1930 reveals that the second-floor deck had been removed and the center entryway door had been replaced by a one-over-one single hung sash window. By the late Twentieth Century, a second entryway was constructed on the far-right side of the building, replacing a former picture window unit. The cornice was also altered, and the corbelled brick was removed, leaving the brick belt course. Historical aerial imagery between 2017 and 2019 demonstrates that an addition was made to the west elevation of the building. During this same period, the windows along the first floor of the primary (south) elevation were replaced; although, the historic main entryway was retained. The center window located on the center floor of the façade was also replaced by a wood panel door with a radiused pictured window.

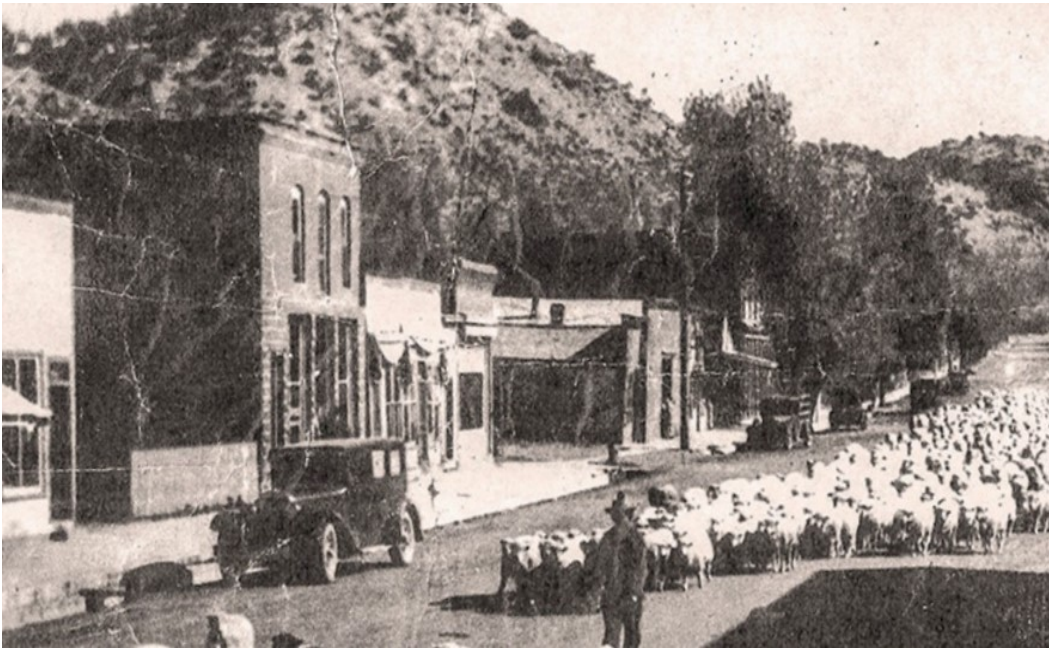
Historic Photo 2

Description: Looking at the west and primary (south) elevation of the building. Note that the building is the two-story building on the far-left side of the photo.

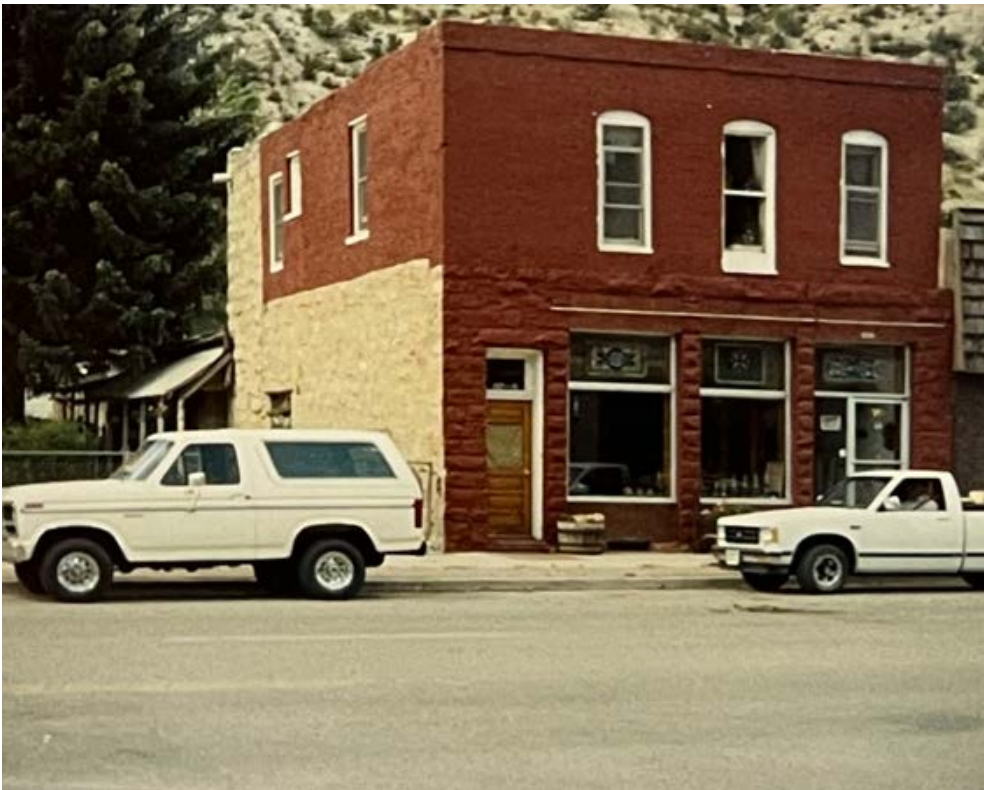
Reference Photo 1

Description: Image title block states, "Rock Saloon - Post Office 1928-1985."

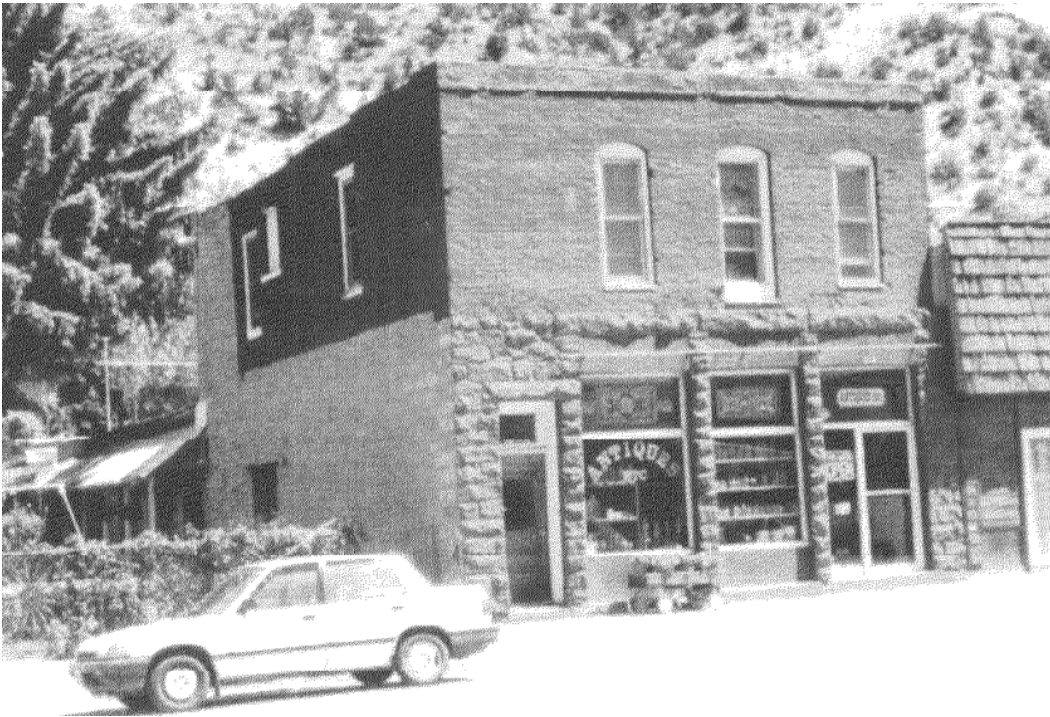
Reference Photo 2

Description: Looking at the primary (south) and west elevations of the building.

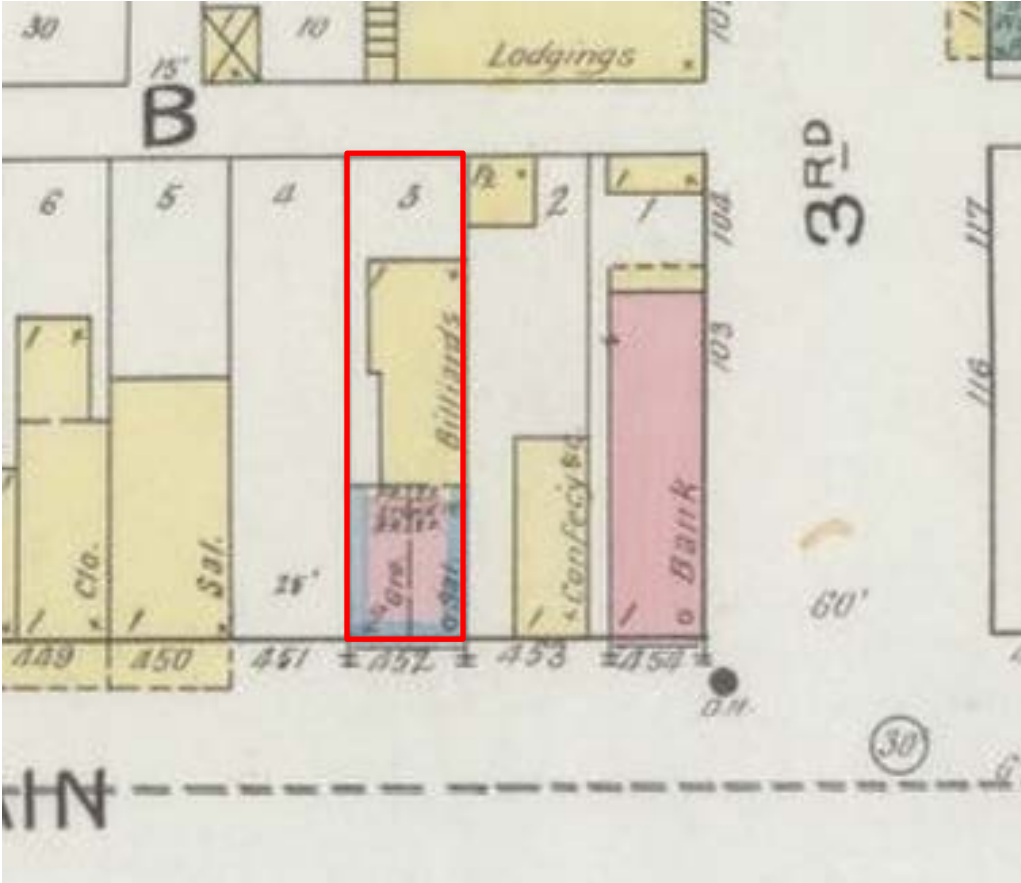
Reference Photo 3

Description: 1893 Sanborn Fire Insurance map of the resource located on lot 3 of block B. The property is outlined in red.

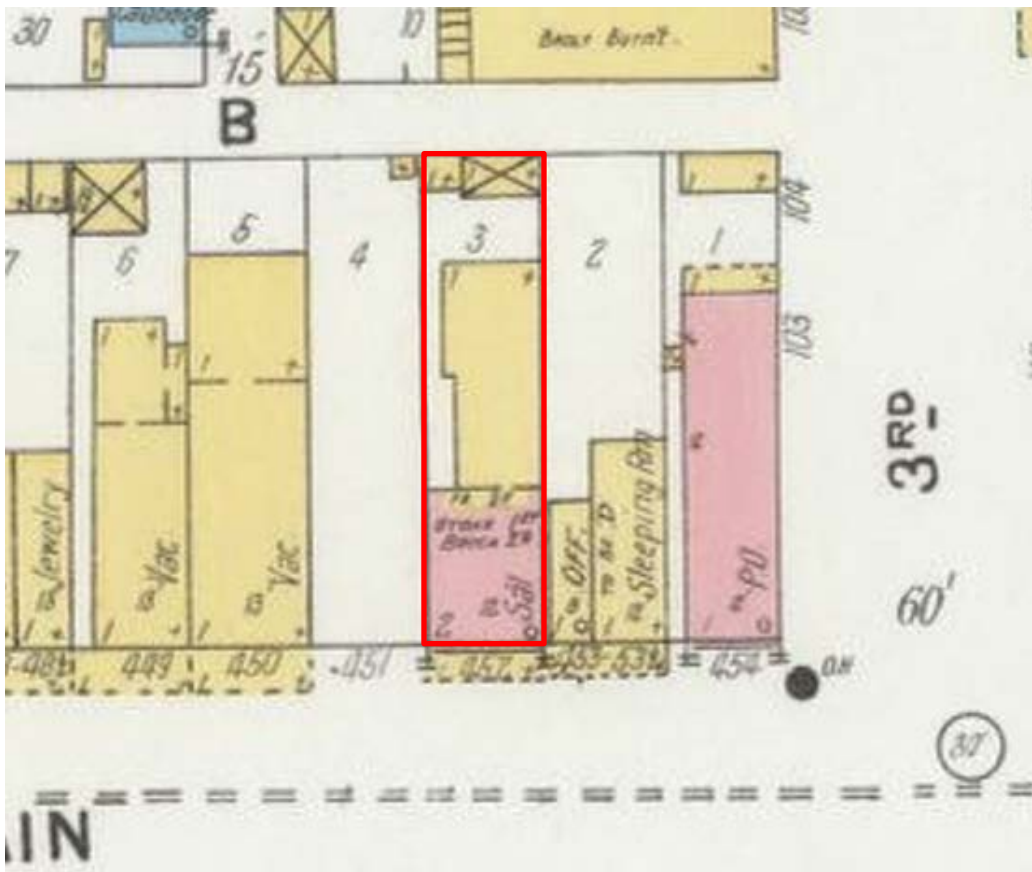
Reference Photo 4

Description: 1899 Sanborn Fire Insurance map of the resource. The property is outlined in red.

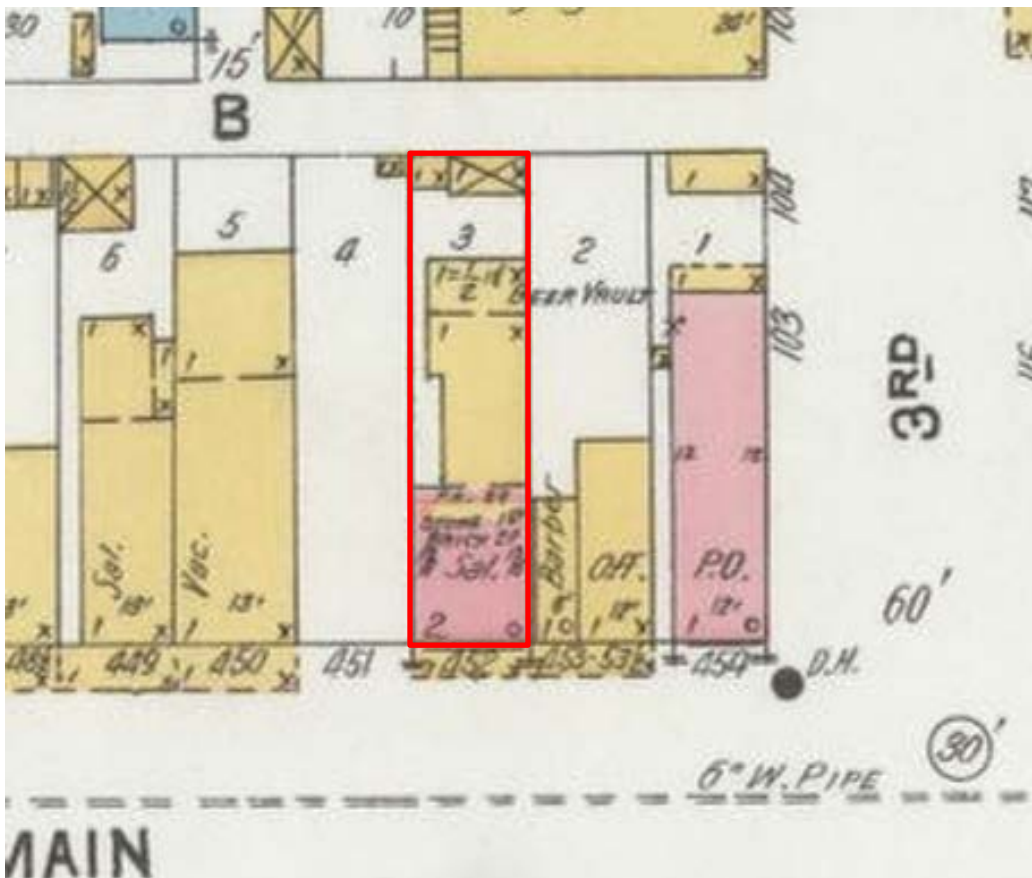
Reference Photo 5

Description: 1904 Sanborn Fire Insurance map of the resource. The property is outlined in red.
