COLORADO CULTURAL RESOURCES INVENTORY

Historical and Architectural Reconnaissance

1. Property Name: Trimble Block Historic Current Other:
2. Resource Classification: Building Structure Object Sites/Landscape
3. Ownership: Federal State Local Non-profit Private Unknown

4. Street Address: 331 West Main Street
5. Municipality: New Castle, CO Vicinity:
6. County: Garfield
- **7. USGS Quad: New Castle, CO Year: 2022 7.5'
- **8. Parcel Number: 212331409002

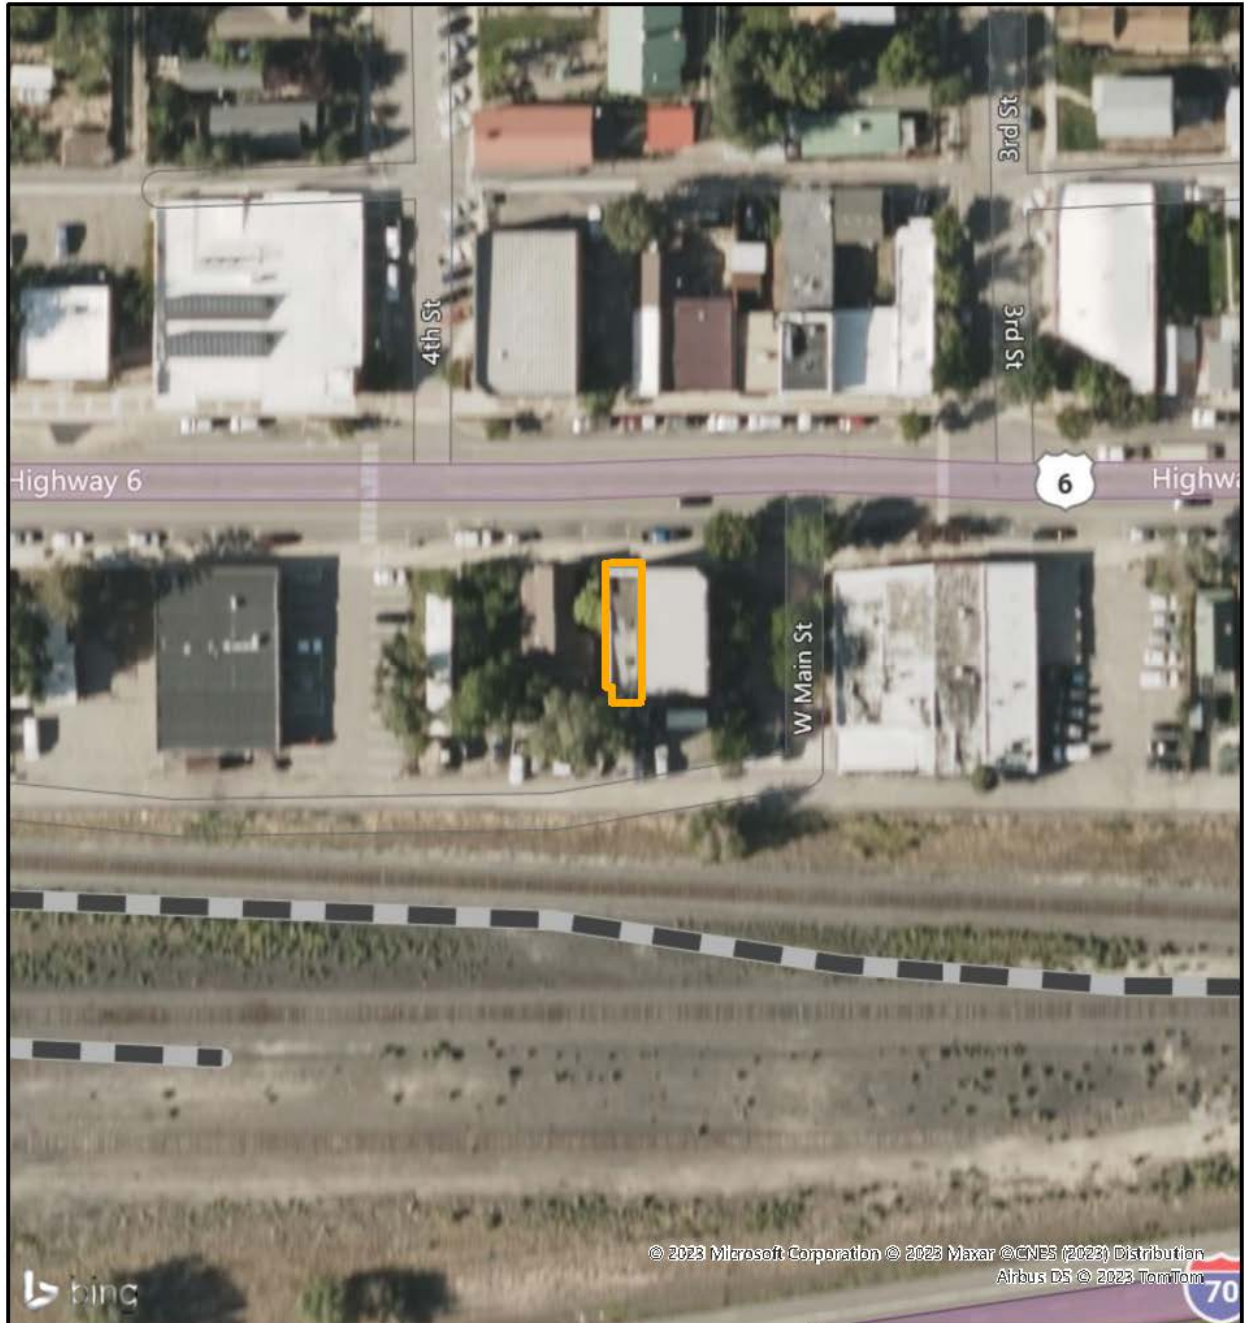
Sketch Map

</div>	<p>Pinyon Professional, Inc.</p> <p>Sketch Map 331 West Main Street (5GF.2379) New Castle, Colorado Garfield County</p>				
<p>Pinyon Project Number: I 22156.001</p>	<table border="1" style="width: 100%;"> <tr> <td style="width: 50%;">Drawn By: CJB</td> <td style="width: 50%;">Figure: 2</td> </tr> <tr> <td>Reviewed By: CMW</td> <td>Date: 4/10/2023</td> </tr> </table>	Drawn By: CJB	Figure: 2	Reviewed By: CMW	Date: 4/10/2023
Drawn By: CJB	Figure: 2				
Reviewed By: CMW	Date: 4/10/2023

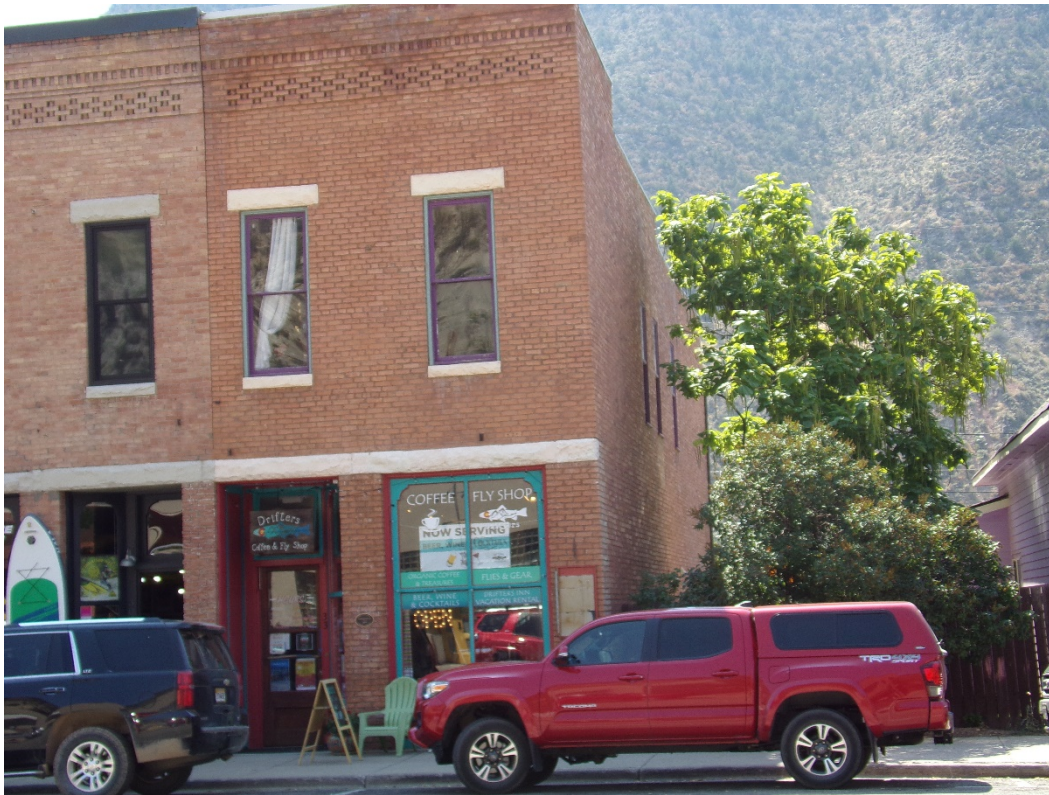
Photo Number: 5GF.2379_1
Description: Looking at the primary (north) and west elevations of the building. Note the decorative brickwork below the cornice.
Date: 9/6/2022
View: Southeast

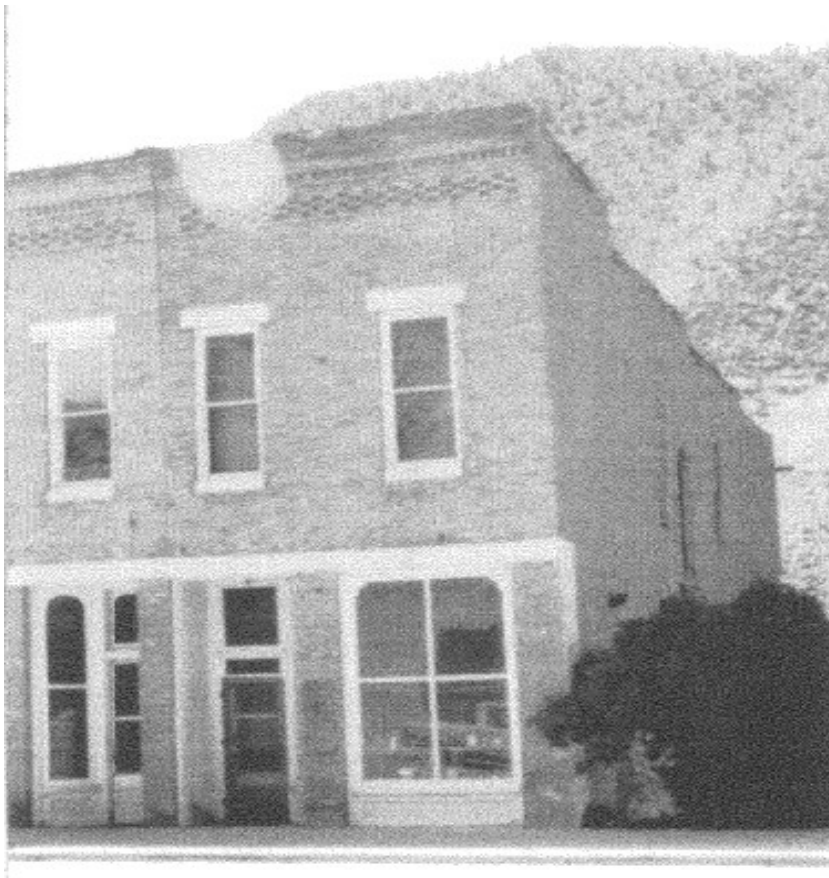
Reference Photo 1
Description: Looking at the primary (north) and west elevations of the building.
Date: 9/6/2022
Source: 1996 OAHP Historic Building Inventory Record (5GF.2379)

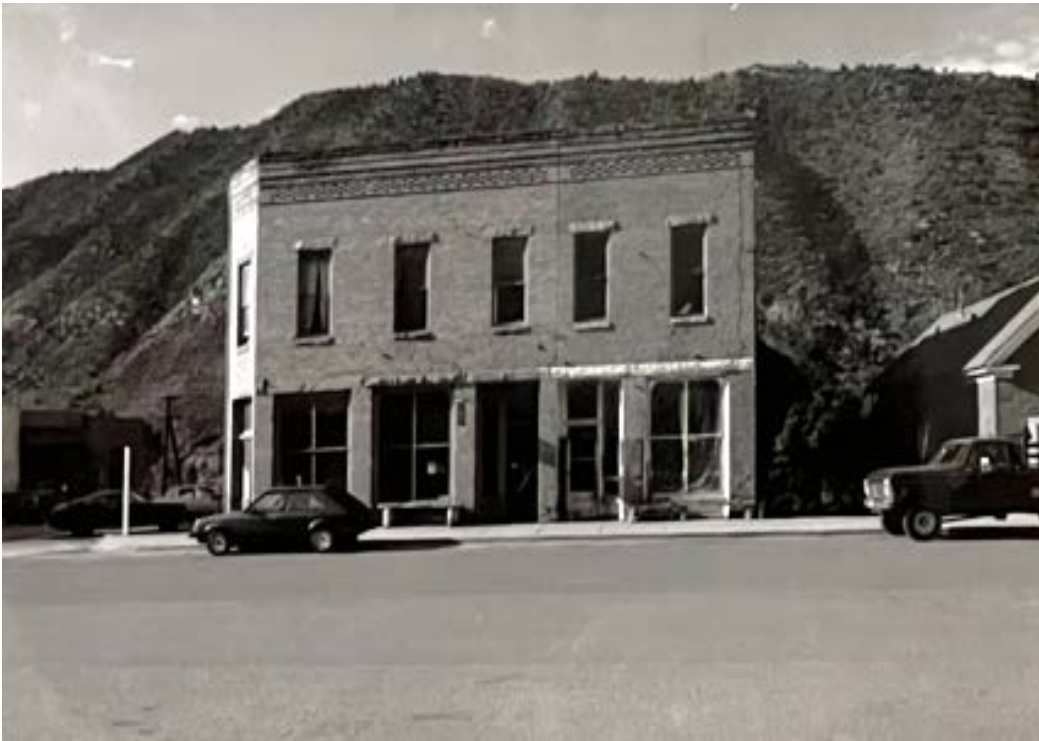
Reference Photo 2

Description: The building is located on the right side of the photo.

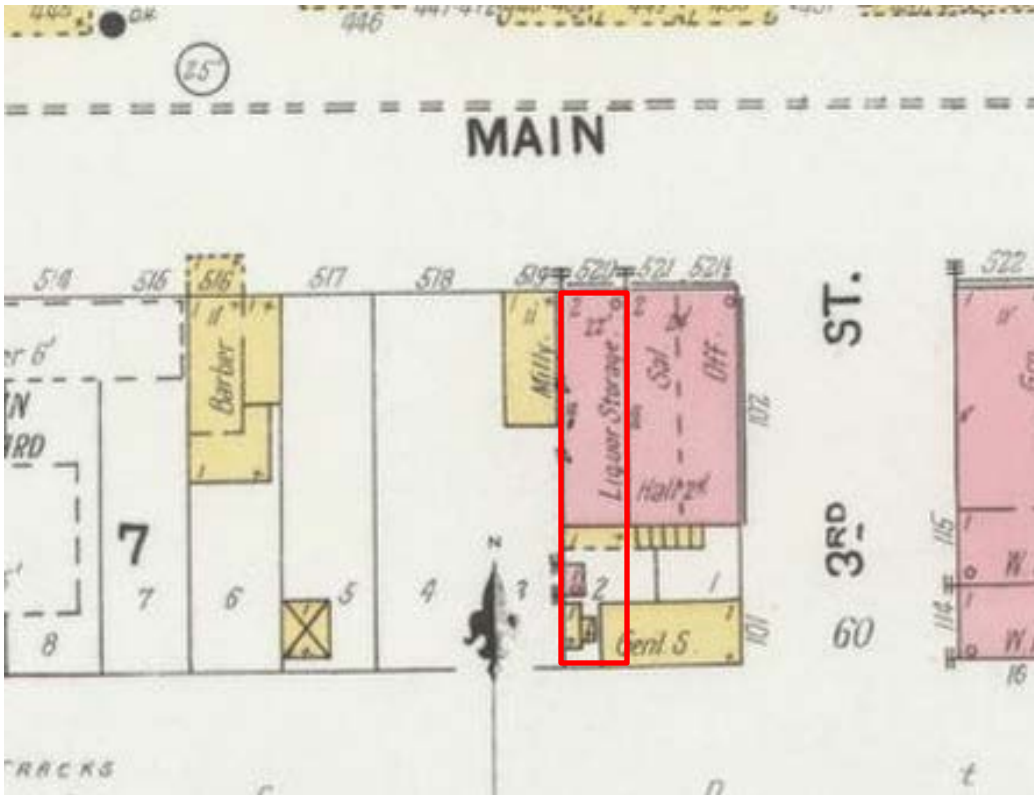
Reference Photo 4

Description: 1899 Sanborn Fire Insurance map of the resource after its construction 4 years earlier. The building is located partially on lot 2 of block 7. The property is outlined in red.

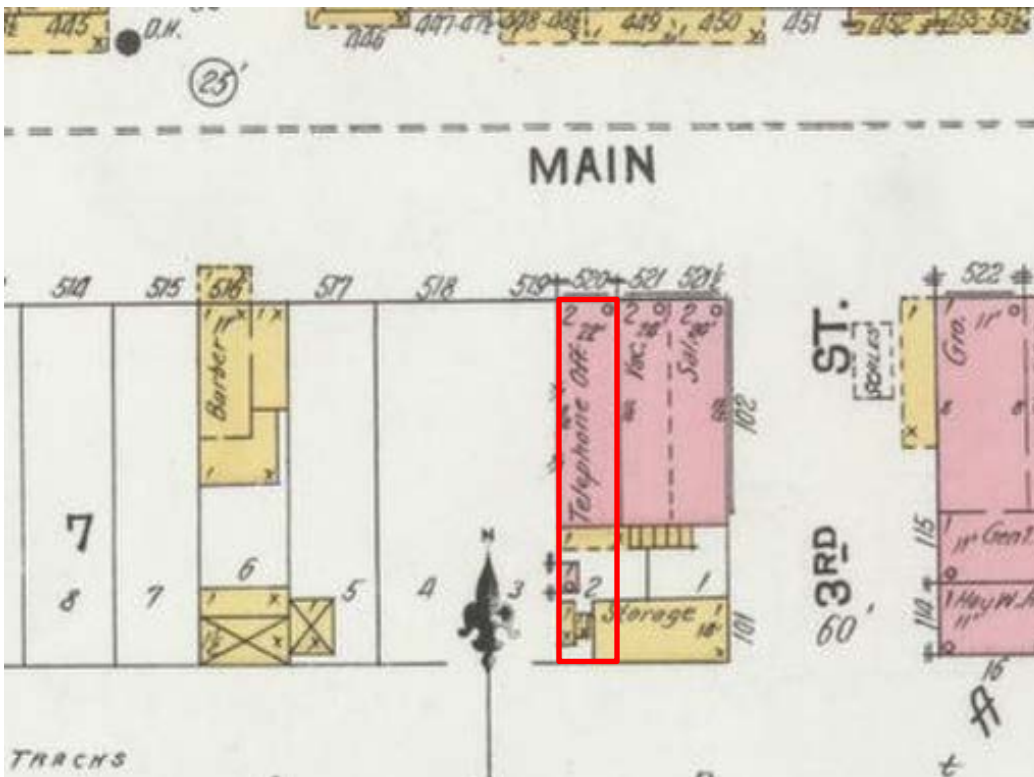
Reference Photo 5

Description: 1904 Sanborn Fire Insurance map of the resource. The property is outlined in red.
