COLORADO CULTURAL RESOURCES INVENTORY

Historical and Architectural Reconnaissance

Sketch Map
333 West Main Street (5GF.5914)
New Castle, Colorado
Garfield County

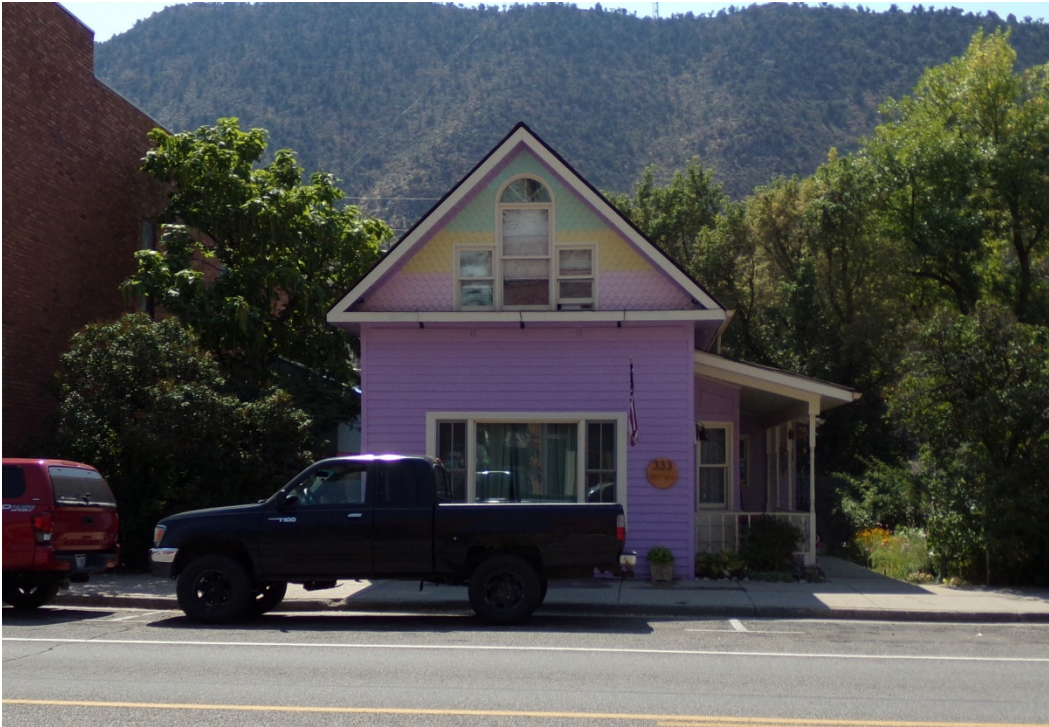
Photo Number: 5GF.5914_1
Description: Looking at the north elevation of the building.
Date: 9/6/2022
View: South

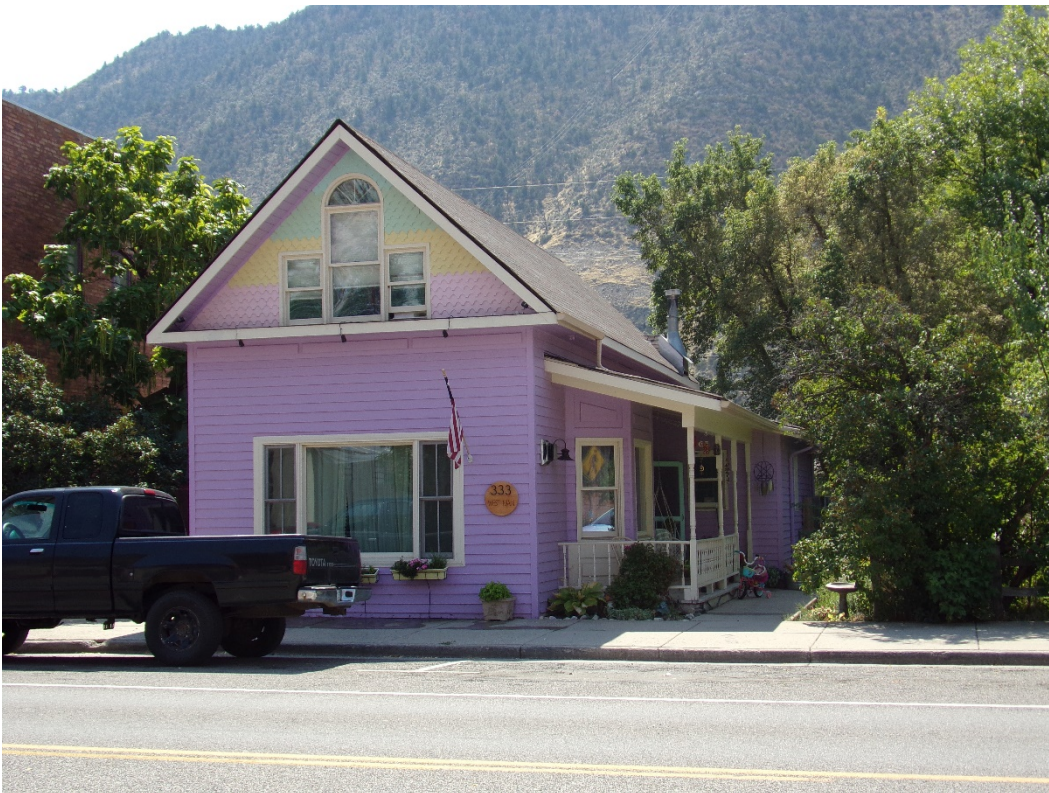
Photo Number: 5GF.5914_2
Description: Looking at the north and primary (west) elevations of the building.
Date: 9/6/2022
View: Southeast

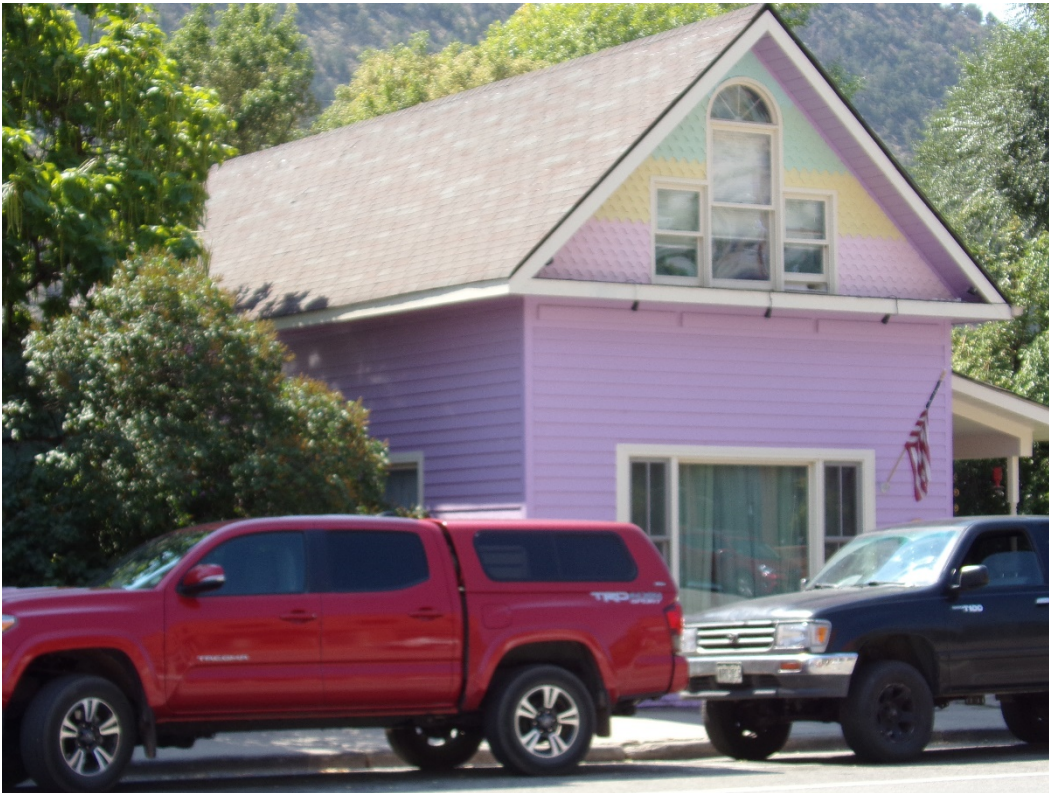
Photo Number: 5GF.5914_3
Description: Looking at the east and north elevation of the building.
Date: 9/6/2022
View: Southwest

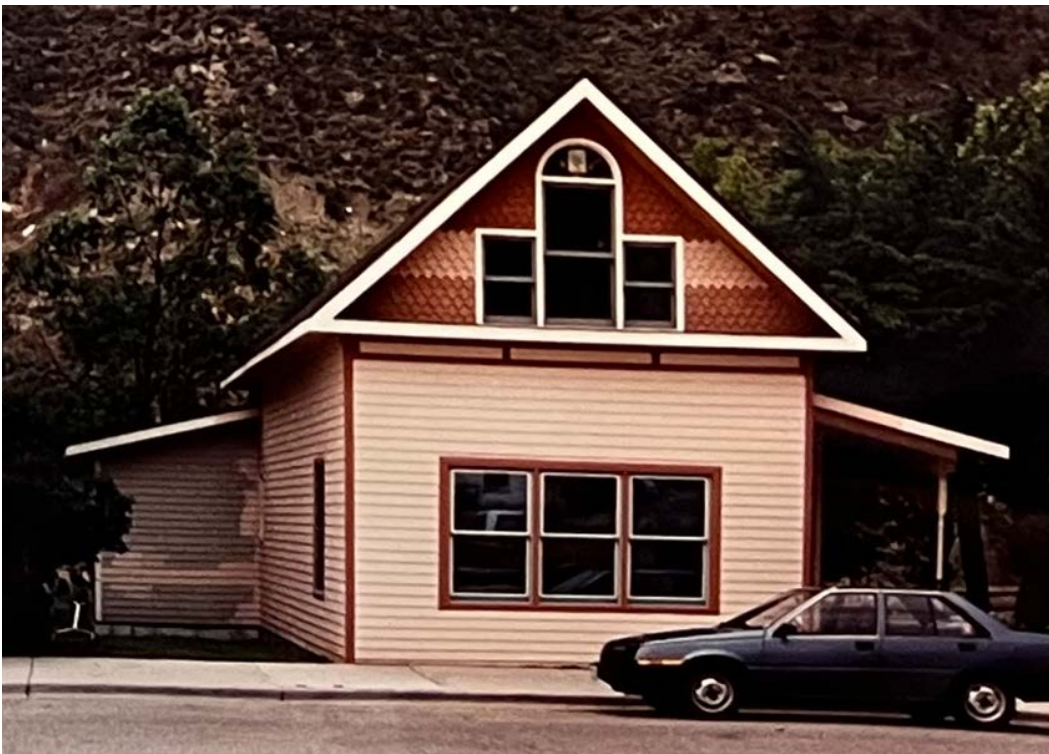
Reference Photo 1
Description: Looking at the west and north elevations of the residence.
Date: Unknown
Source: New Castle Museum Collection

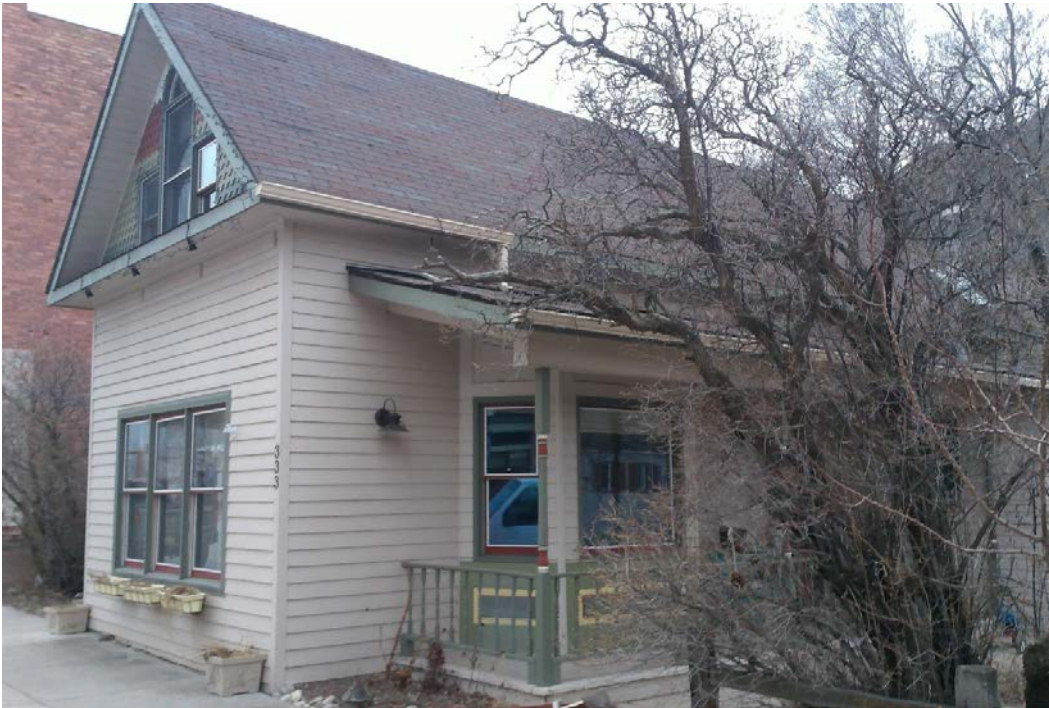
Reference Photo 2

Description: Looking at the north and primary (west) elevations of the building.

Date: circa 2009
