COLORADO CULTURAL RESOURCES INVENTORY

Historical and Architectural Reconnaissance

1. Property Name: Gerstner Building								t 🛛 Other:	
2. Resource Class	ification: 🛛 🖾 E	Building	□ Structure	• 🗆	Object	□ S	ites/Landsc	ape	
3. Ownership:	Federal	□ State	🗆 Local		Non-profit	⊠P	rivate	🗆 Unknown	
LOCATION 4. Street Address: <u>366 West Main Street</u>

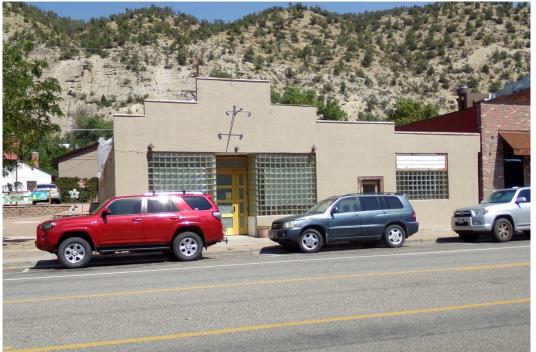
Photo Number: 5GF.5912_1 Description: Looking at the primary (south) elevation of the building. Date: 9/6/2022 View: North

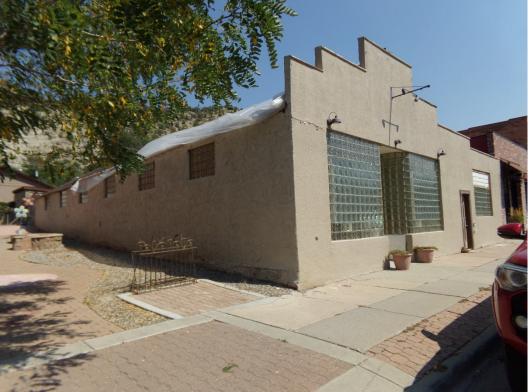
Photo Number: 5GF.5912_2 Description: Looking at the west and primary (south) elevations of the building. Date: 9/6/2022 View: Northeast
