COLORADO CULTURAL RESOURCES INVENTORY

Historical and Architectural Reconnaissance

1. Property Name: Webster Evans' House and Hospital Historic Current Other:
2. Resource Classification: Building Structure Object Sites/Landscape
3. Ownership: Federal State Local Non-profit Private Unknown

4. Street Address: 396 East Main Street
5. Municipality: New Castle, CO Vicinity:
6. County: Garfield
- **7. USGS Quad: New Castle, CO Year: 2022 7.5'
- **8. Parcel Number: 212331104008
- **9. Parcel Information: Lot(s): 1-4 Block: G Addition: Spencer's Addition
- **10. Acreage: 0.22 Actual Estimated
11. PLSS information: Principal Meridian: 6th Township: 5S Range: 90W
SE ¼ of SW ¼ of SE ¼ of NE ¼ of section: 31

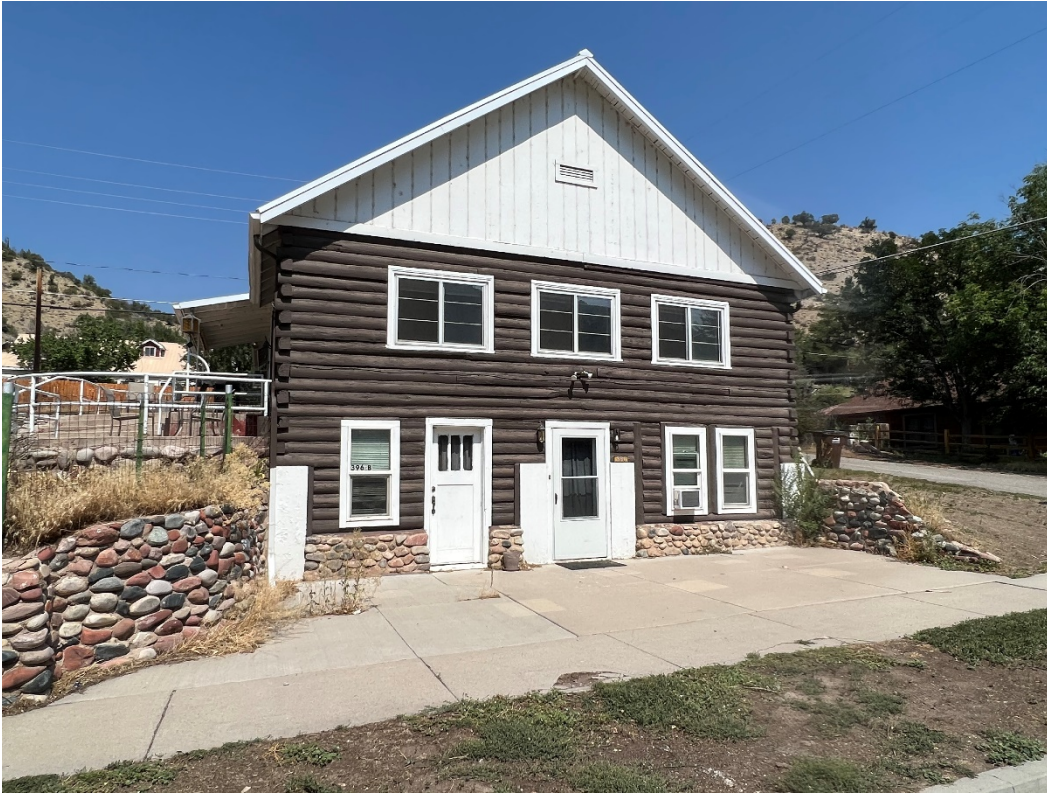
Photo Number: 5GF.5932_1
Description: Looking at the south elevation of the building.
Date: 9/6/2022
View: Northeast

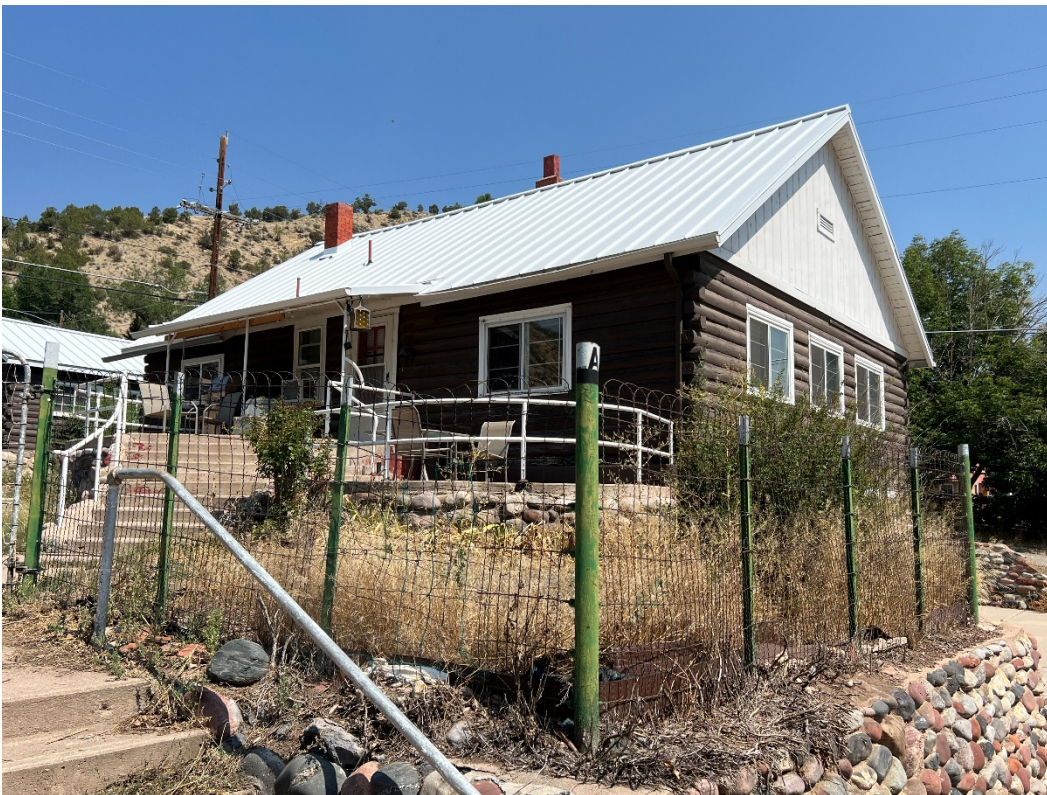
Photo Number: 5GF.5932_2
Description: Looking at the primary (west) and south elevations of the building.
Date: 9/6/2022
View: Northeast

exposed rafter tails under the eaves have been partially covered due to fascia board being added for the installation gutters at some point. Likewise, the shed roof overhang was added above the main entryway along the primary (west) elevation at some point.

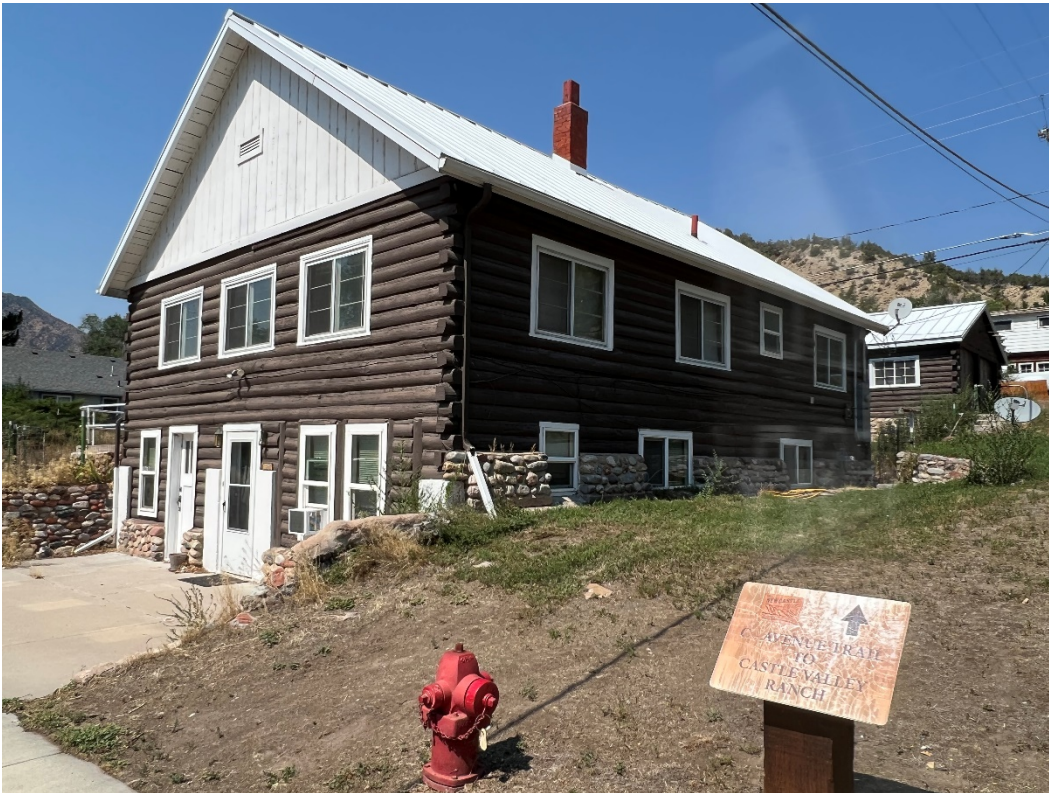
Photo Number: 5GF.5932_3

Description: Looking at the south and east elevations of the building.

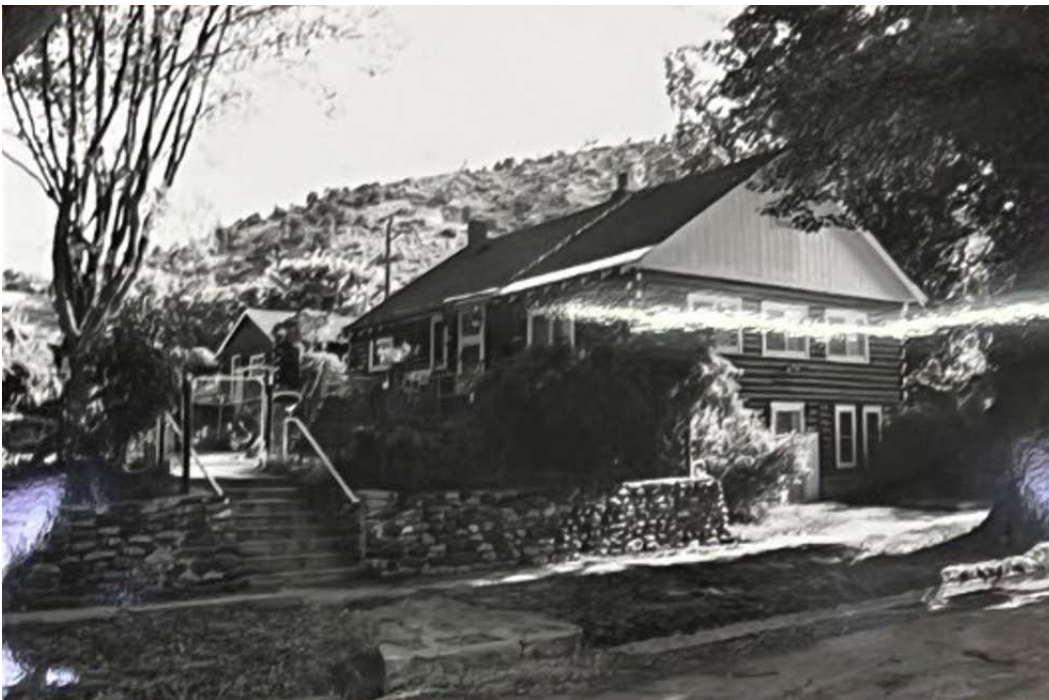
Historic Photo 1

Description: Undated photo looking at the primary (west) and south elevations of the building. Note the exposed rafter tails under the eaves. Additionally, the shed roof overhang above the main entryway is not present. Image is sub-titled, "Dr. Webster Evans Home & Hospital."
