COLORADO CULTURAL RESOURCES INVENTORY

Historical and Architectural Reconnaissance

1. Property Name: Scott & Sarah Worton Residence Historic Current Other:
2. Resource Classification: Building Structure Object Sites/Landscape
3. Ownership: Federal State Local Non-profit Private Unknown

4. Street Address: 403 East Main Street
5. Municipality: New Castle, CO Vicinity:
6. County: Garfield
- **7. USGS Quad: New Castle, CO Year: 2022 7.5'
- **8. Parcel Number: 212331403003
- **9. Parcel Information: Lot(s): 8-9 Block: N Addition: Spencer's 2nd
- **10. Acreage: 0.11 Actual Estimated
11. PLSS information: Principal Meridian: 6th Township: 5S Range: 90W
NE ¼ of NW ¼ of NE ¼ of SE ¼ of section: 31
- **12. Location Coordinates:
 UTM reference: Zone 13 ;mE 282864 ;mN 4383016 NAD 1927 NAD 1983
 or
 Lat/Long: Latitude _____ ; Longitude _____ WGS84 Other:

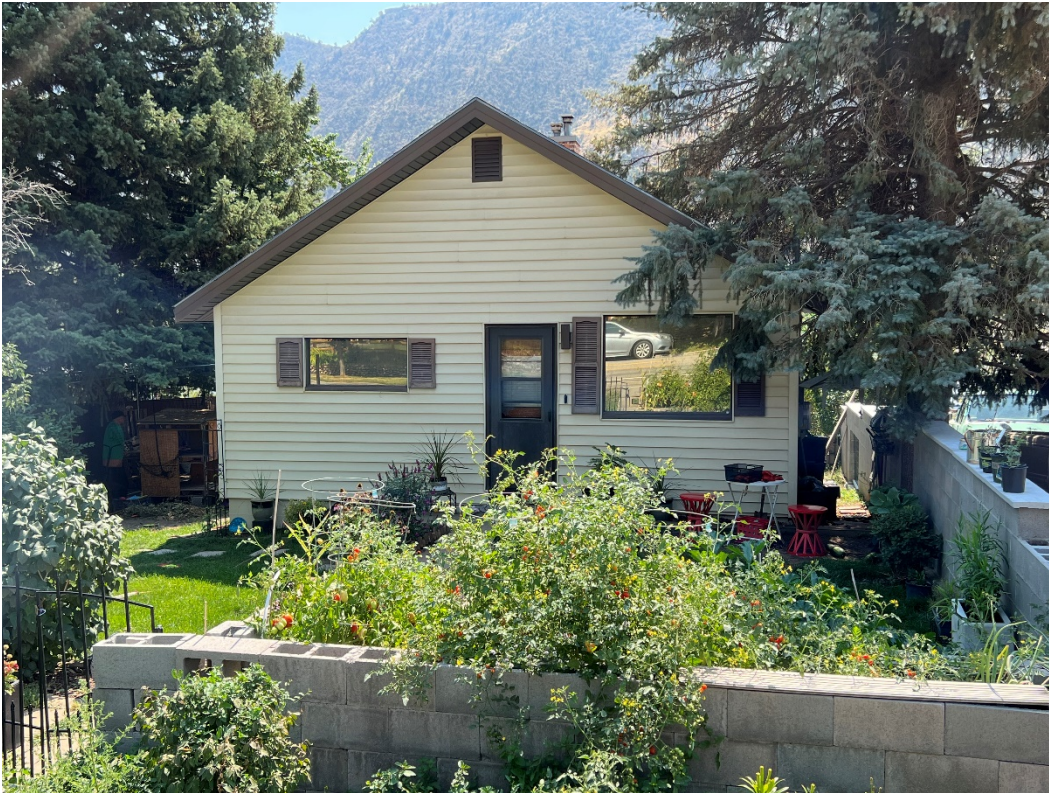
Photo Number: 5GF.5933_1
Description: Looking at the primary (north) elevation of the building.
Date: 9/22/2022
View: South

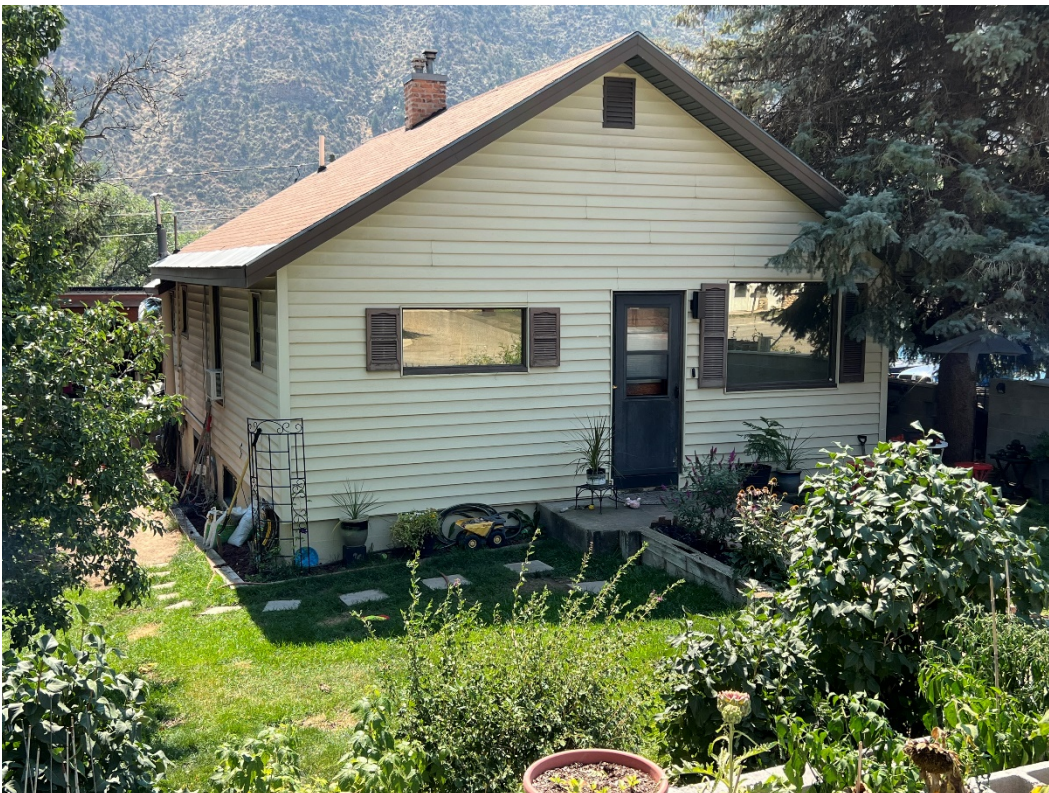
Photo Number: 5GF.5933_2
Description: Looking at the east and primary (north) elevation of the building.
Date: 9/6/2022
View: Southwest

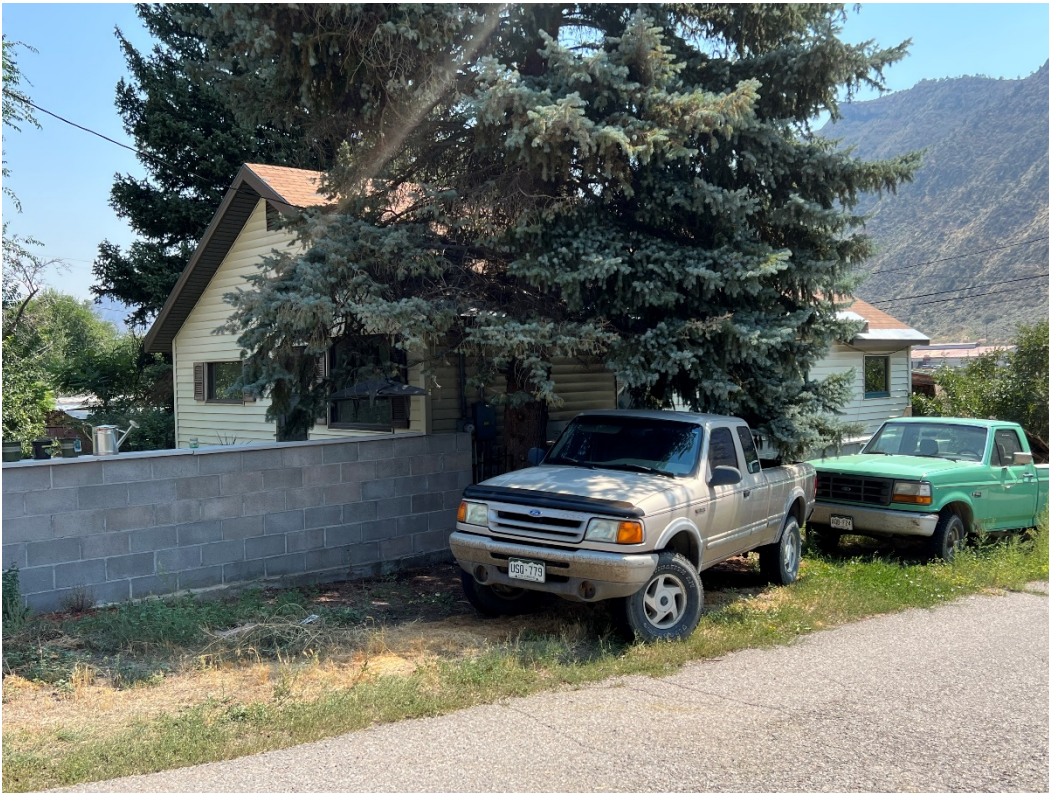
Photo Number: 5GF.5933_3
Description: Looking at the primary (north) and west elevations of the building.
Date: 9/6/2022
View: Southeast

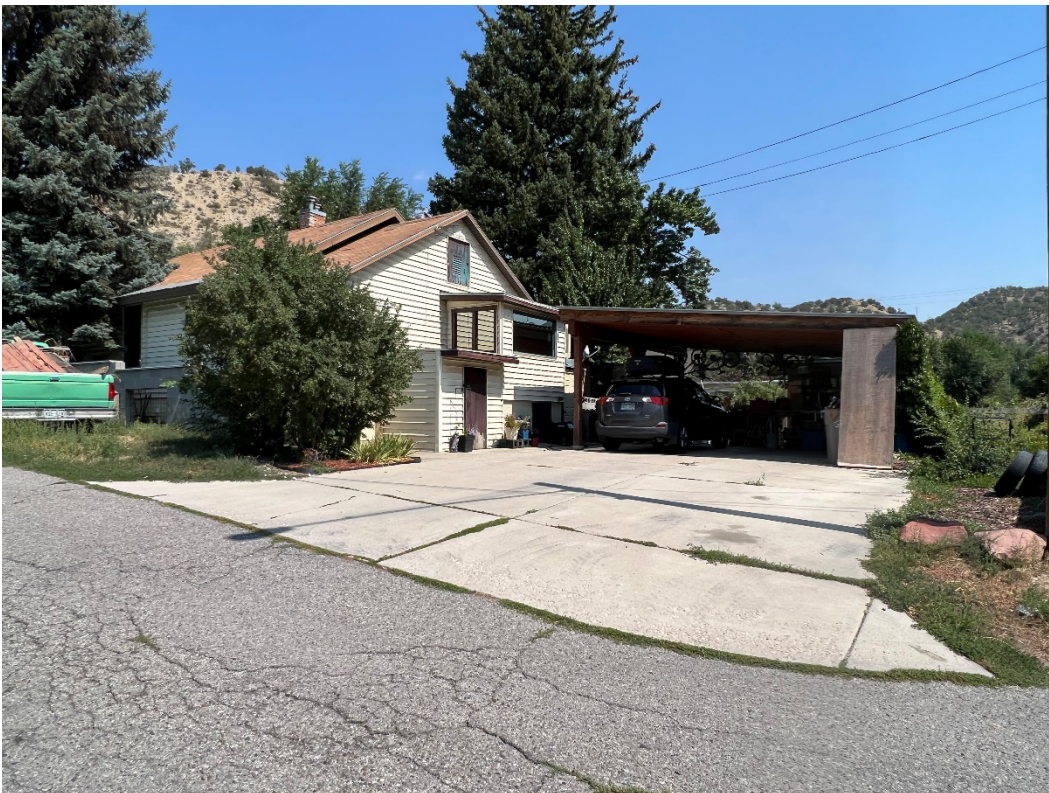
The one-story, rectangular shaped building was constructed in 1936 as shown through review of Garfield County Assessor's Office records. The approximately 46' by 28' residence is not representative of a particular style due to it possessing unornamented surfaces and lacking decorative detailing. Overall, the building is a No Style residence. Architectural features of the building include a concrete foundation; Front gable roof; asphalt shingles; closed overhanging eaves; attic vents under the gable peaks; decorative shutters; a vinyl exterior envelope; a partial length open porch along the primary (north) elevation; and a brick masonry chimney. The building also includes several window configurations including picture; one-over-one single hung sash; and one-by-one sliding sash units. Additionally, these windows incorporate wood frames. The main entryway is located in the center of the primary (north) elevation and features a wood door that is fronted by a metal storm door with a one-over-one single hung sash window. The south elevation demonstrates several additions since it was initially constructed.

Photo Number: 5GF.5933_4
Description: Looking at the west elevation and south elevation of the building.
Date: 9/6/2022
View: Northeast
