COLORADO CULTURAL RESOURCES INVENTORY

Historical and Architectural Reconnaissance

1. Property Name: Margarete Brooks Residence Historic Current Other:
2. Resource Classification: Building Structure Object Sites/Landscape
3. Ownership: Federal State Local Non-profit Private Unknown

4. Street Address: 406 East Main Street
5. Municipality: New Castle, CO Vicinity:
6. County: Garfield
- **7. USGS Quad: New Castle, CO Year: 2022 7.5'
- **8. Parcel Number: 212331103021
- **9. Parcel Information: Lot(s): 8-9 Block: H Addition: Spencer's Addition
- **10. Acreage: 0.14 Actual Estimated
11. PLSS information: Principal Meridian: 6th Township: 5S Range: 90W
SE ¼ of SW ¼ of SE ¼ of NE ¼ of section: 31

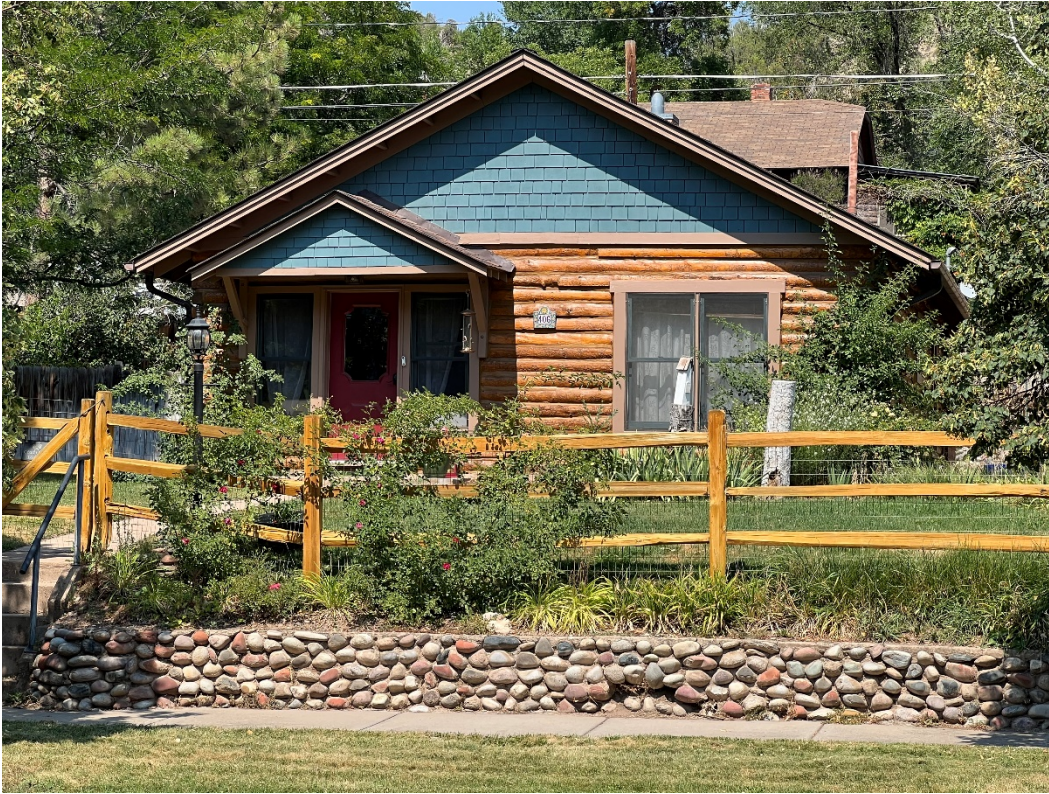
Photo Number: 5GF.5935_1
Description: Looking at the primary (south) elevation of the building. Note the decorative stone masonry wall, and the post and rail fencing.
Date: 9/6/2022
View: North

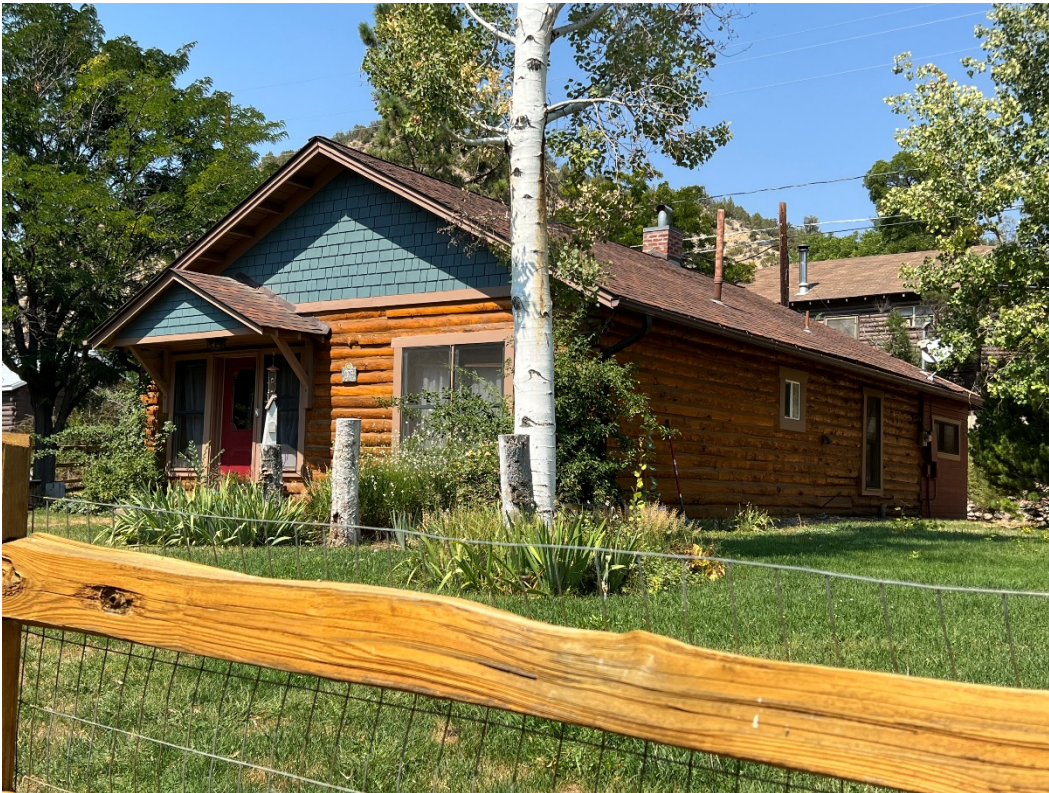
Photo Number: 5GF.5935_2
Description: Looking at the primary (south) and east elevations of the building.
Date: 9/6/2022
View: Northwest

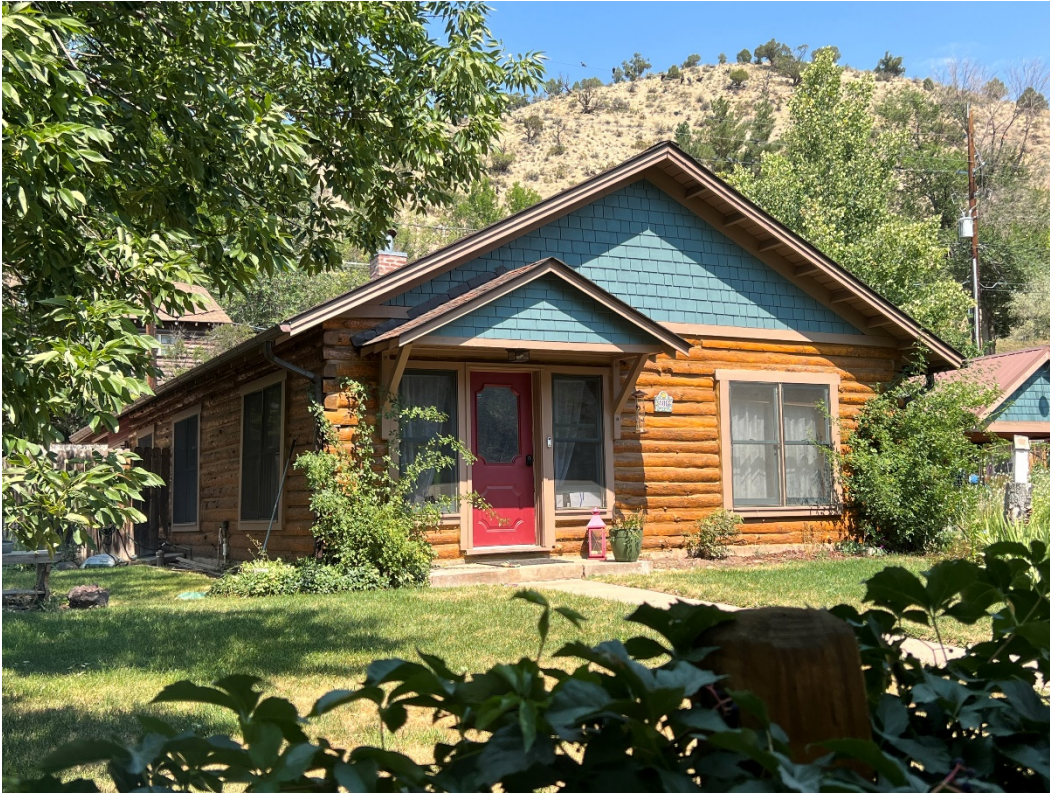
Photo Number: 5GF.5935_3
Description: Looking at the west and primary (south) elevations of the building.
Date: 9/6/2022
View: Northeast
