COLORADO CULTURAL RESOURCES INVENTORY

Historical and Architectural Reconnaissance

1. Property Name: Jo Bradley Residence Historic Current Other:
2. Resource Classification: Building Structure Object Sites/Landscape
3. Ownership: Federal State Local Non-profit Private Unknown

4. Street Address: 436 East Main Street
5. Municipality: New Castle, CO Vicinity:
6. County: Garfield
- **7. USGS Quad: New Castle, CO Year: 2022 7.5'
- **8. Parcel Number: 212331103020
- **9. Parcel Information: Lot(s): 5-6 Block: H Addition: Spencer's Addition
- **10. Acreage: 0.14 Actual Estimated
11. PLSS information: Principal Meridian: 6th Township: 5S Range: 90W
SE ¼ of SW ¼ of SE ¼ of NE ¼ of section: 31

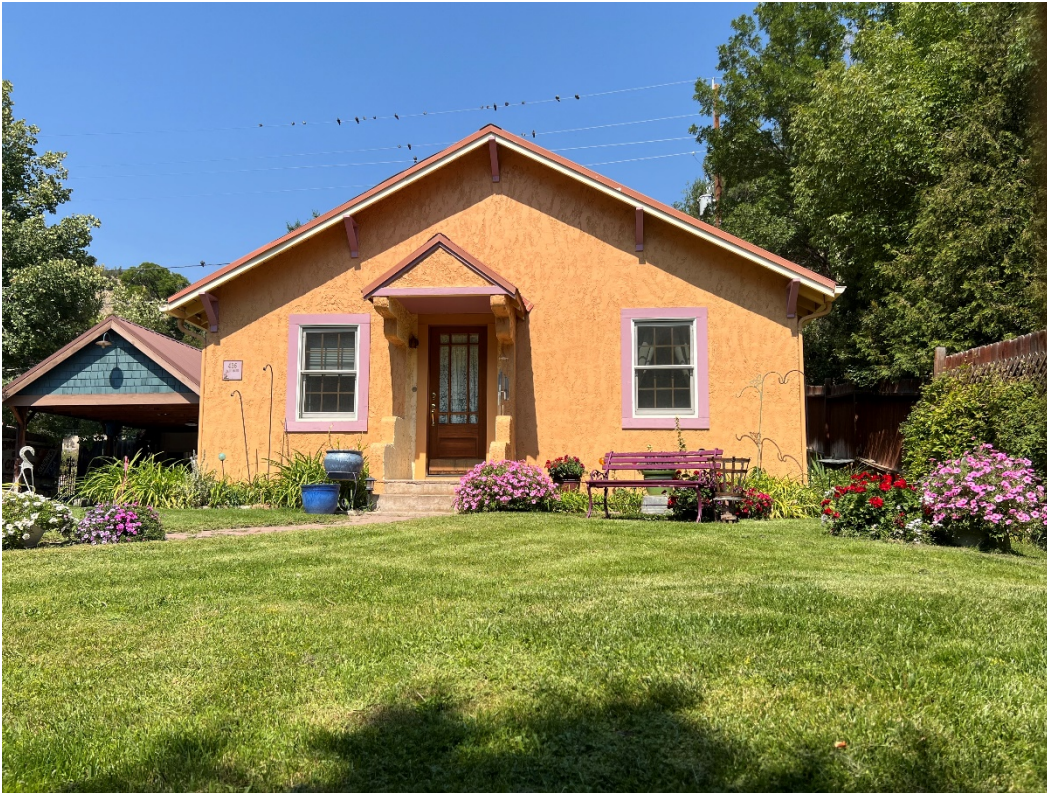
Photo Number: 5GF.5937_1
Description: Looking at the primary (south) elevation of the building. Note the decorative entryway and brackets under the gable peak.
Date: 9/6/2022
View: North

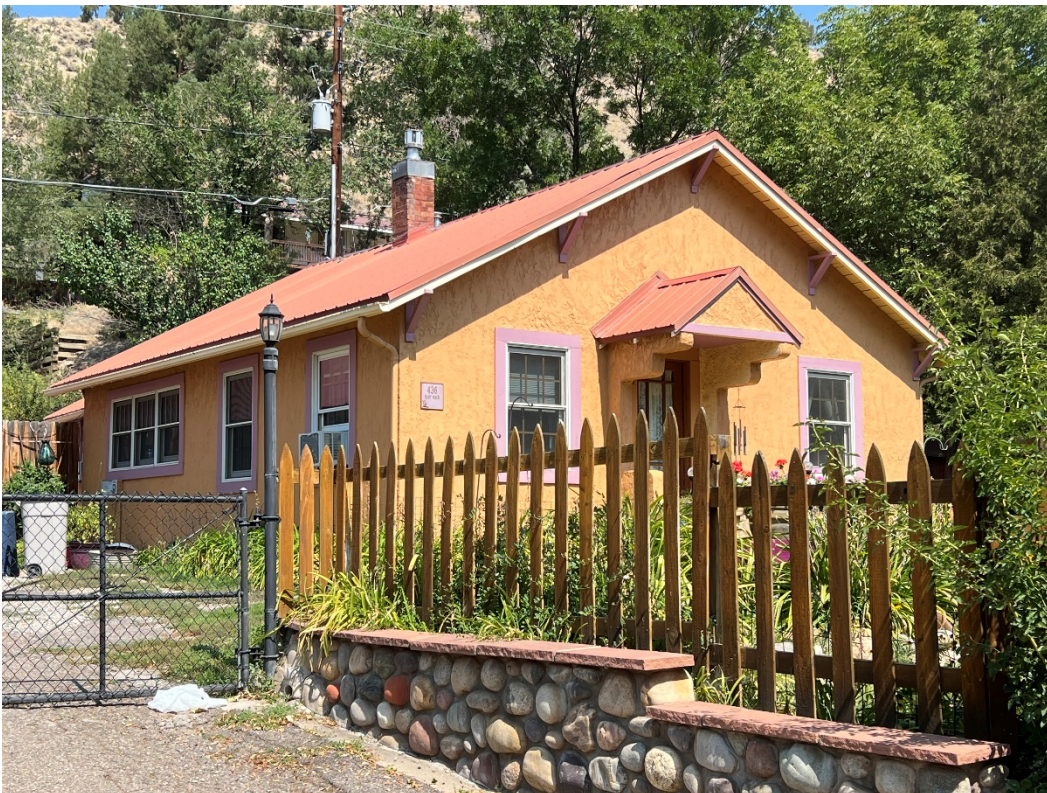
Photo Number: 5GF.5937_2
Description: Looking at the west and primary (south) elevation of the building.
Date: 9/6/2022
View: Northeast

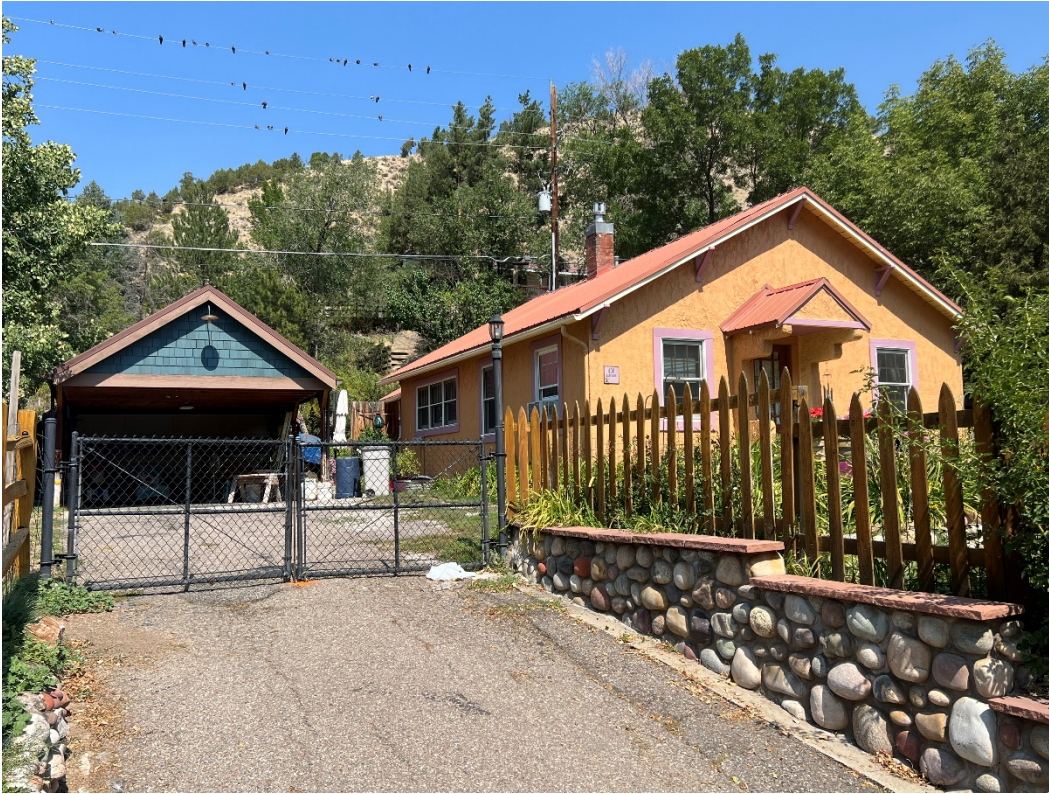
Photo Number: 5GF.5937_3
Description: Context view of the residence's west and primary (south) elevations. Note the stone masonry wall and wood picket fencing along the legal parcel boundary.
Date: 9/6/2022
View: Northeast

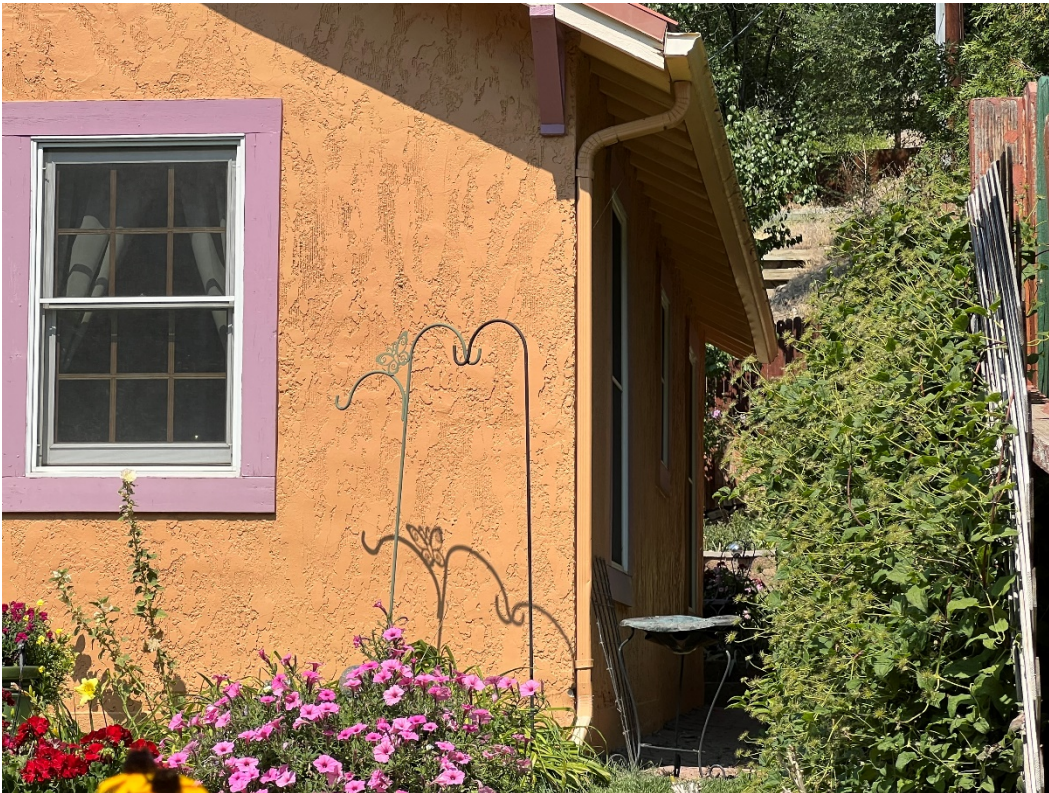
Photo Number: 5GF.5937_4
Description: Looking at the east elevation of the building. The building's proximity to the wall on the right makes it difficult to observe the entire elevation.
Date: 9/6/2022
View: Northwest
