COLORADO CULTURAL RESOURCES INVENTORY

Historical and Architectural Reconnaissance

1. Property Name: Chapin Residence Historic Current Other:
2. Resource Classification: Building Structure Object Sites/Landscape
3. Ownership: Federal State Local Non-profit Private Unknown

4. Street Address: 437 West Main Street
5. Municipality: New Castle, CO Vicinity:
6. County: Garfield
- **7. USGS Quad: New Castle, CO Year: 2022 7.5'
- **8. Parcel Number: 212331409007
- **9. Parcel Information: Lot(s): 12-14 Block: 7 Addition: ORIGINAL TWNSTE NEW CASTLE
- **10. Acreage: 0.17 Actual Estimated
11. PLSS information: Principal Meridian: 6th Township: 5S Range: 90W
NW ¼ of NW ¼ of NW ¼ of SE ¼ of section: 31

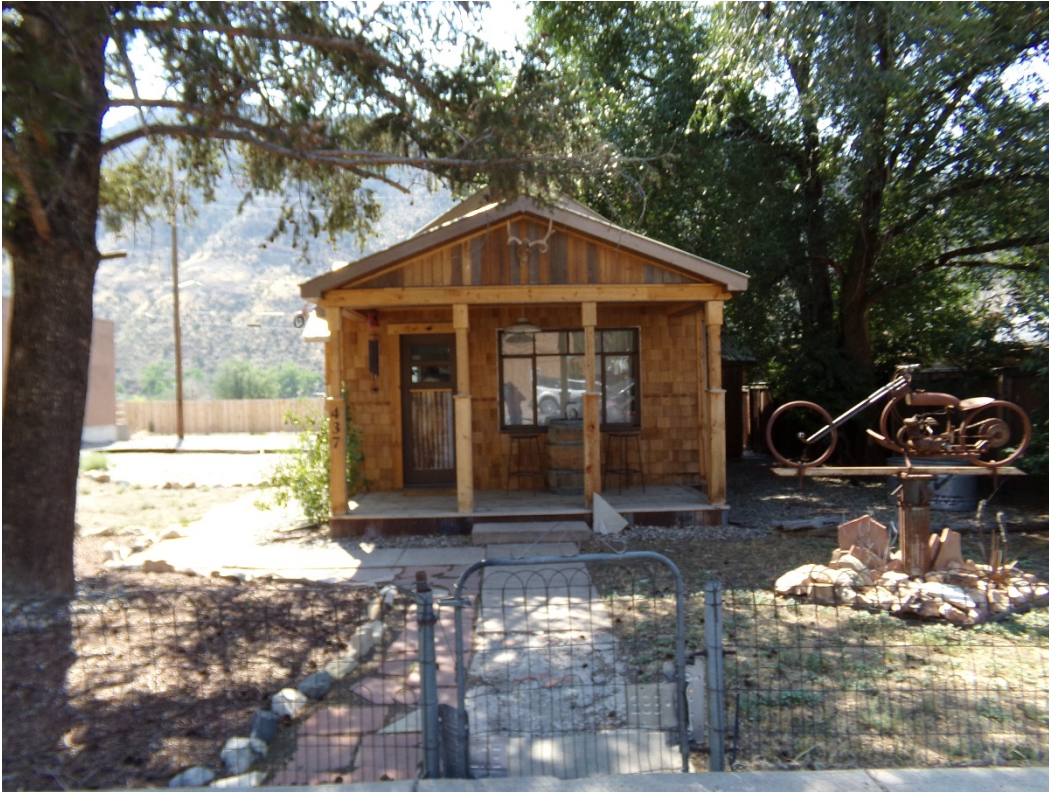
Photo Number: 5GF.5910_1
Description: Looking at the primary (north) elevation of the residence.
Date: 9/6/2022
View: South

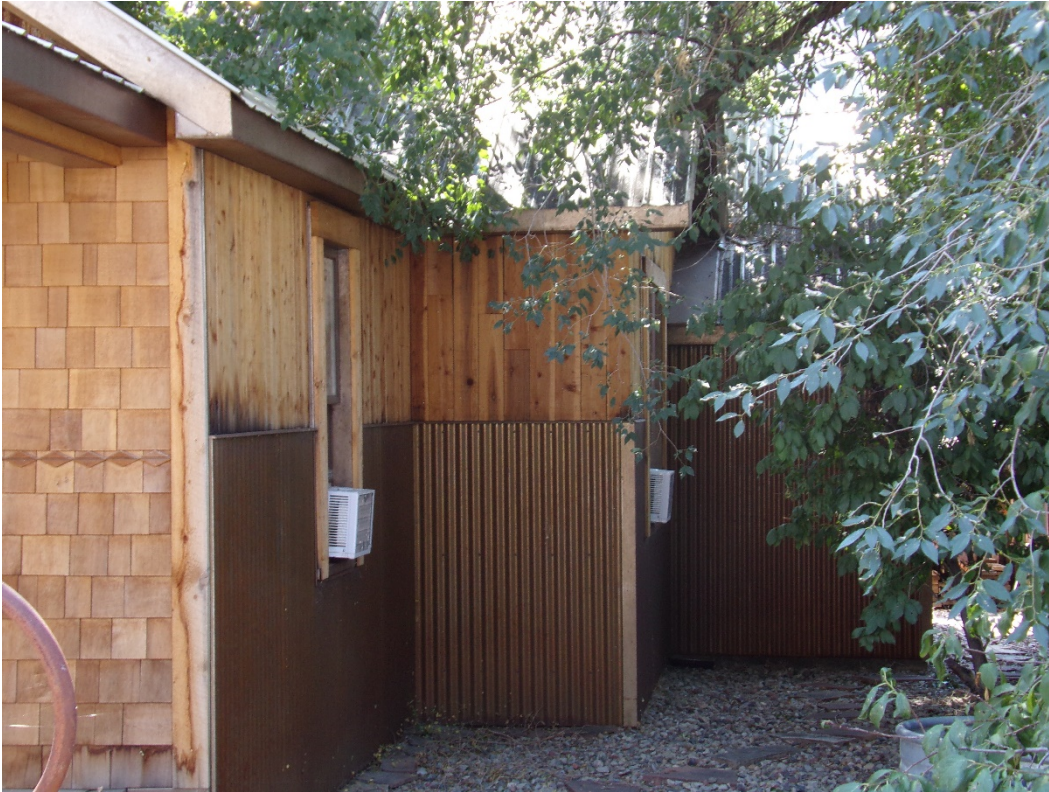
Photo Number: 5GF.5910_2
Description: Looking at the west elevation of the building.
Date: 9/6/2022
View: Southeast

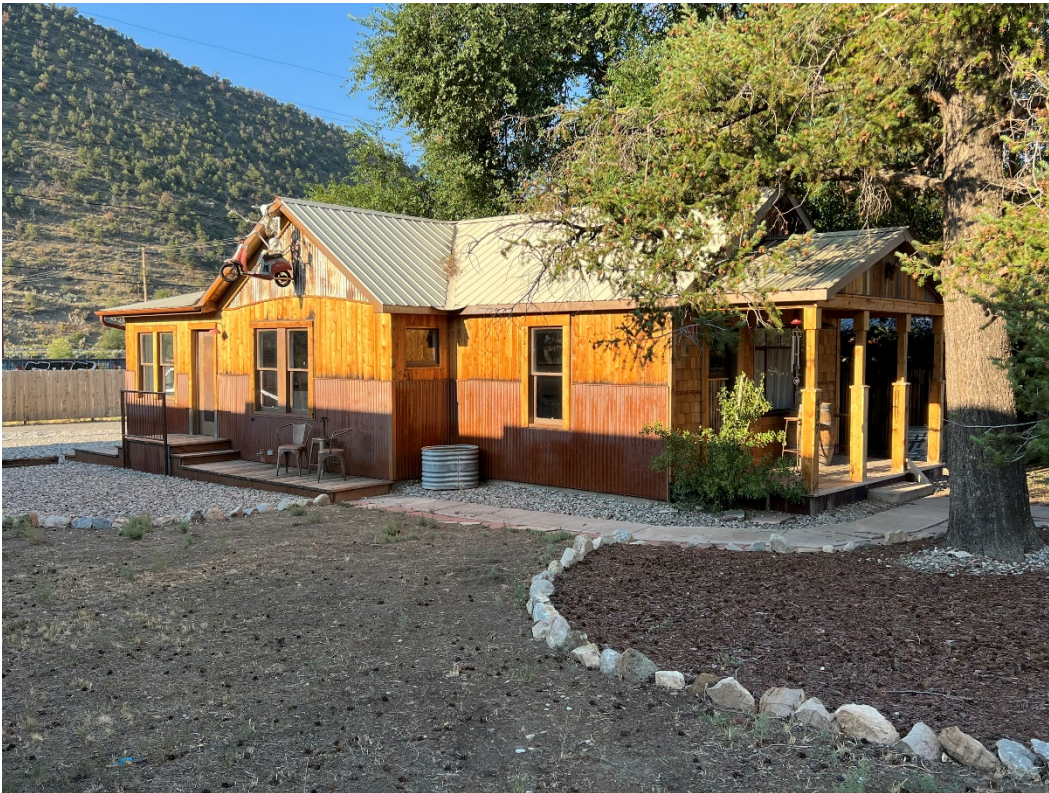
Photo Number: 5GF.5910_3
Description: Looking at the east and primary (north) elevations of the building.
Date: 9/6/2022
View: Southwest

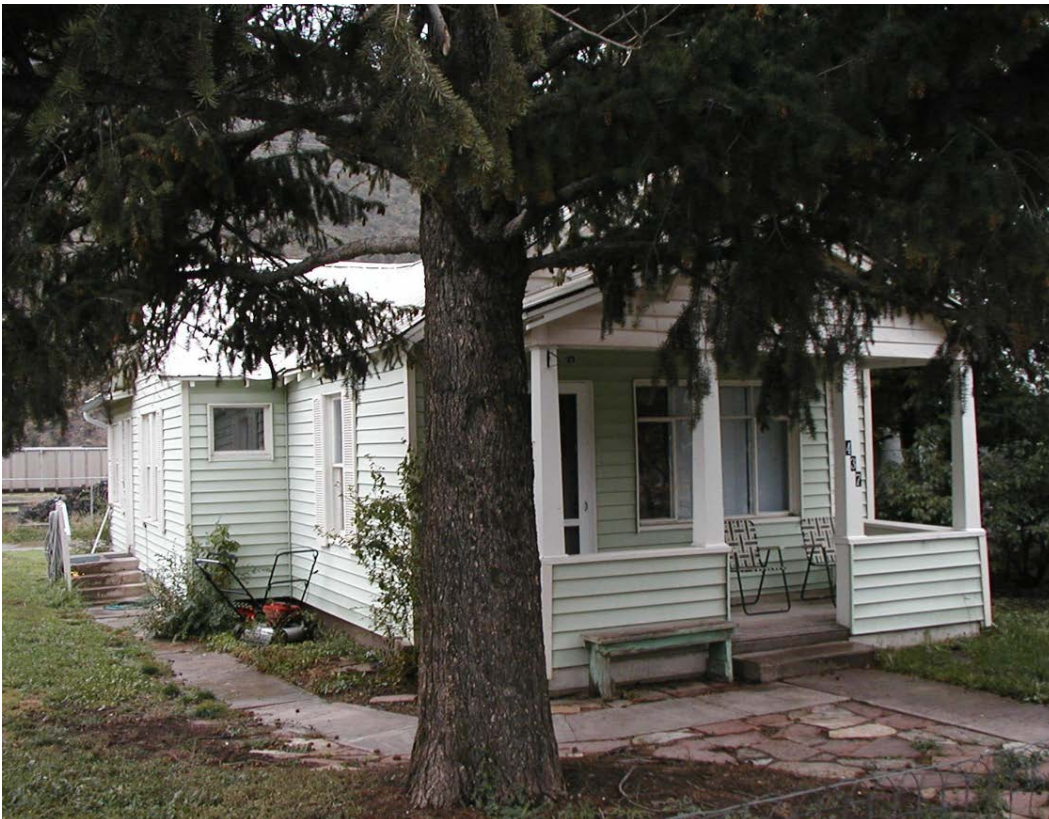
Reference Photo 1
Description: Looking at the east and primary (north) elevation of the building.
Date: Circa 2009
View: Southwest
