# **COLORADO CULTURAL RESOURCES INVENTORY**

# **Historical and Architectural Reconnaissance**

| 1. Property Name: <u>Hogback Pizza Building</u> | | | | | | | |
| 4. Street Address: | 457 West Main | <u>Street</u> | | | | | |

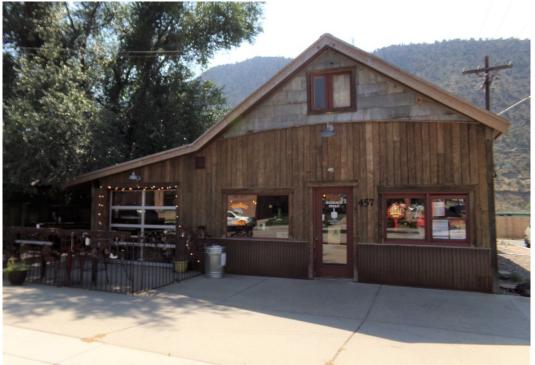
Photo Number: 5GF.5909\_1 Description: Looking at the primary (north) elevation of the building. Date: 9/6/2022 View: South

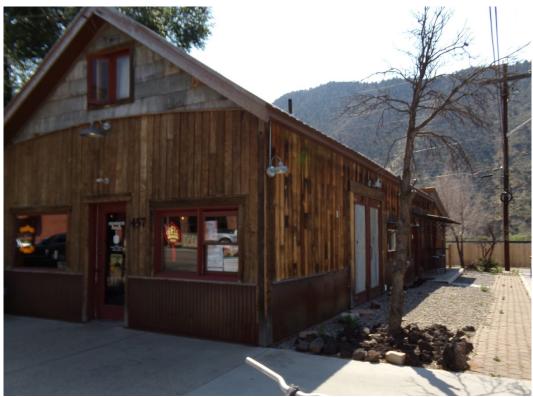
Photo Number: 5GF.5909\_2
Description: Looking at the primary (north) and west elevations of the building.
Date: 9/6/2022
View: Southeast

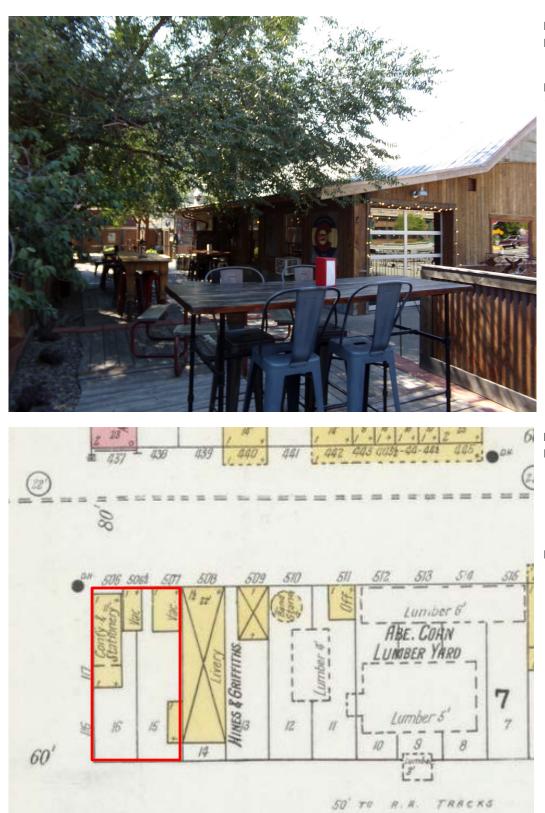
Photo Number: 5GF.5909\_3

Description: Looking at the east and primary (north) elevations of the building. Date: 9/6/2022 View: Southwest

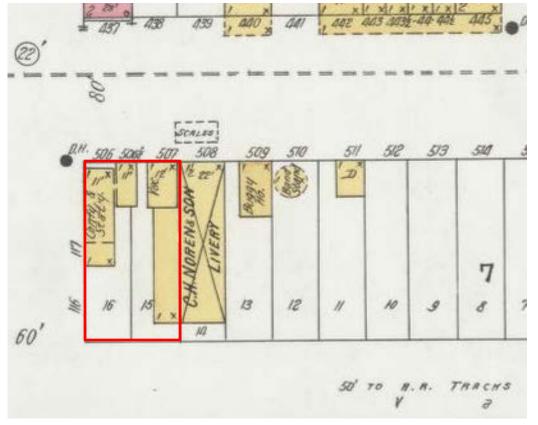
### **Reference Photo 5**

**Description:** 1904 Sanborn Fire Insurance map of the resource. The property is outlined in red. **Date:** 1904
