## COLORADO CULTURAL RESOURCES INVENTORY

### Historical and Architectural Reconnaissance

4. Street Address: 502 West Main Street
5. Municipality: New Castle, CO  Vicinity:
6. County: Garfield
- \*\*7. USGS Quad: New Castle, CO Year: 2022  7.5'
- \*\*8. Parcel Number: 212331222019
- \*\*9. Parcel Information: Lot(s): 1, 2 Block: 8 Addition: ORIGINAL TWNSTE NEW CASTLE
- \*\*10. Acreage: 0.11  Actual  Estimated
11. PLSS information: Principal Meridian: 6<sup>th</sup> Township: 5S Range: 90W  
SE ¼ of SE ¼ of SE ¼ of NW ¼ of section: 31
- \*\*12. Location Coordinates:  
 UTM reference: Zone 13 ;mE 282249 ;mN 4383086  NAD 1927  NAD 1983  
 or  
 Lat/Long: Latitude \_\_\_\_\_ ; Longitude \_\_\_\_\_  WGS84  Other:

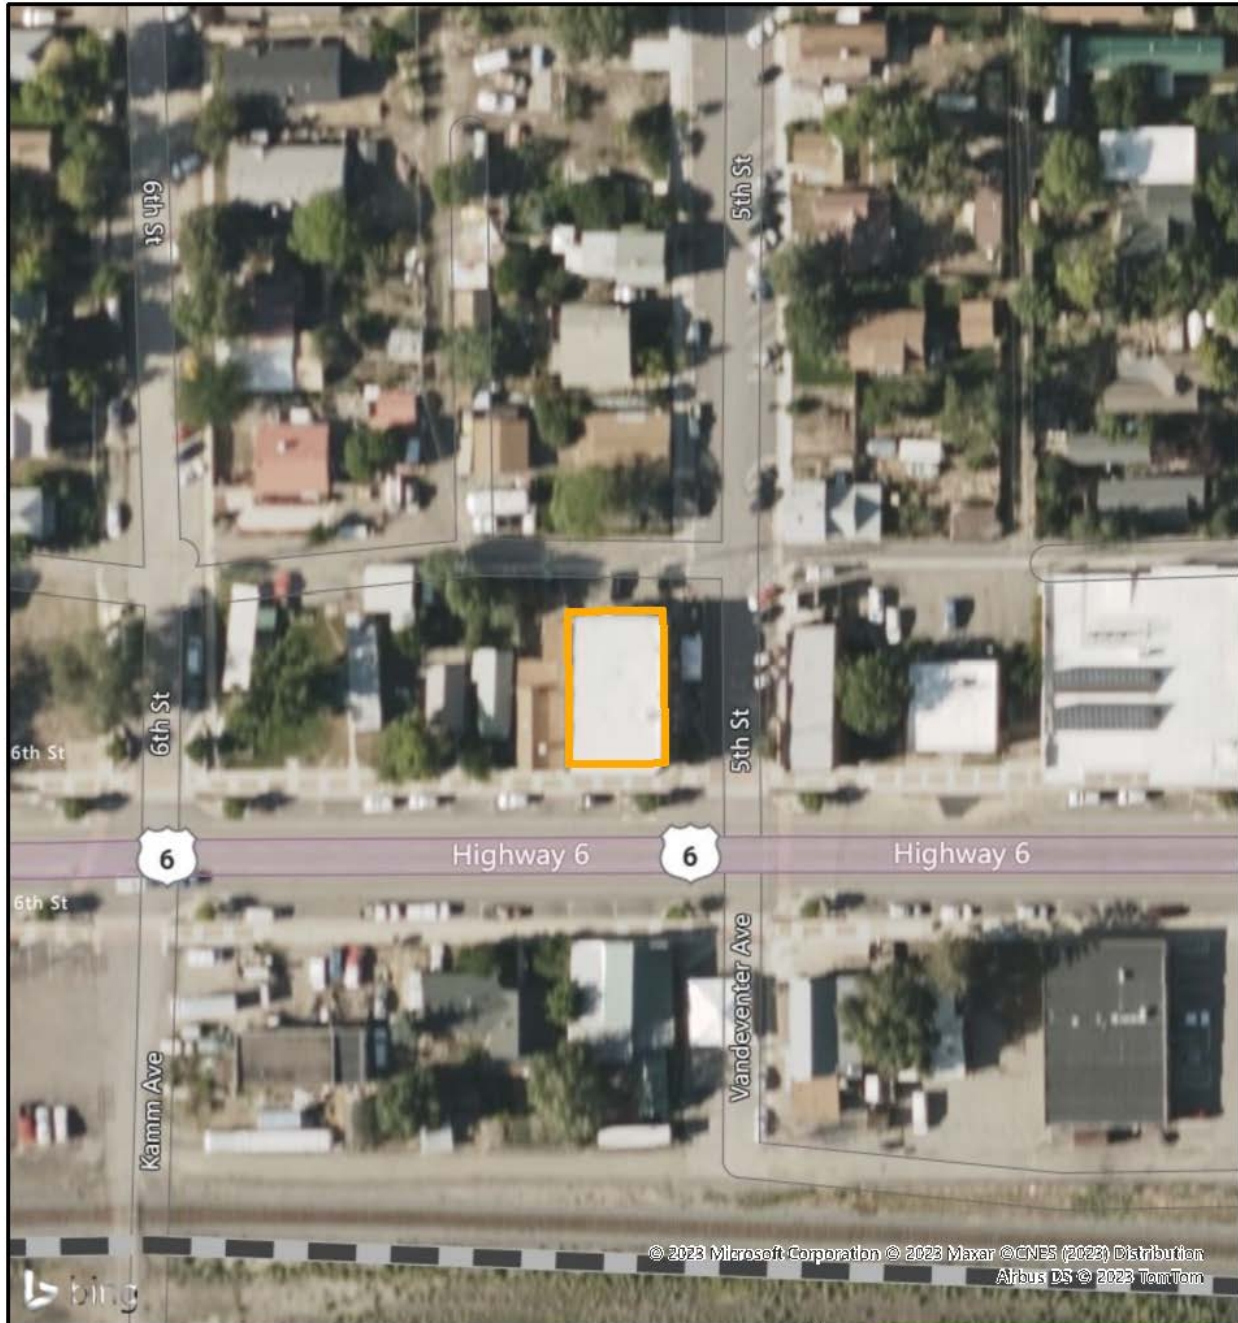
### Sketch Map

<p><b>Sketch Map</b>          502 West Main Street (5GF.1166)          New Castle, Colorado          Garfield County</p>				
<p>Pinyon Project Number: I 22156.001</p>	<table border="1"> <tr> <td>Drawn By: CJB</td> <td>Figure: 2</td> </tr> <tr> <td>Reviewed By: CMW</td> <td>Date: 4/10/2023</td> </tr> </table>	Drawn By: CJB	Figure: 2	Reviewed By: CMW	Date: 4/10/2023
Drawn By: CJB	Figure: 2				
Reviewed By: CMW	Date: 4/10/2023

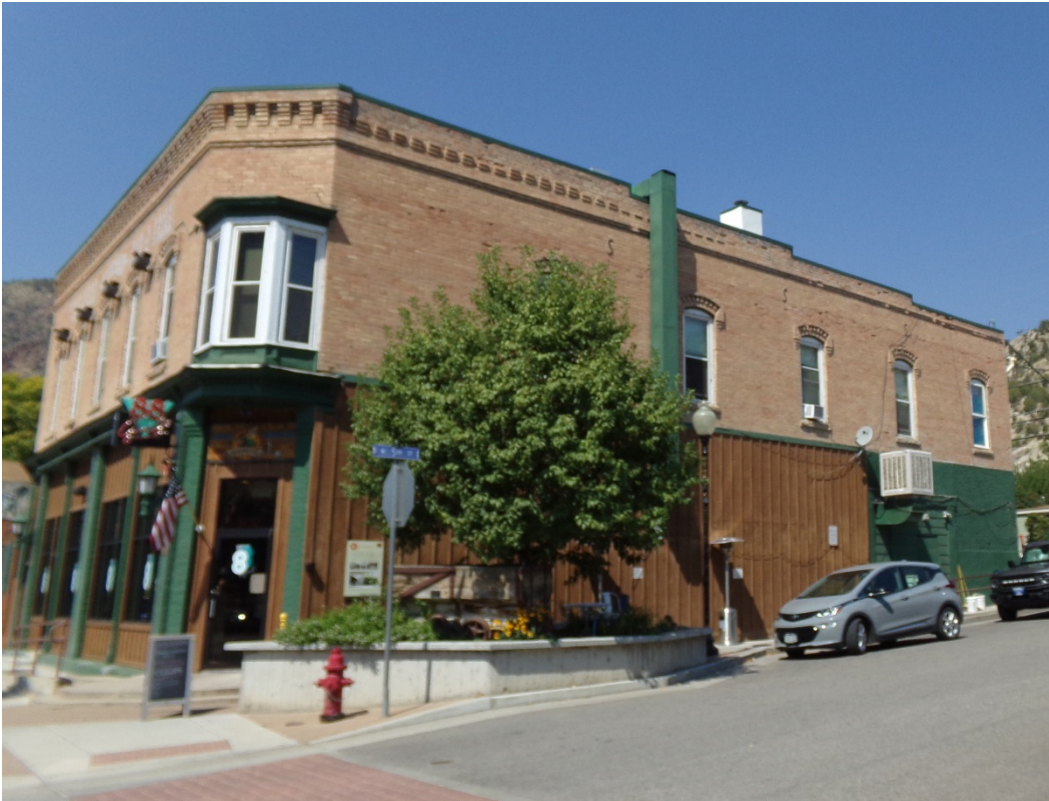
**Photo Number:** 5GF.1166\_1  
**Description:** Looking at the primary (south) and east elevations of the building.  
**Date:** 9/6/2022  
**View:** Northwest

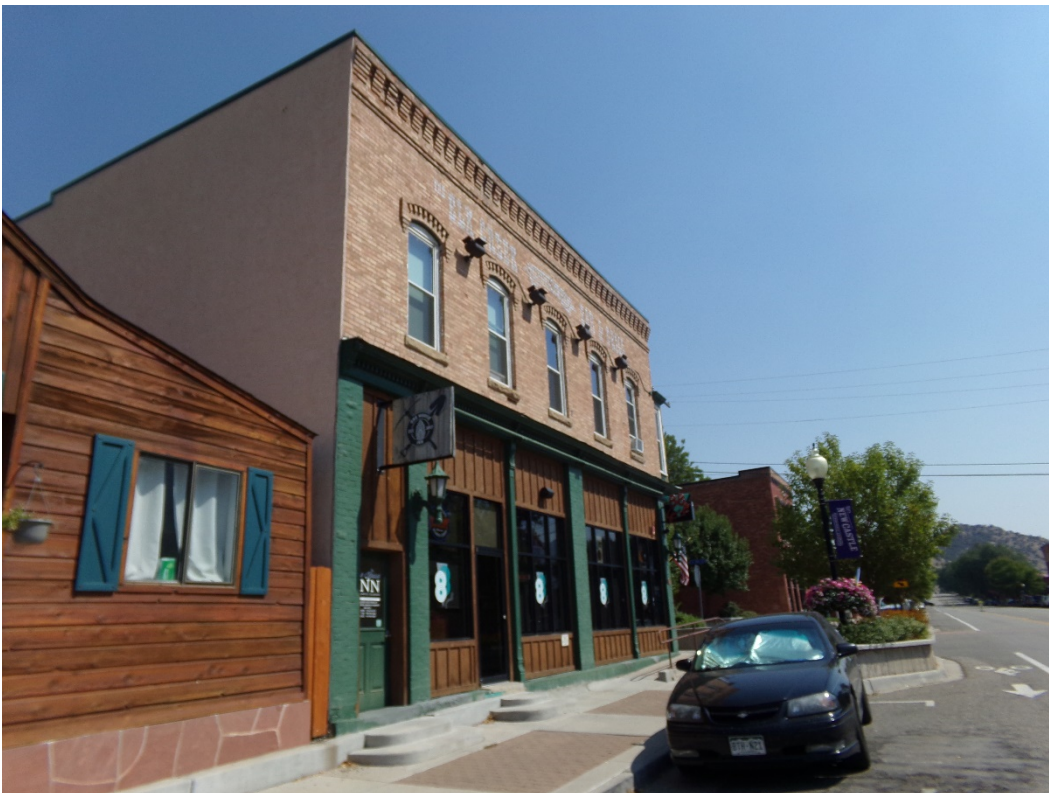
**Photo Number:** 5GF.1166\_1  
**Description:** Looking at the west and primary (south) elevation of the building.  
**Date:** 9/6/2023  
**View:** Northeast

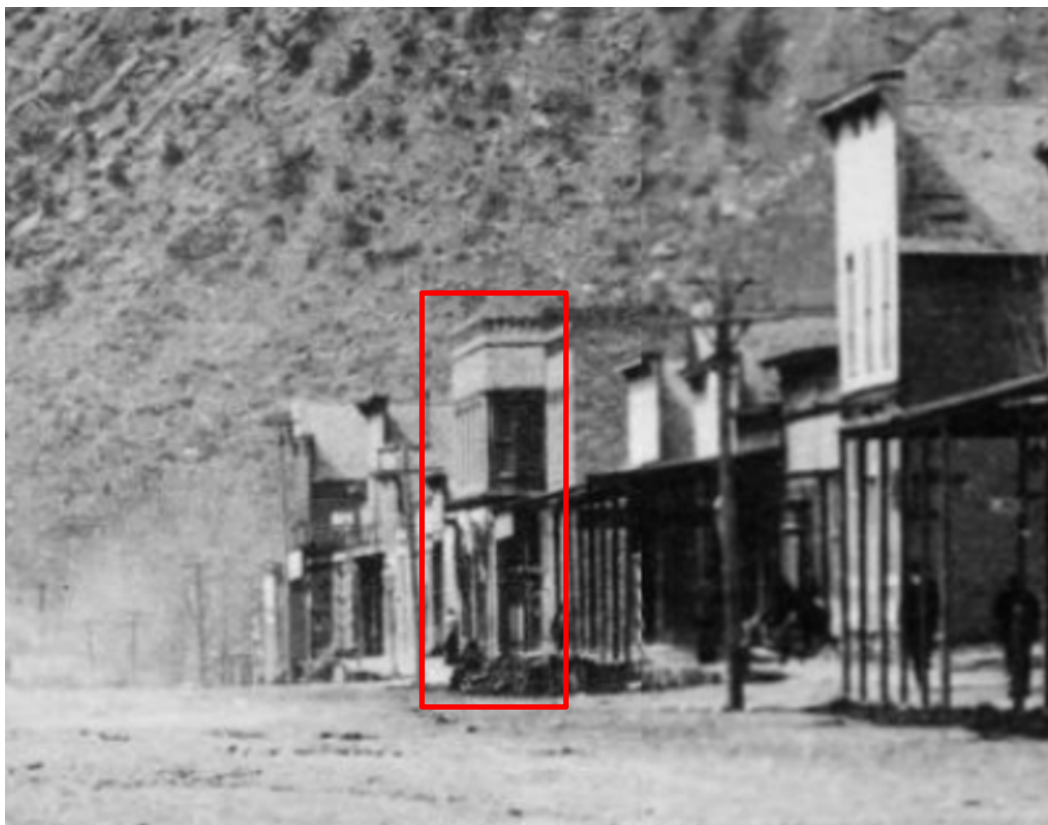
**Historic Photo 1**

**Description:** Image of downtown New Castle looking west down Main Street from the intersection of Main Street and North 4<sup>th</sup> Street. The resource is outlined in red.

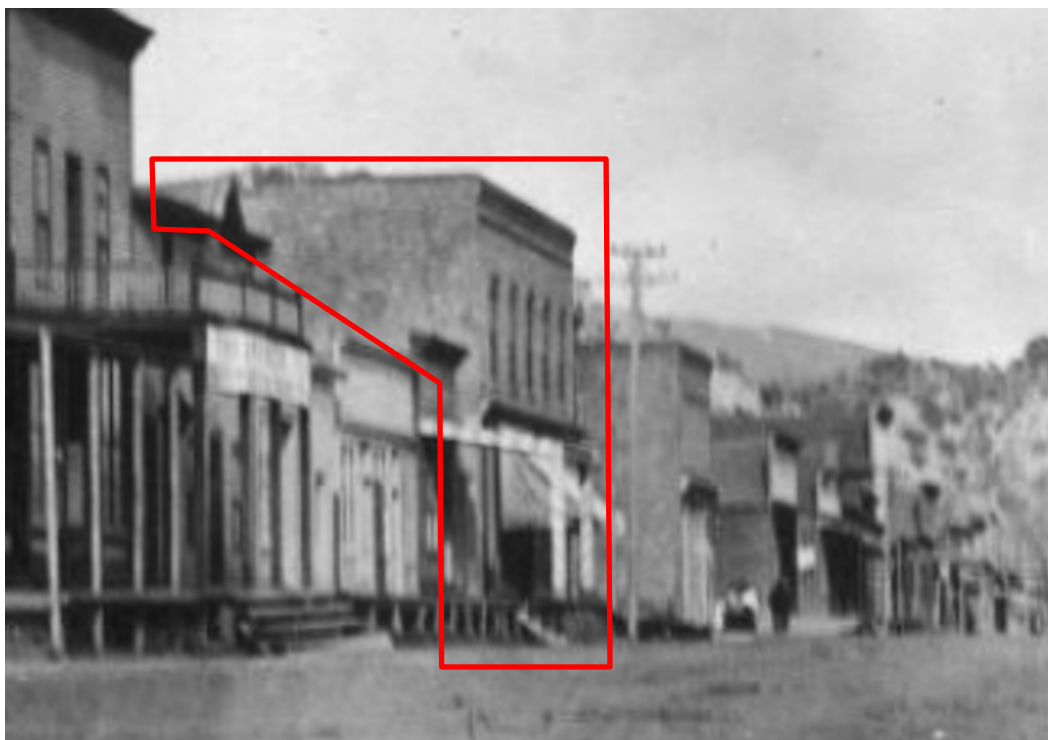
**Historic Photo 2**

**Description:** Image of downtown New Castle looking east down Main Street from the intersection of Main Street and North 6<sup>th</sup> Street. The resource is outlined in red.

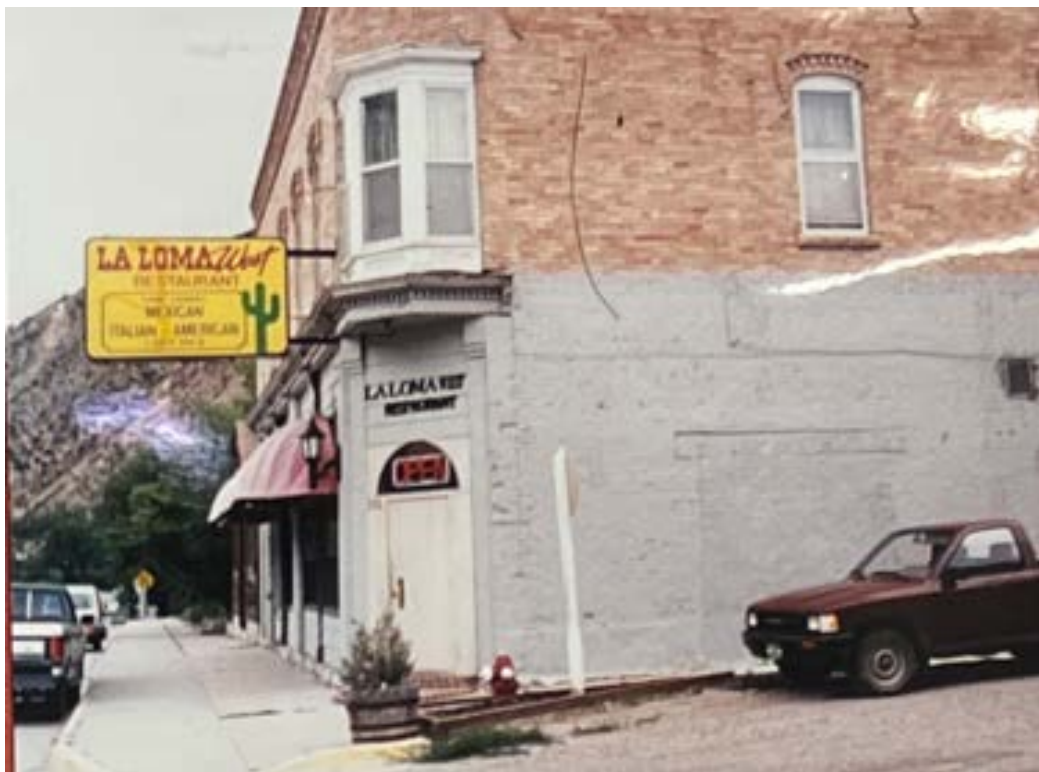
**Reference Photo 1**

**Description:** Image states, "Laloma Resturant was Doll Bros. & Rocky Mountain store. It was also the Brunetti Garage. Now Elk Creek Mining Co."

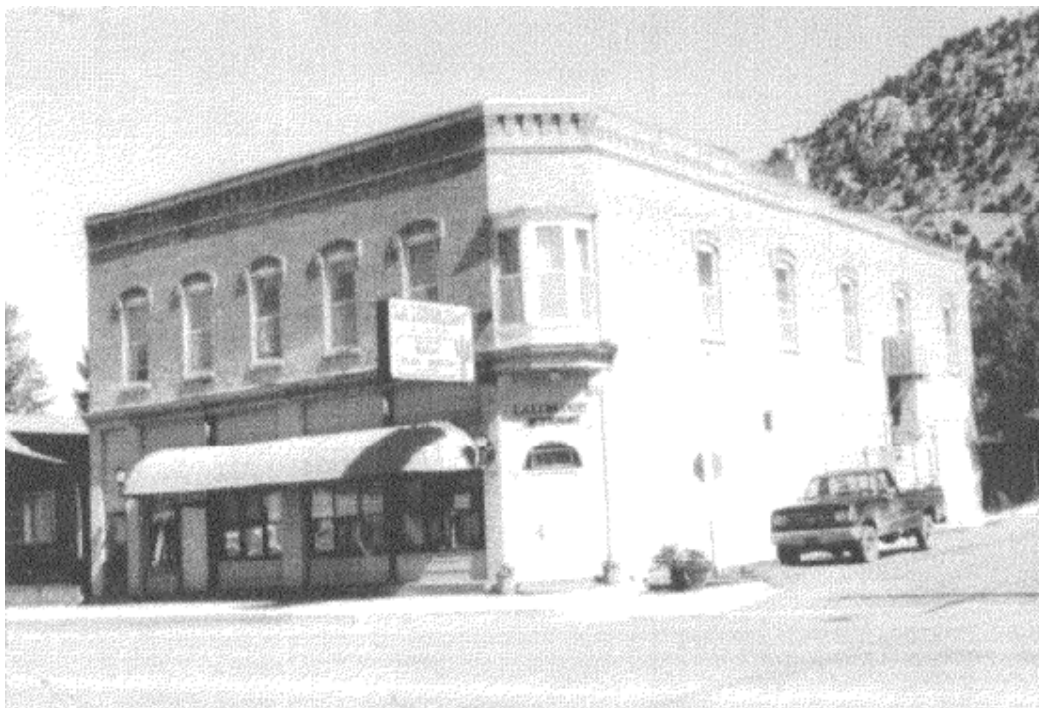
**Reference Photo 2**

**Description:** Looking at the primary (south) and east elevations of the building.
