## COLORADO CULTURAL RESOURCES INVENTORY

### Historical and Architectural Reconnaissance

1. Property Name: Exchange Stables  Historic  Current  Other:
2. Resource Classification:  Building  Structure  Object  Sites/Landscape
3. Ownership:  Federal  State  Local  Non-profit  Private  Unknown

4. Street Address: 503 West Main Street
5. Municipality: New Castle, CO  Vicinity:
6. County: Garfield
- \*\*7. USGS Quad: New Castle, CO Year: 2022  7.5'
- \*\*8. Parcel Number: 212331301001
- \*\*9. Parcel Information: Lot(s): 1, 2 Block: 9 Addition: ORIGINAL TWNSTE NEW CASTLE
- \*\*10. Acreage: 0.11  Actual  Estimated
11. PLSS information: Principal Meridian: 6<sup>th</sup> Township: 5S Range: 90W  
NE ¼ of NE ¼ of NE ¼ of SW ¼ of section: 31

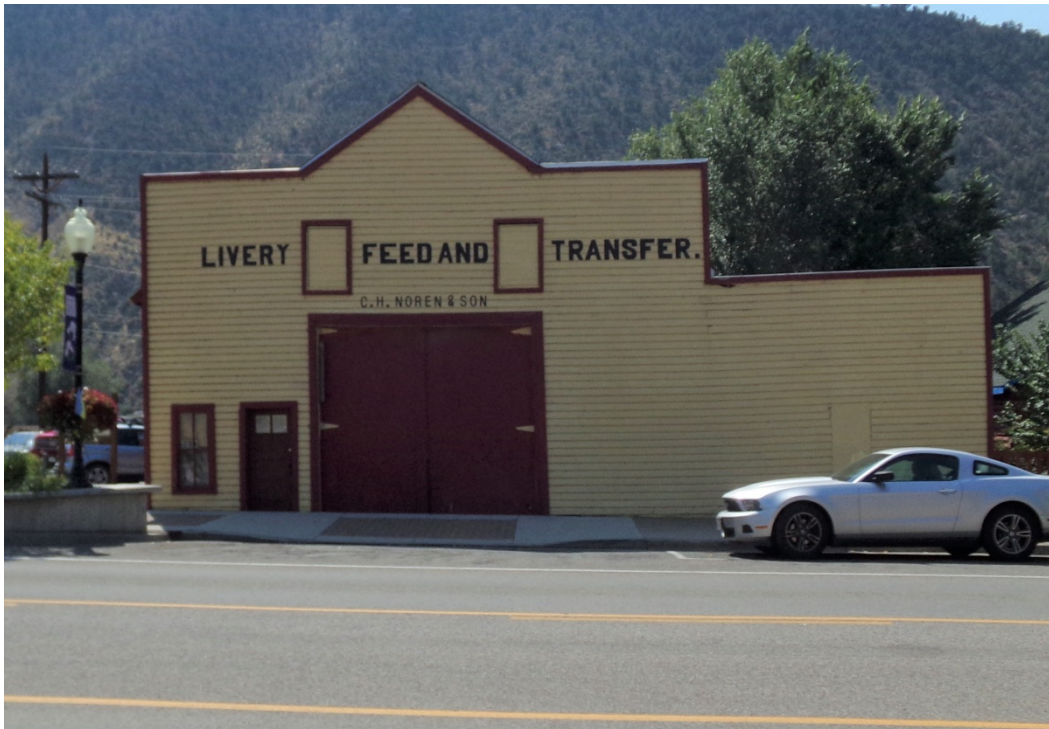
**Photo Number:** 5GF.2380\_1  
**Description:** Looking at the primary (north) elevation of the building.  
**Date:** 9/6/2022  
**View:** South

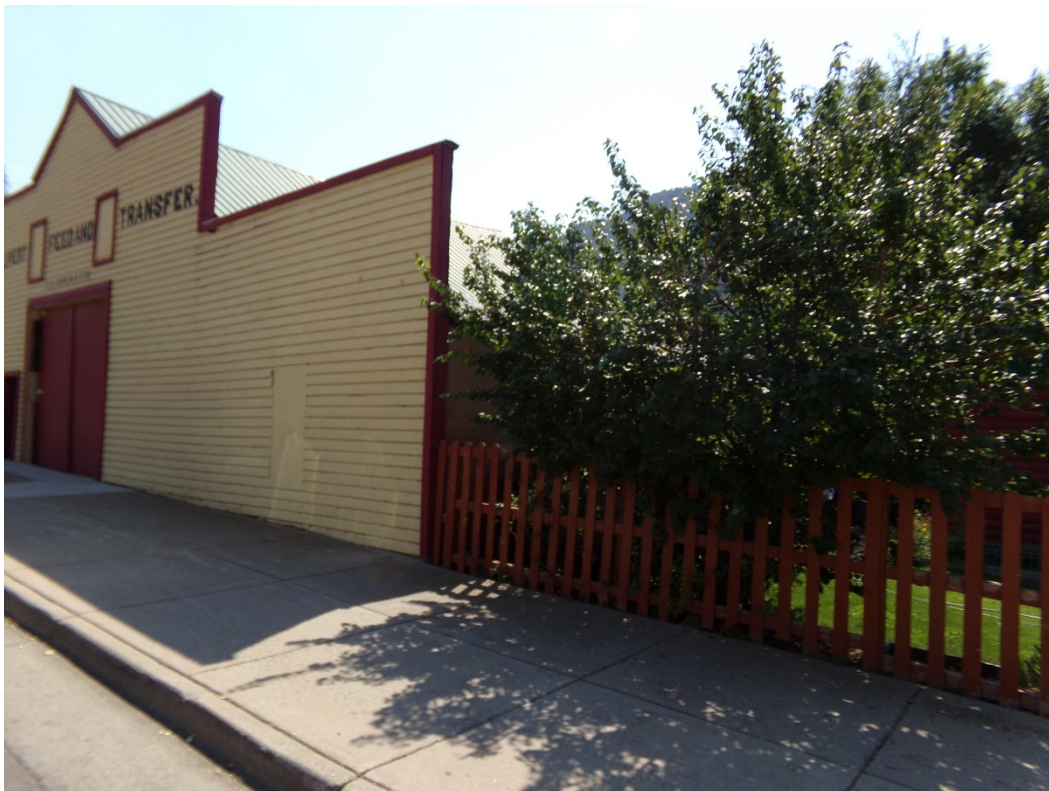
**Photo Number:** 5GF.2380\_2  
**Description:** Looking at the primary (north) and west elevation of the building; though, the west elevation is obscured by vegetation.  
**Date:** 9/6/2022  
**View:** Southeast

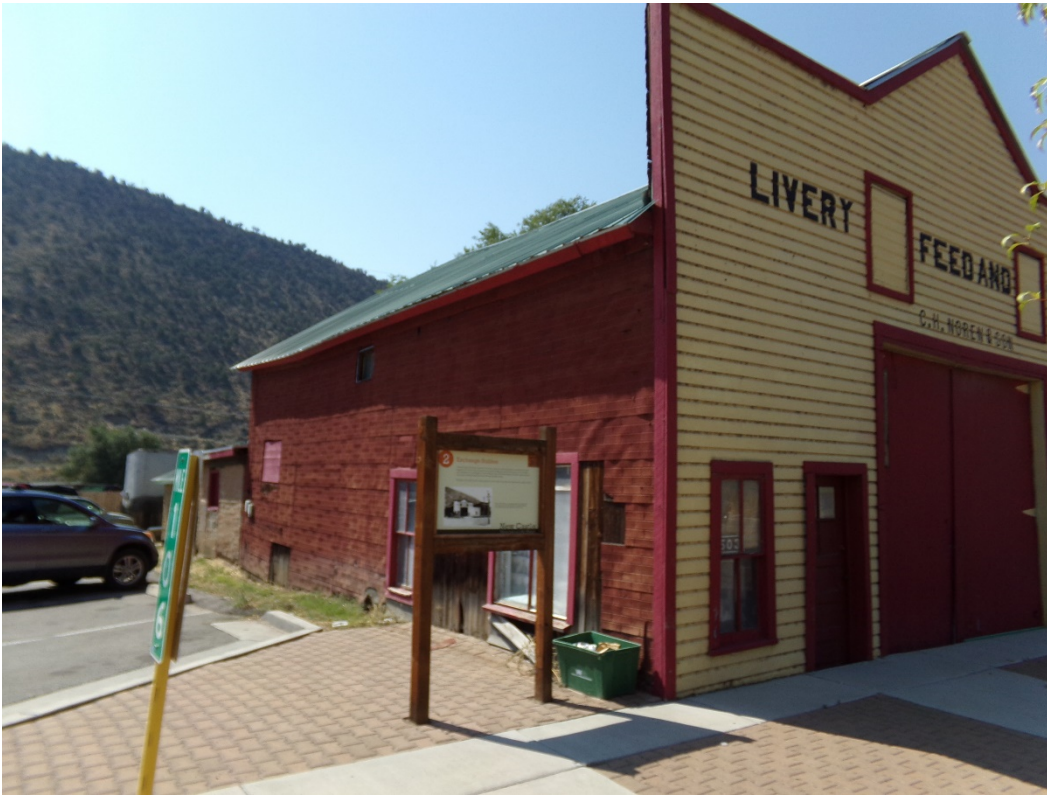
**Photo Number:** 5GF.2380\_3

**Description:** Looking at the east elevation and primary (north) elevation of the building. Note the embossed asphalt siding.

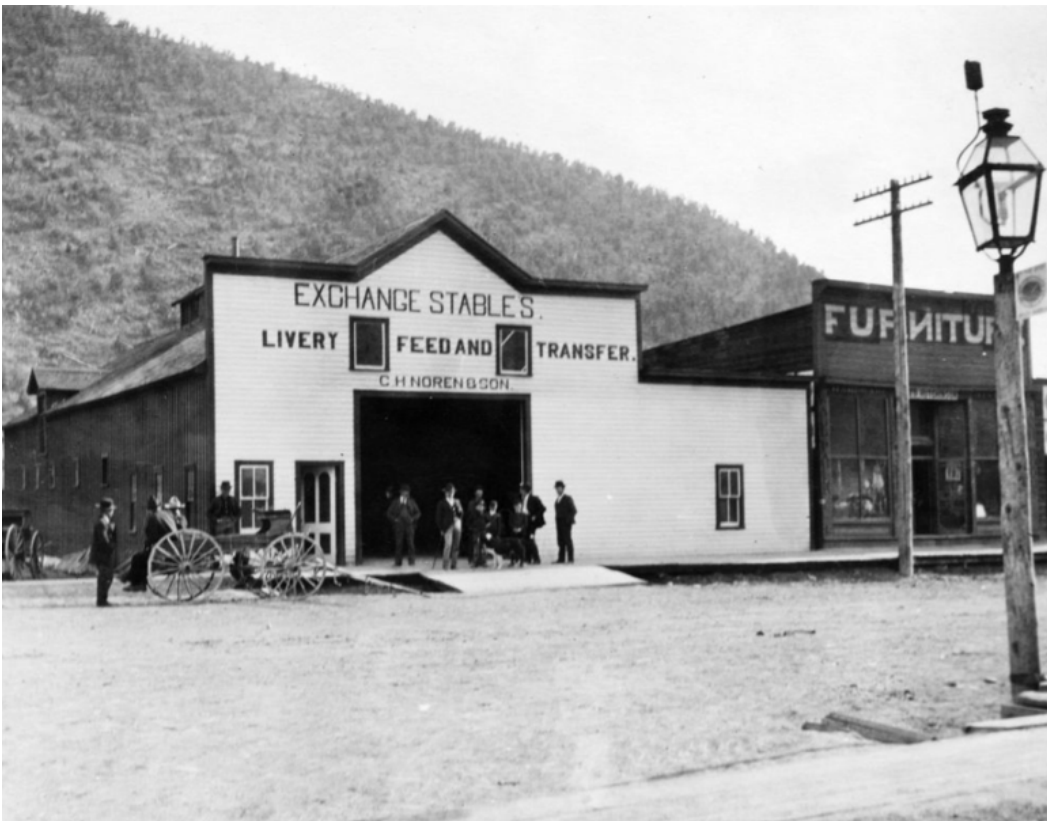
**Historic Photo 1**

Historical photos of the building in 1905 demonstrate that the building had a larger footprint along the south elevation. A front gable roof vent was also located in the center of the roofline. A front gable dormer was also located in the center of the east elevation. A cast iron cornice was also present along the false front. By the late Twentieth Century, photos of the building demonstrate that the southern half of the building was removed and several additions to the south elevation were constructed including a residence. In addition, the main entryway door was replaced, and the cast iron cornice was removed. Several door and window openings were also covered. During this same period, embossed asphalt siding was added to the east elevation of the building.

**Description:** Looking at the east and primary (north) elevations of the building

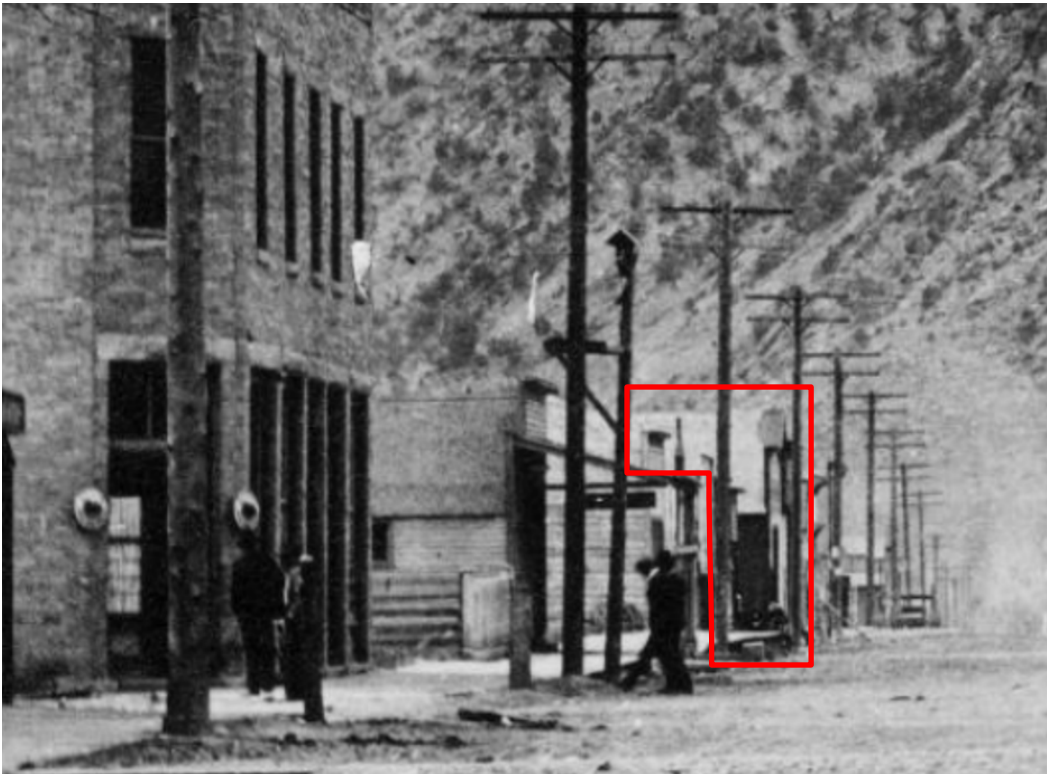
**Description:** Image of downtown New Castle looking west down Main Street from the intersection of Main Street and North 4<sup>th</sup> Street. The resource is outline in red.

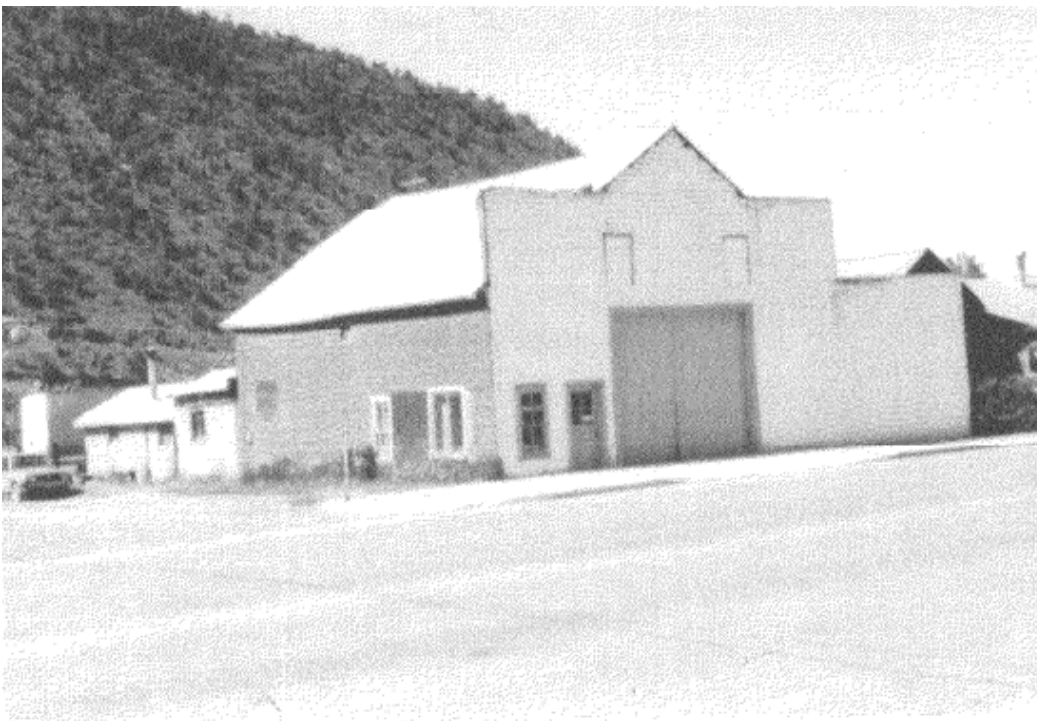
**Reference Photo 1**

**Description:** Looking at the east and primary (north) elevation of the building.
