COLORADO CULTURAL RESOURCES INVENTORY

Historical and Architectural Reconnaissance

1. Property Name: William & Janetta Strouse Residence Historic Current Other:
2. Resource Classification: Building Structure Object Sites/Landscape
3. Ownership: Federal State Local Non-profit Private Unknown

4. Street Address: 505 East Main Street
5. Municipality: New Castle, CO Vicinity:
6. County: Garfield
- **7. USGS Quad: New Castle, CO Year: 2022 7.5'
- **8. Parcel Number: 212331402003
- **9. Parcel Information: Lot(s): 6-9 Block: M Addition: Spencer's 2nd
- **10. Acreage: 0.22 Actual Estimated
11. PLSS information: Principal Meridian: 6th Township: 5S Range: 90W
NW ¼ of NE ¼ of NE ¼ of SE ¼ of section: 31
- **12. Location Coordinates:
 UTM reference: Zone 13 ;mE 282955 ;mN 4383015 NAD 1927 NAD 1983
 or
 Lat/Long: Latitude _____ ; Longitude _____ WGS84 Other:

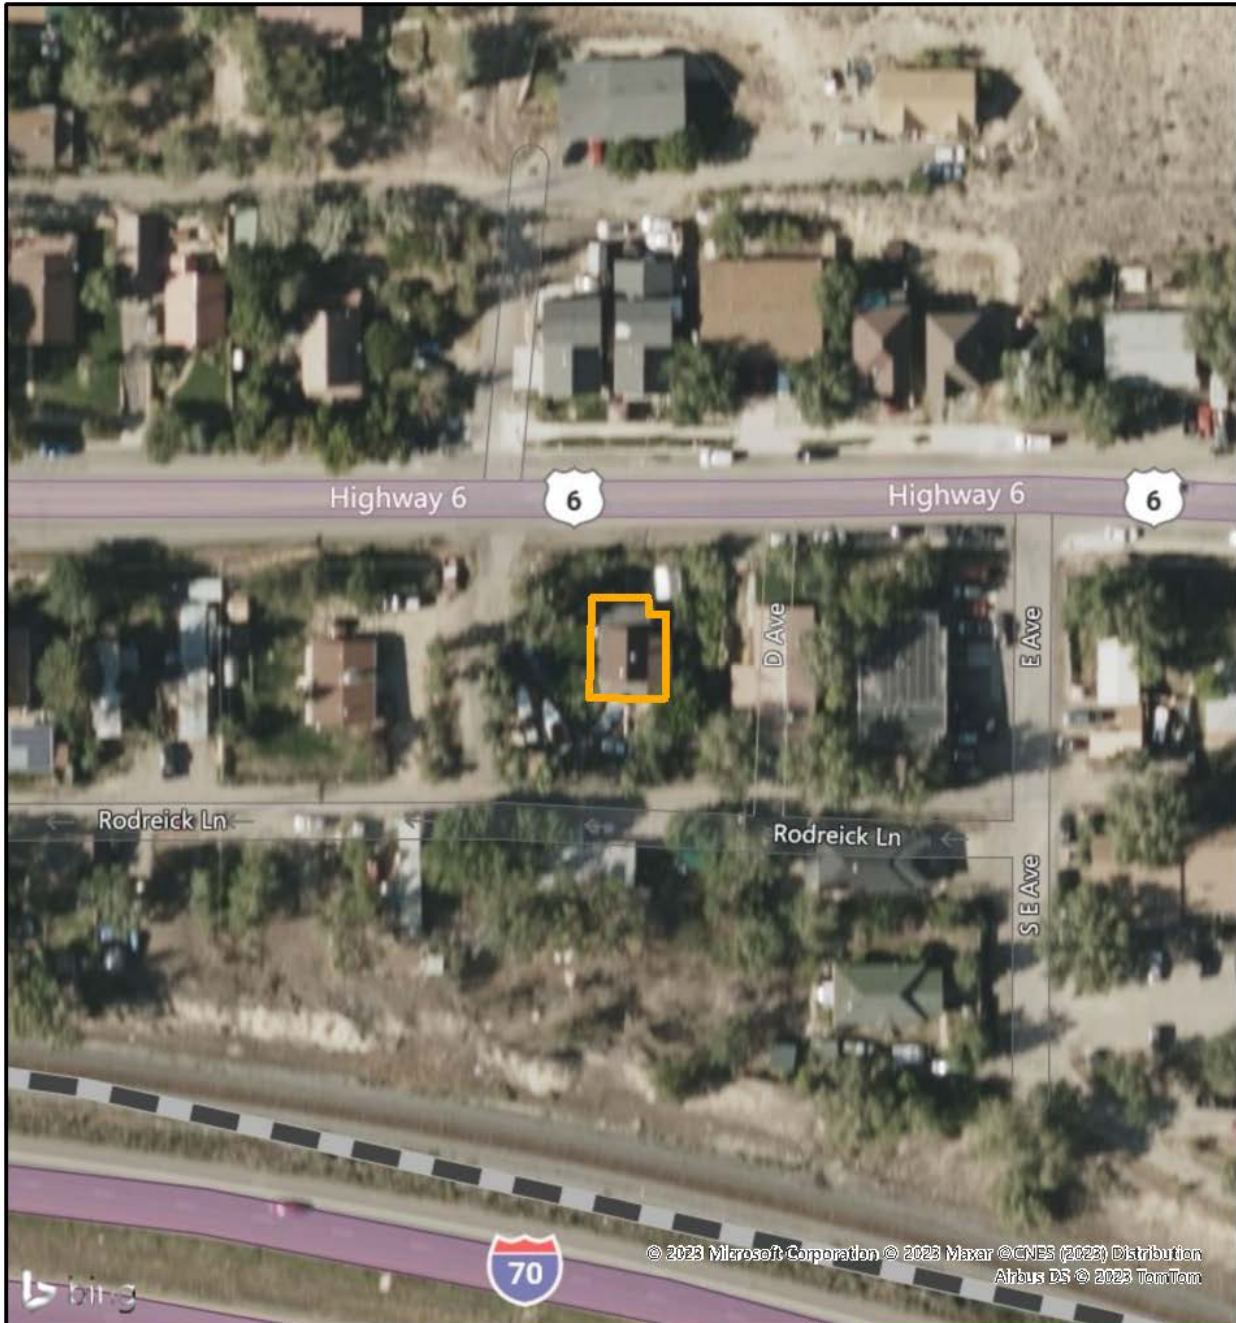
Sketch Map

<p>Sketch Map 505 East Main Street (5GF.5939) New Castle, Colorado Garfield County</p>				
<p>Pinyon Project Number: I 22156.001</p>	<table border="1"> <tr> <td>Drawn By: CJB</td> <td>Figure: 2</td> </tr> <tr> <td>Reviewed By: CMW</td> <td>Date: 4/10/2023</td> </tr> </table>	Drawn By: CJB	Figure: 2	Reviewed By: CMW	Date: 4/10/2023
Drawn By: CJB	Figure: 2				
Reviewed By: CMW	Date: 4/10/2023

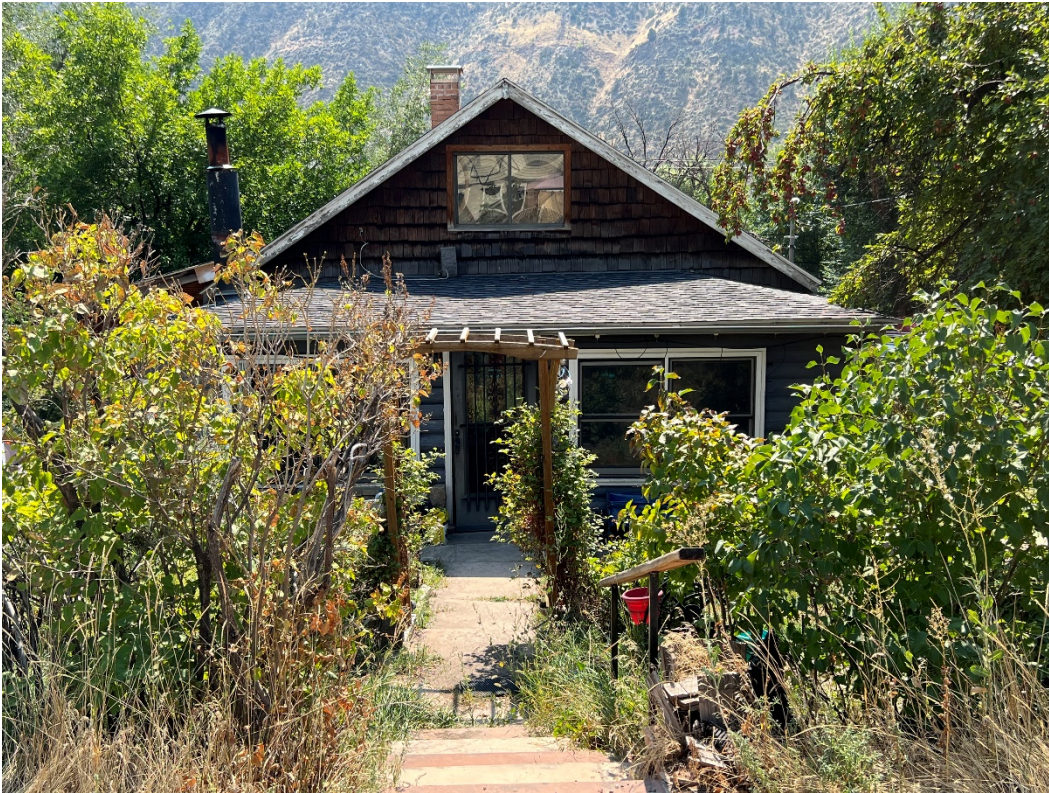
Photo Number: 5GF.5939_1
Description: Looking at the primary (north) elevation of the building. Note the wood shingles under the gable end.
Date: 9/6/2022
View: South

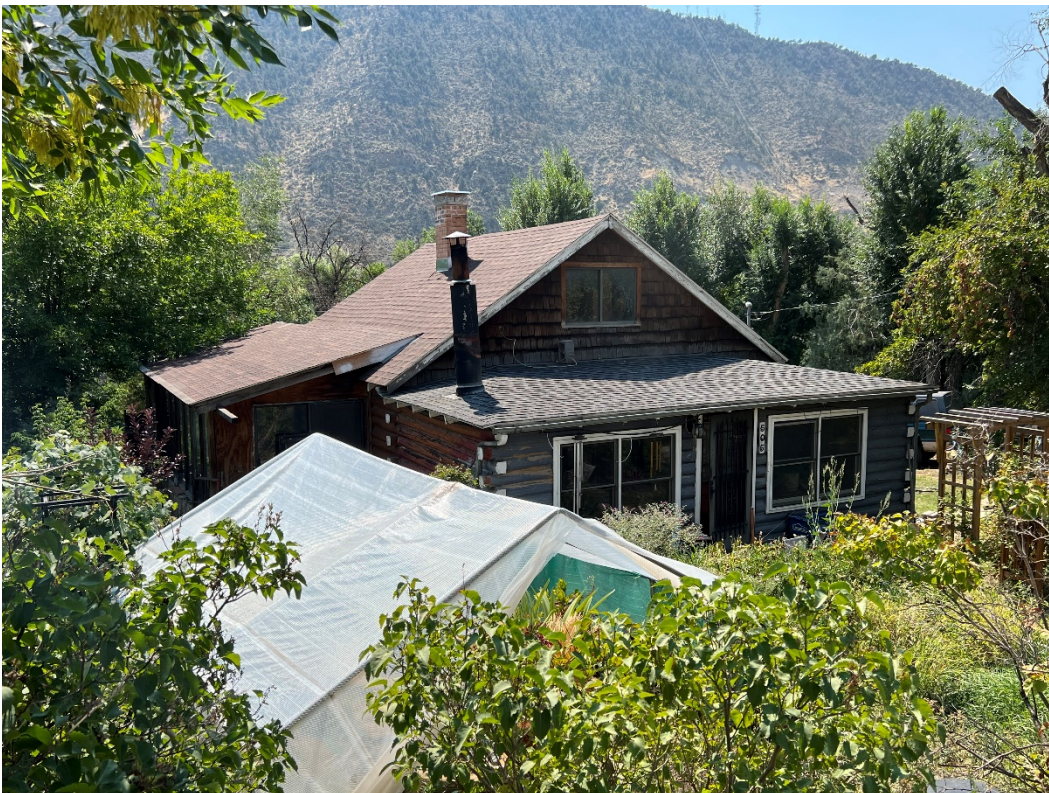
Photo Number: 5GF.5939_2
Description: Looking at the east and primary (north) elevations of the building.
Date: 9/6/2022
View: Southwest

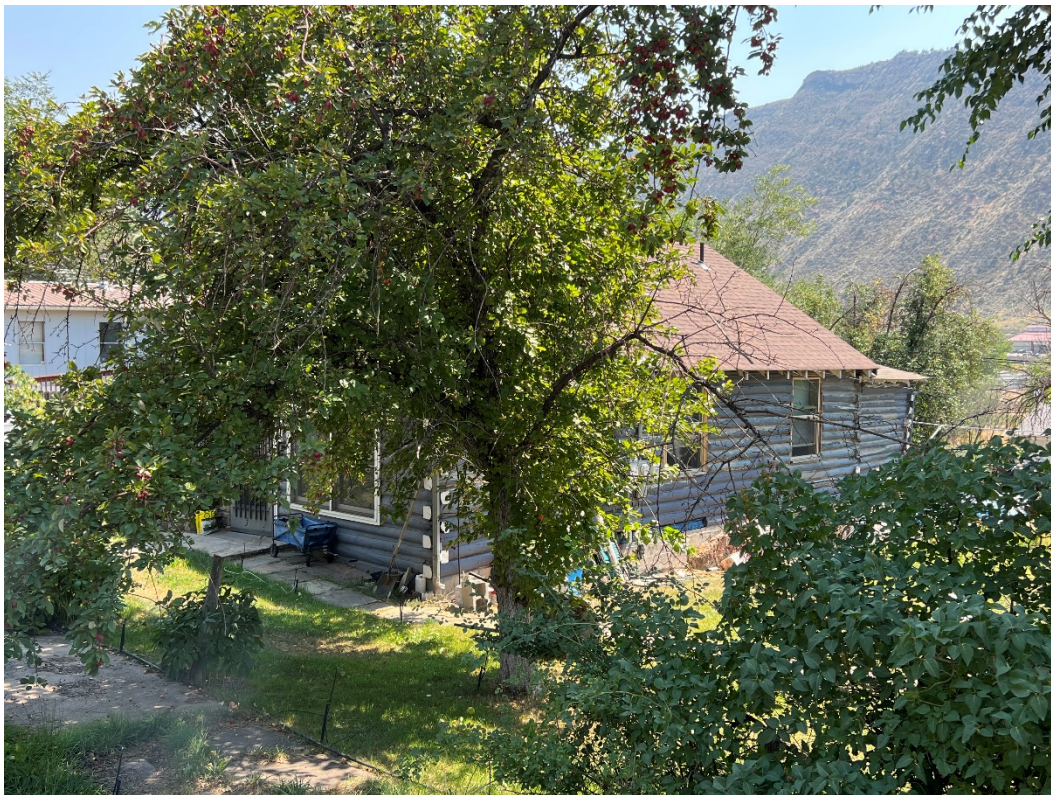
Photo Number: 5GF.5939_3
Description: Looking at an obscured portion of the primary (north) elevation and the west elevation of the building.
Date: 9/6/2022
View: Southeast

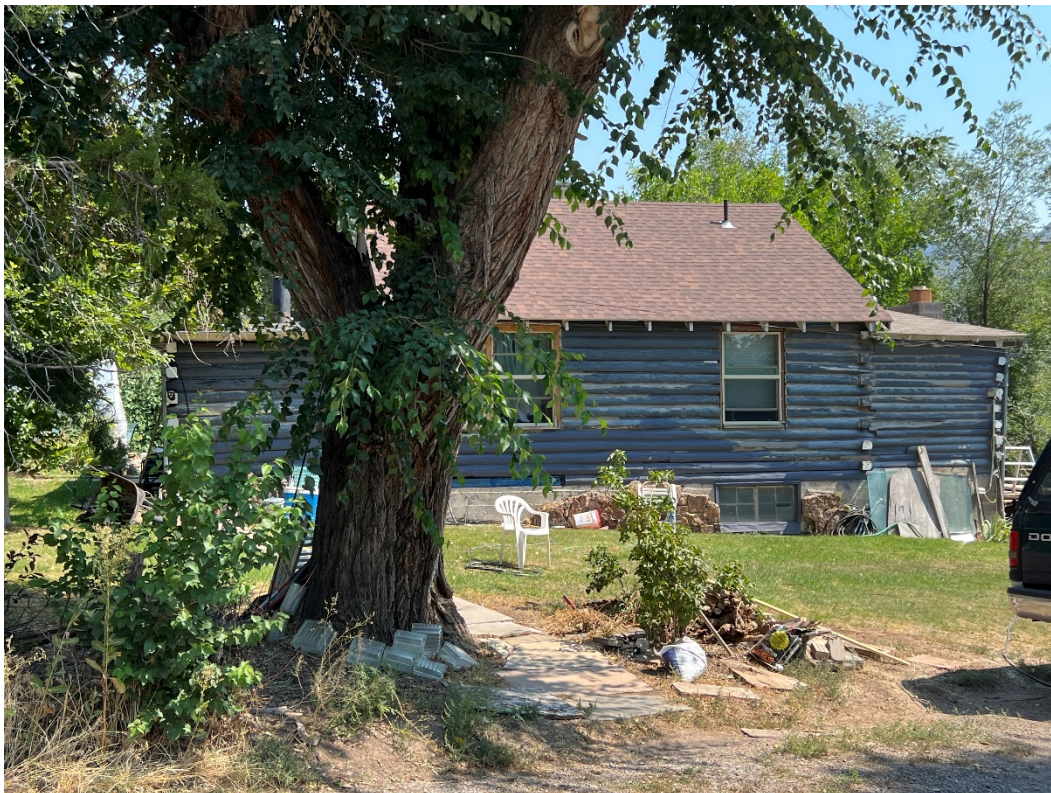
Photo Number: 5GF.5939_4
Description: Looking at the west elevation of the building. Note the CMU block chimney along the south elevation of the building.
Date: 9/6/2022
View: East
