COLORADO CULTURAL RESOURCES INVENTORY

Historical and Architectural Reconnaissance

1. Property Name: Wigger Residence Historic Current Other:
2. Resource Classification: Building Structure Object Sites/Landscape
3. Ownership: Federal State Local Non-profit Private Unknown

4. Street Address: 532 West Main Street
5. Municipality: New Castle, CO Vicinity:
6. County: Garfield
- **7. USGS Quad: New Castle, CO Year: 2022 7.5'
- **8. Parcel Number: 212331222018
- **9. Parcel Information: Lot(s): 3 Block: 8 Addition: ORIGINAL TWNSTE NEW CASTLE
- **10. Acreage: 0.05 Actual Estimated
11. PLSS information: Principal Meridian: 6th Township: 5S Range: 90W
SE ¼ of SE ¼ of SE ¼ of NW ¼ of section: 31

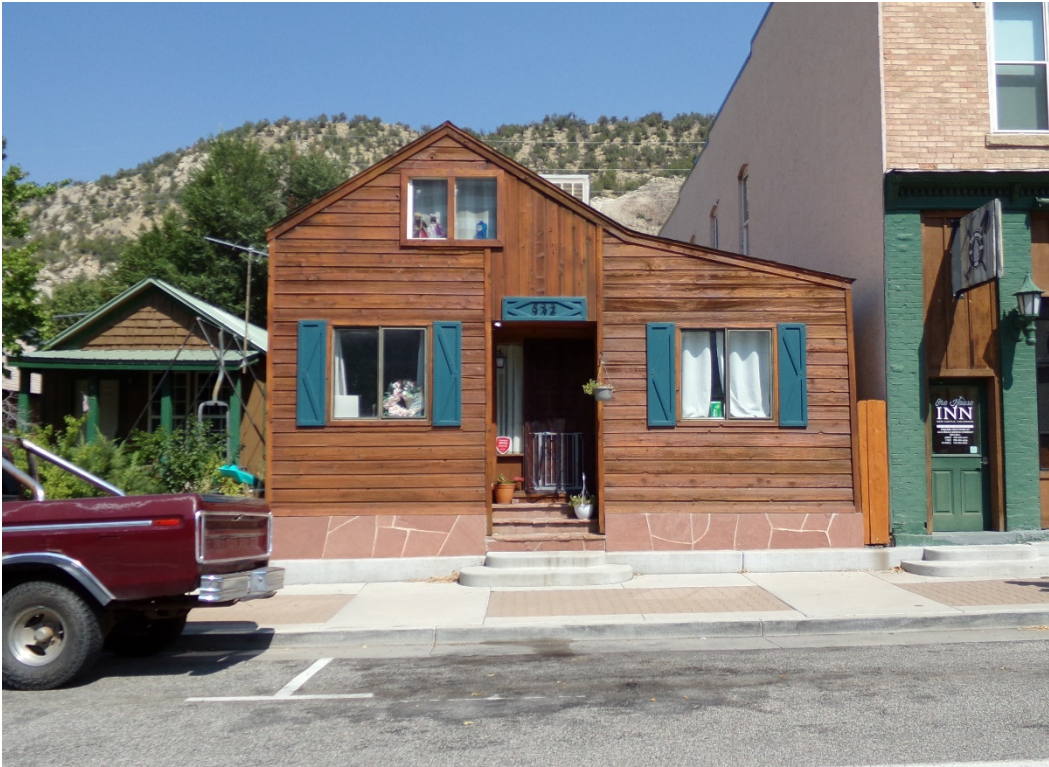
Photo Number: 5GF.5908_1
Description: Looking at the primary (south) elevation.
Date: 9/6/2022
View: North

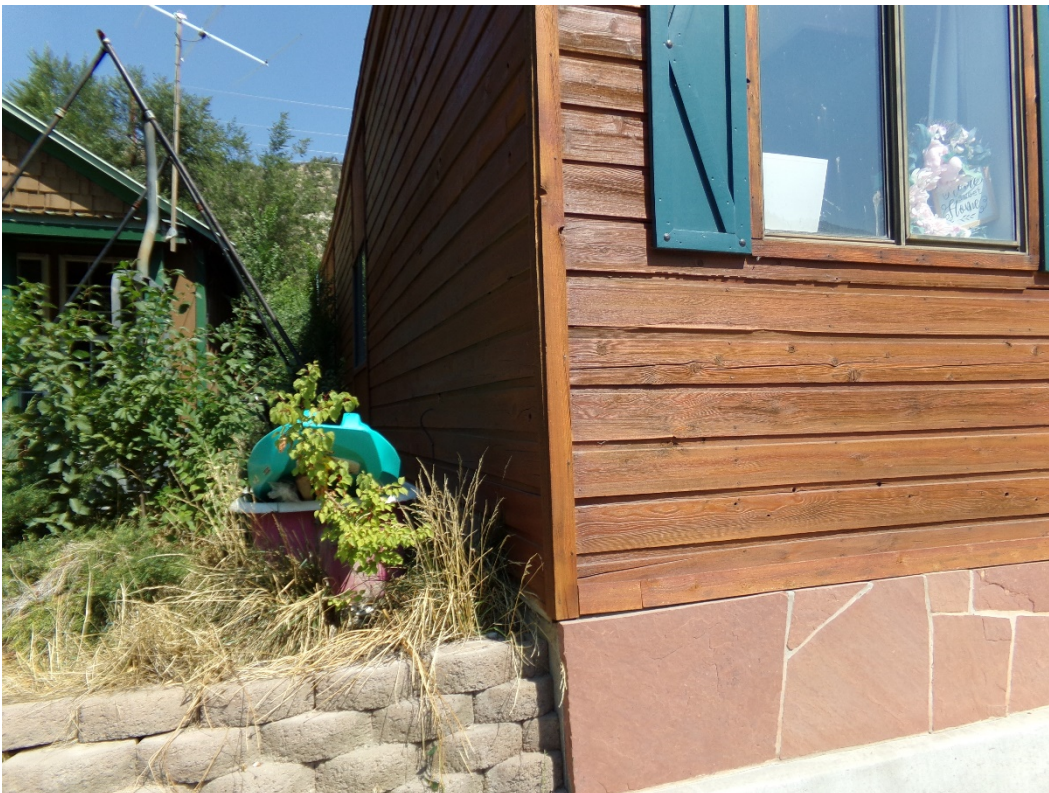
Photo Number: 5GF.5908_2
Description: Looking at the west and primary (south) elevation of the building.
Date: 9/6/2022
View: Northeast

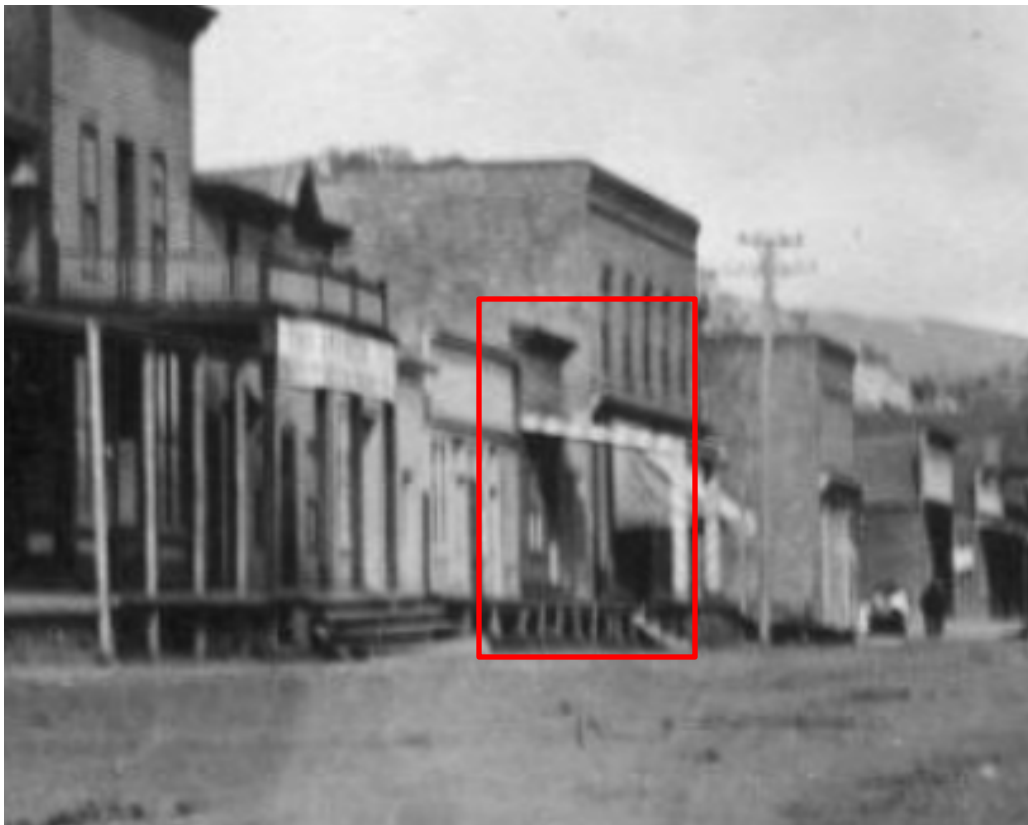
Historic Photo 1

Description: Image of downtown New Castle looking east down Main Street from the intersection of Main Street and North 6th Street. The resource is outlined in red. Note that the building incorporated a false front and shed roof overhang at the time.

Date: Circa 1900-1905

Historic imagery in 1905 demonstrates that the primary (south) elevation incorporated a false front and a shed roof overhang when the building was utilized as a barbershop. By the late Twentieth Century, the false front was removed along with the shed roof overhang as the building transitioned from a commercial to residential building. An addition was also constructed along the north elevation. Between
