COLORADO CULTURAL RESOURCES INVENTORY

Historical and Architectural Reconnaissance

1. Property Name: Allen Residence Historic Current Other:
2. Resource Classification: Building Structure Object Sites/Landscape
3. Ownership: Federal State Local Non-profit Private Unknown

4. Street Address: 542 West Main Street
5. Municipality: New Castle, CO Vicinity:
6. County: Garfield
- **7. USGS Quad: New Castle, CO Year: 2022 7.5'
- **8. Parcel Number: 212331222017
- **9. Parcel Information: Lot(s): 4 Block: 8 Addition: ORIGINAL TWNSTE NEW CASTLE
- **10. Acreage: 0.05 Actual Estimated
11. PLSS information: Principal Meridian: 6th Township: 5S Range: 90W
SE ¼ of SE ¼ of SE ¼ of NW ¼ of section: 31

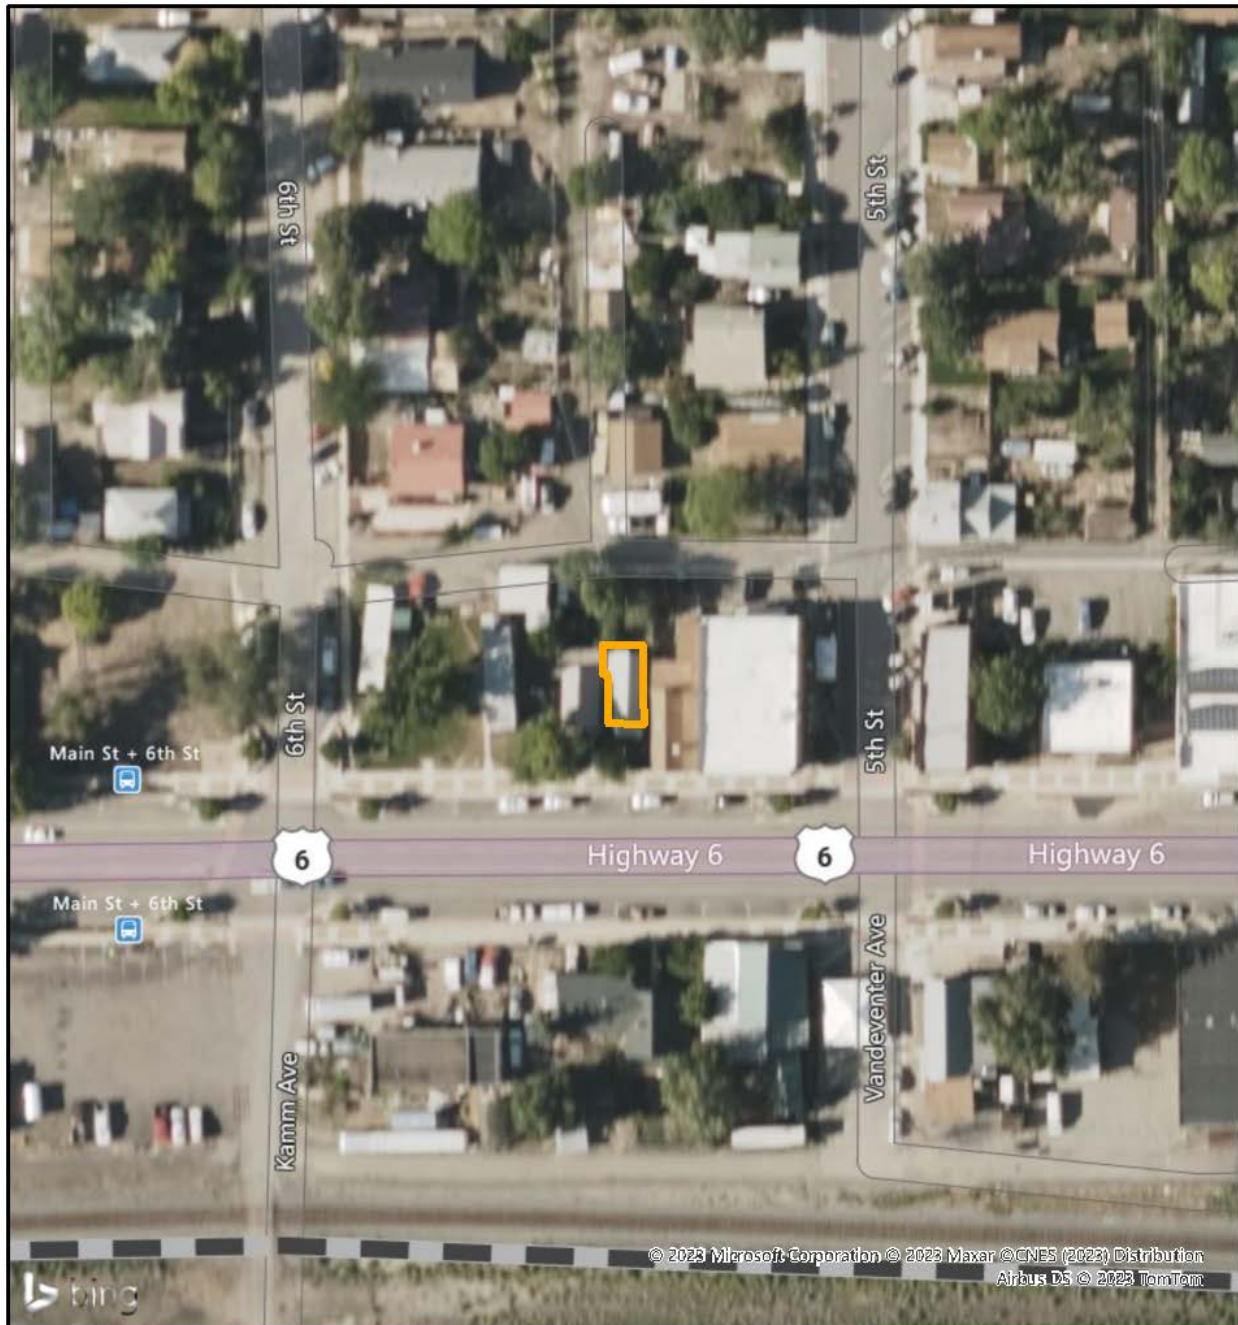
<p>Sketch Map 542 West Main Street (5GF.5907) New Castle, Colorado Garfield County</p>	
<p>Pinyon Project Number: I 22156.001</p>		<p>Drawn By: CJB</p>	<p>Figure: 2</p>
		<p>Reviewed By: CMW</p>	<p>Date: 4/10/2023</p>

The one-story, rectangular shaped building was constructed in 1942 as shown through review of Garfield County Assessor's Office records. The approximately 40' by 16' building is representative of a Shotgun style of architecture. Architectural elements of the building include a poured concrete foundation; front gable roof clad in metal; overhanging eaves; an exterior envelope vertical weatherboard siding; wood shingles in the gable end; and a full-length porch with a shed roof along the primary (south) elevation. The typical window consists of a nine-over-nine single hung sash with snap on muntins. These windows are replacements due to their vinyl construction. Another window found through the building includes a one-over-one single hung sash. The main entryway is located on the far-left side of the primary (south) elevation. The main door consists of a replacement panel door. Two typical window units are located to the right of the door. A protected full-length porch can be noticed along the façade and is supported by unornate square post columns. A majority of the primary (south) elevation is obscured by dense vegetation.

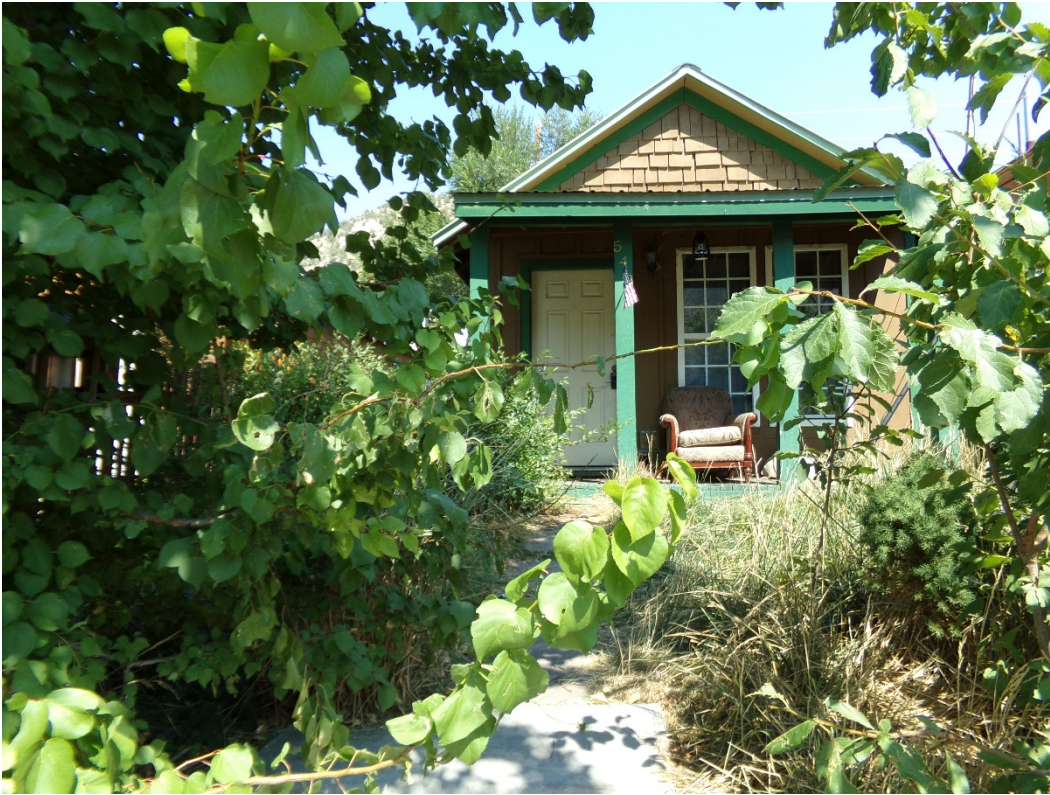
Photo Number: 5GF.5907_1
Description: Looking at the primary (south) elevation of the building.
Date: 9/6/2022
View: North

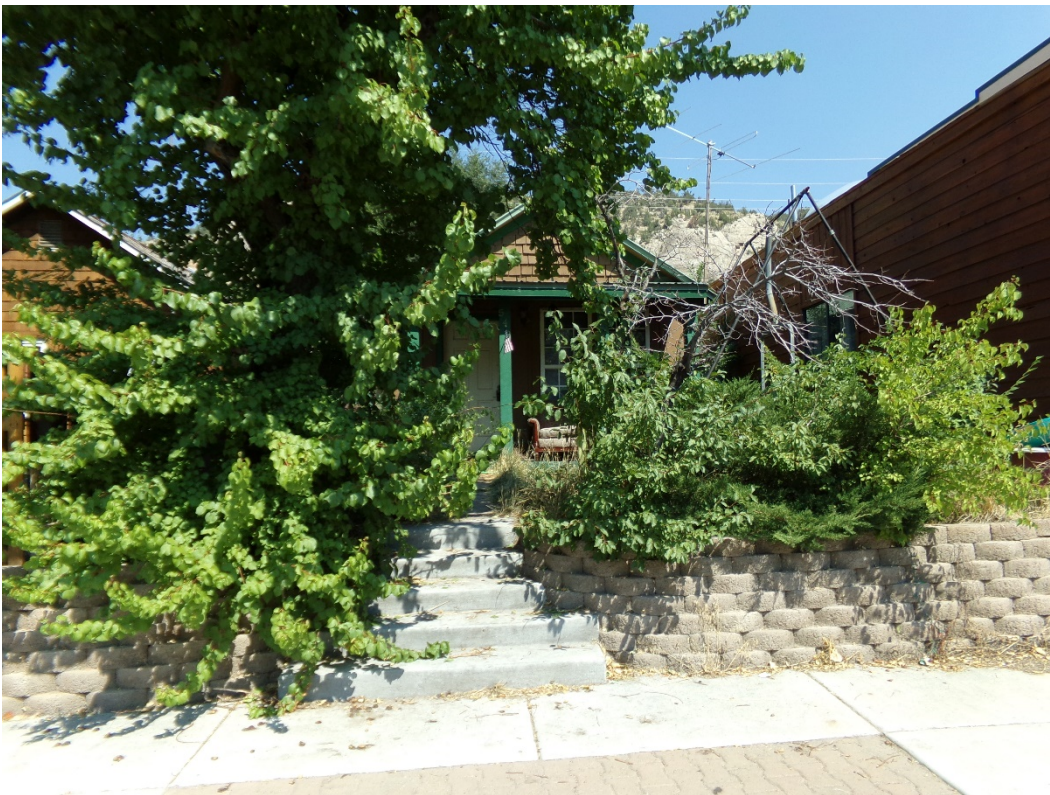
Photo Number: 5GF.5907_2
Description: Context view of the primary (south) elevation of the building.
Date: 9/6/2022
View: North

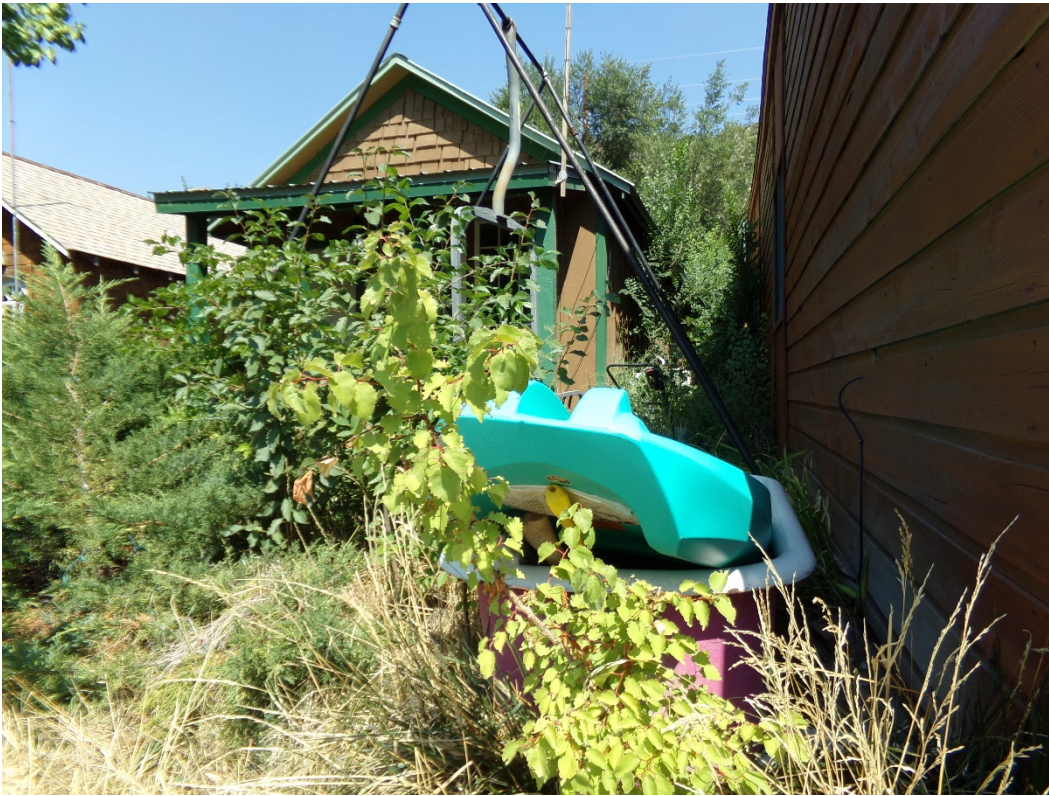
Photo Number: 5GF.5907_3
Description: Looking at the primary (south) and east elevations of the building.
Date: 9/6/2022
View: Northwest

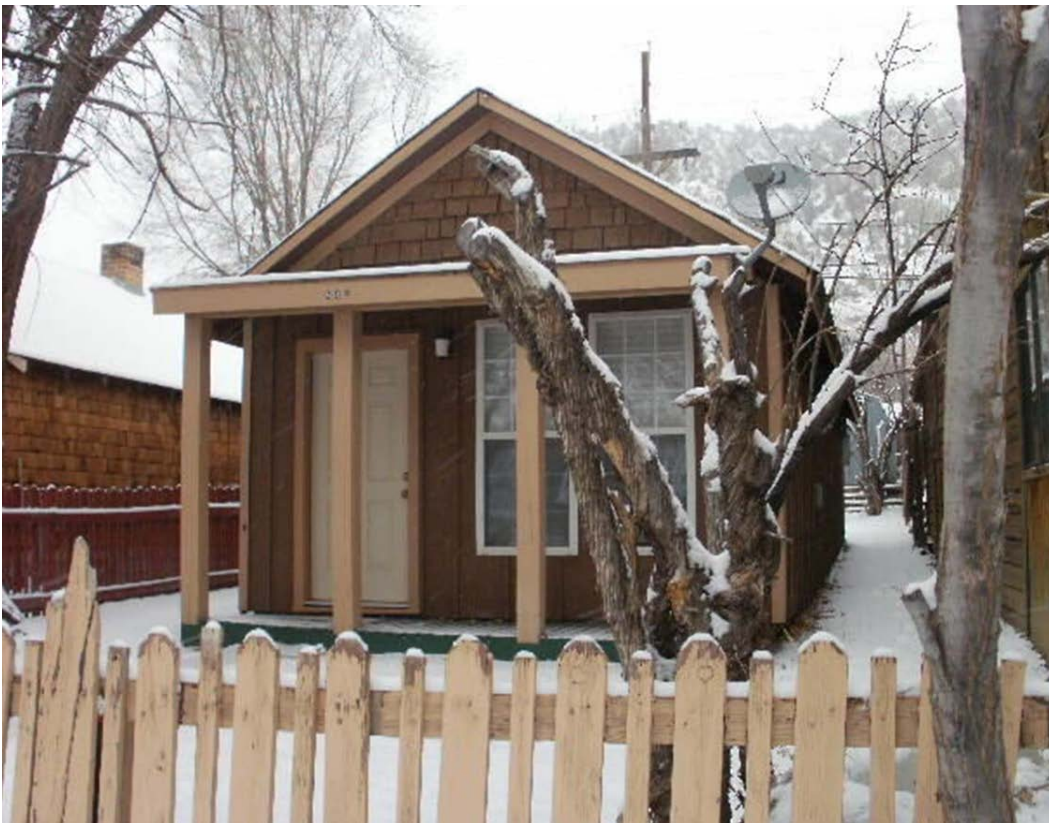
Between 2008 and 2022, historical street imagery reveals that windows were replaced along with the main entry door. In addition, wood shingles were placed in the gable ends. At some point, a small addition was constructed at the far-left side of the west elevation.

Reference Photo 1
Description: Looking at the primary (south) elevation.
Date: Circa 2009
Source: Garfield County Assessor's Office
