# **COLORADO CULTURAL RESOURCES INVENTORY**

# **Historical and Architectural Reconnaissance**

1. Property Name: <u>Texaco Service Station</u>							
2. Resource Class	ification: 🛛 🖂 B	uilding	□ Structure	□ Object □ Sites/Landscape			
3. Ownership:	Federal	□ State	Local	🗆 Non-profit	⊠ Private		
LOCATION 4. Street Address: 589 West Main Street

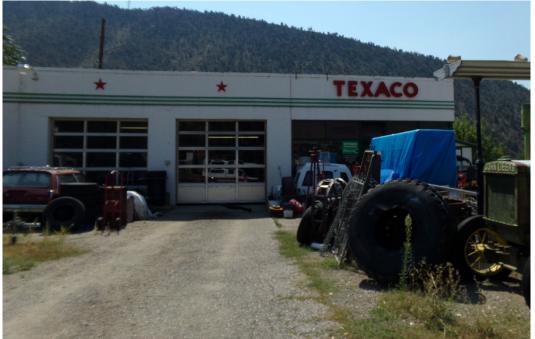
Photo Number: 5GF.5903\_1 Description: Looking at the primary (north) elevation of the building from West Main Street. Note the rolled glazed doors in front of the service bays. Date: 9/6/2022 View: South

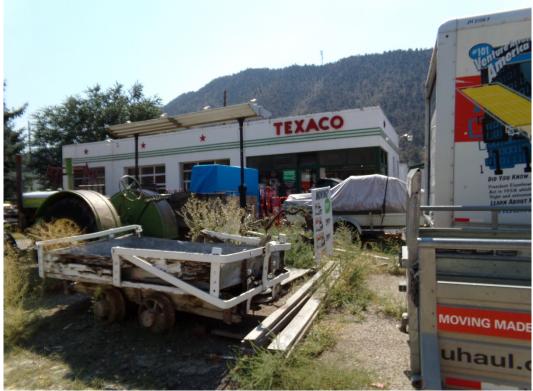
Photo Number: 5GF.5903\_2 Description: Looking at the primary (north) and west elevations of the building. Note the fuel island in the foreground. Date: 9/6/2022 View: Southeast

□ Garden □ Mature Plantings □ Designed Landscape □ Walls □ Parking Lot ⊠ Driveway ⊠ Sidewalk □ Fence □ Seating Other: Fuel islands are located between the building and West Main Street; however, the fuel pumps are not extant.

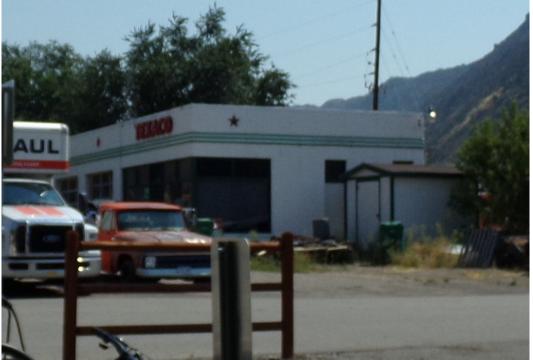
#### Photo Number: 5GF.5903\_3

Description: Looking at the primary (north) elevation and west elevations of the building. Date: 9/6/2022 View: Southeast

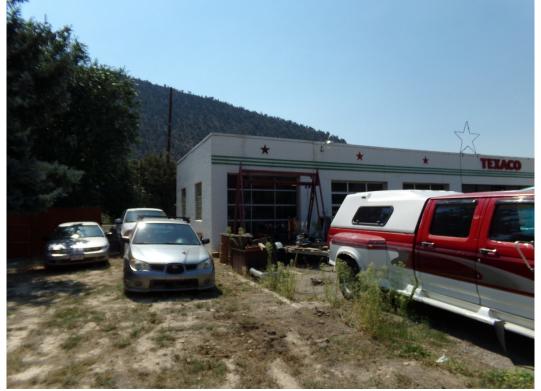
Photo Number: 5GF.5903\_4 Description: Looking at the east and primary (north) elevations of the building. The third bay on the far left is likely an addition. Date: 9/6/2022 View: Southwest
