COLORADO CULTURAL RESOURCES INVENTORY

Historical and Architectural Reconnaissance

1. Property Name: Pickard Residence Historic Current Other:
2. Resource Classification: Building Structure Object Sites/Landscape
3. Ownership: Federal State Local Non-profit Private Unknown

4. Street Address: 640 West Main Street
5. Municipality: New Castle, CO Vicinity:
6. County: Garfield
- **7. USGS Quad: New Castle, CO Year: 2022 7.5'
- **8. Parcel Number: 212331223016
- **9. Parcel Information: Lot(s): 6, 7 Block: 15 Addition: ORIGINAL TWNSTE NEW CASTLE

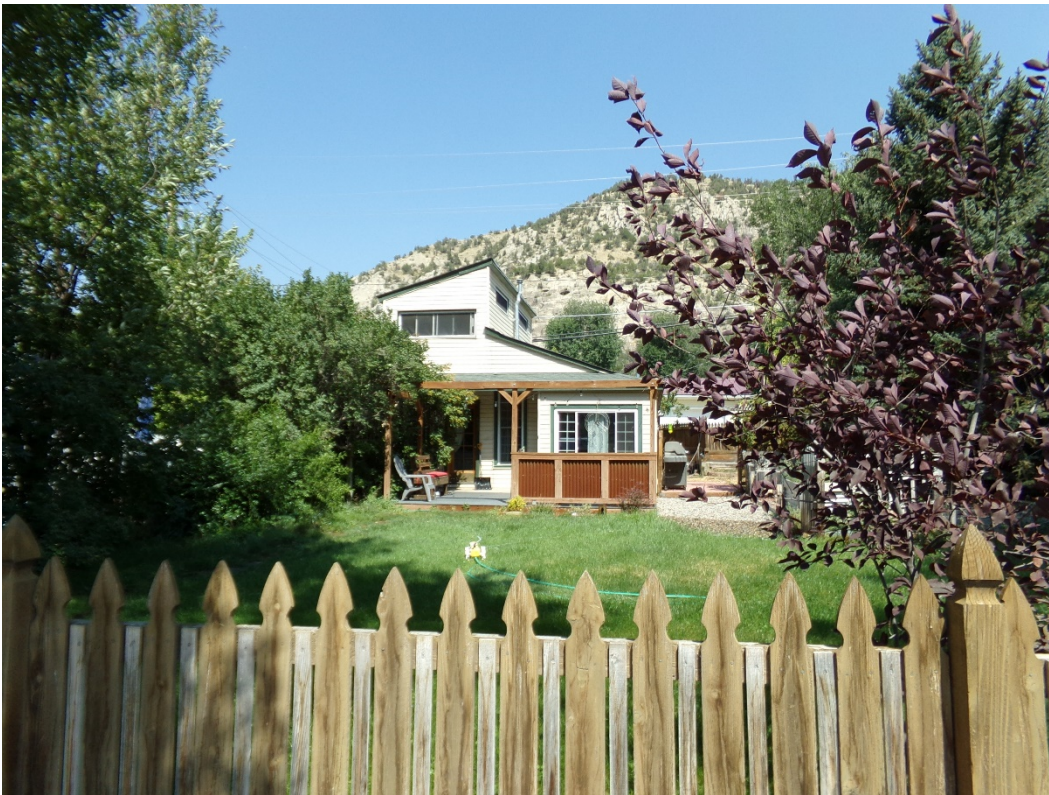
Photo Number: 5GF.5901_1
Description: Context view from Main Street looking at the primary (south) elevation of the building.
Date: 9/6/2022
View: North

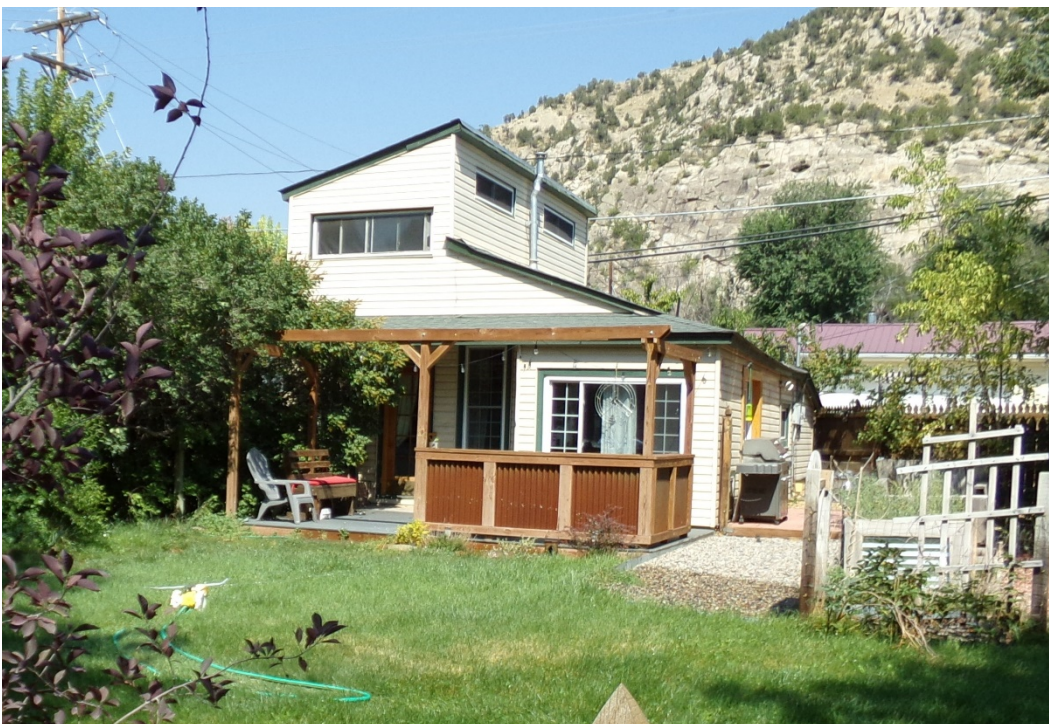
Photo Number: 5GF.5901_2
Description: Looking at the primary (south) and east elevation of the building.
Date: 9/6/2022
View: Northwest
