COLORADO CULTURAL RESOURCES INVENTORY

Historical and Architectural Reconnaissance

4. Street Address: 644 East Main Street
5. Municipality: New Castle, CO Vicinity:
6. County: Garfield
- **7. USGS Quad: New Castle, CO Year: 2022 7.5'
- **8. Parcel Number: 212331101005
- **9. Parcel Information: Lot(s): 2-4 Block: K Addition: Spencer's Addition
- **10. Acreage: 0.17 Actual Estimated
11. PLSS information: Principal Meridian: 6th Township: 5S Range: 90W
SE ¼ of SE ¼ of SE ¼ of NE ¼ of section:

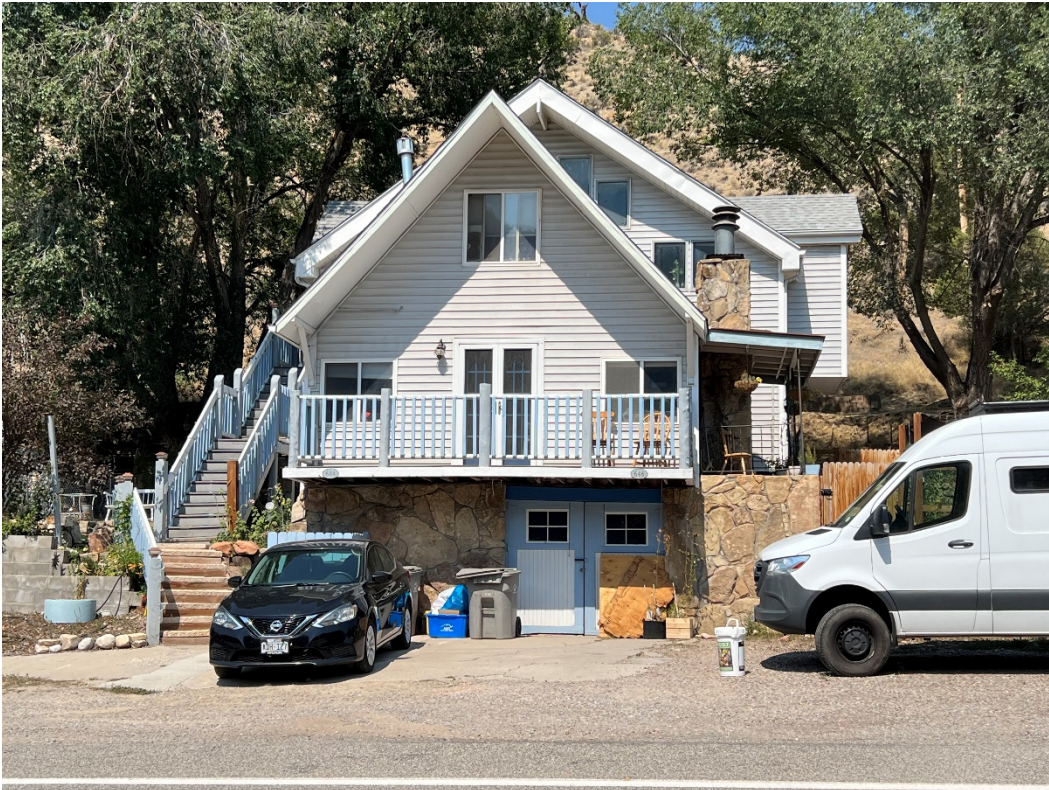
Photo Number: 5GF.5941_1
Description: Looking at the primary (south) elevation of the building. Note the front gable and the side gable projections below the front gable roofline.
Date: 9/6/2022
View: North

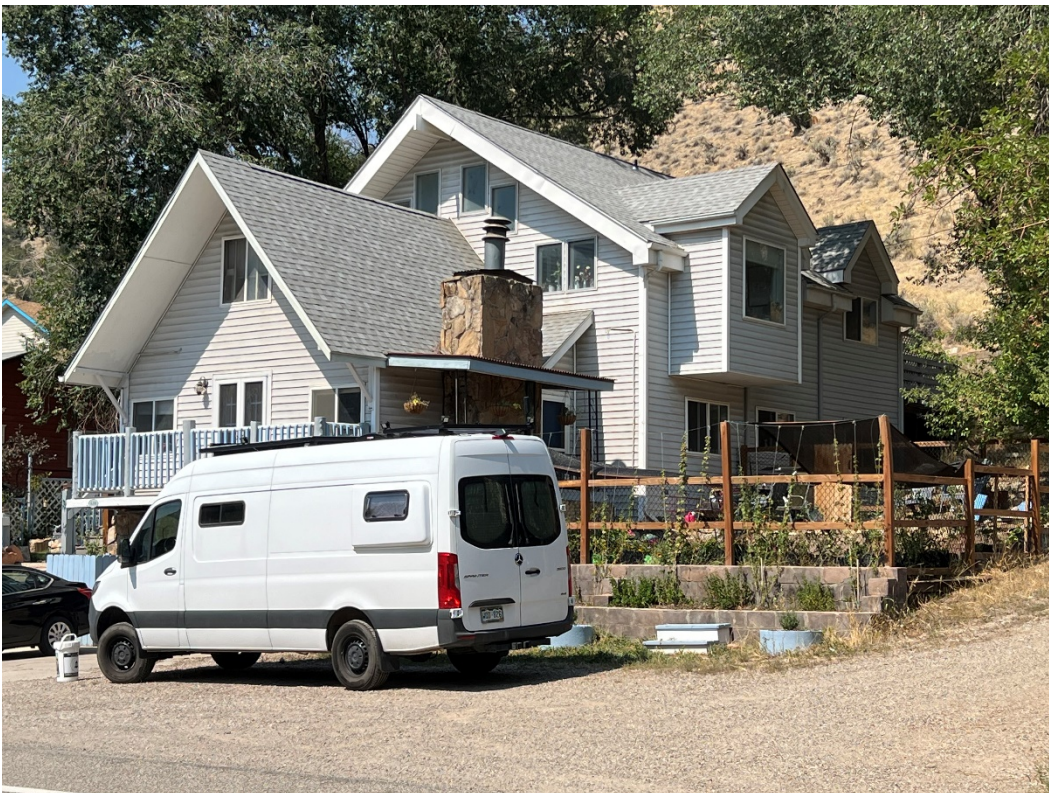
Photo Number: 5GF.5941_2
Description: Looking at the primary (south) and east elevations of the building.
Date: 9/6/2022
View: Northwest

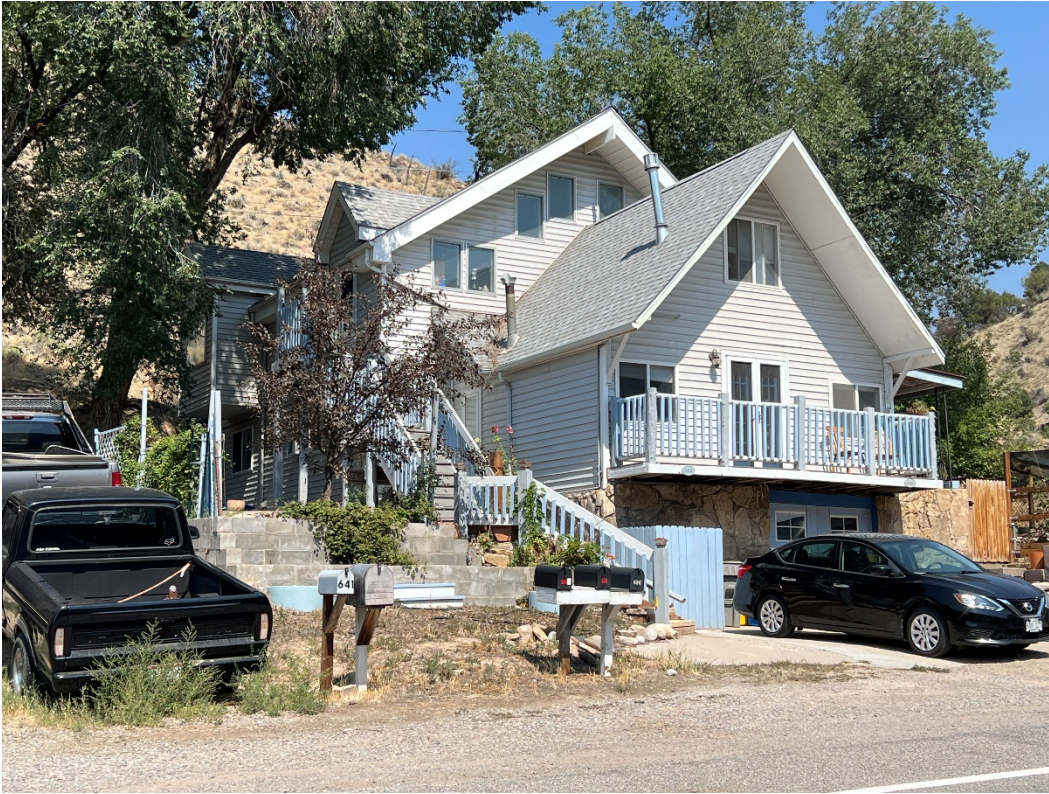
Photo Number: 5GF.5941_3
Description: Looking at the west and primary (south) elevations of the building. Note the staircase leads from the basement level to the second floor.
Date: 9/6/2022
View: Northeast
