COLORADO CULTURAL RESOURCES INVENTORY

Historical and Architectural Reconnaissance

1. Property Name: Gallegos Ventures, Inc. Building Historic Current Other:
2. Resource Classification: Building Structure Object Sites/Landscape
3. Ownership: Federal State Local Non-profit Private Unknown

4. Street Address: 681 East Main Street
5. Municipality: New Castle, CO Vicinity:
6. County: Garfield
- **7. USGS Quad: New Castle, CO Year: 2022 7.5'
- **8. Parcel Number: 212331401004
- **9. Parcel Information: Lot(s): 1-2 Block: L Addition: Spencer's 2nd
- **10. Acreage: 0.18 Actual Estimated
11. PLSS information: Principal Meridian: 6th Township: 5S Range: 90W
NE ¼ of NE ¼ of NE ¼ of SE ¼ of section: 31

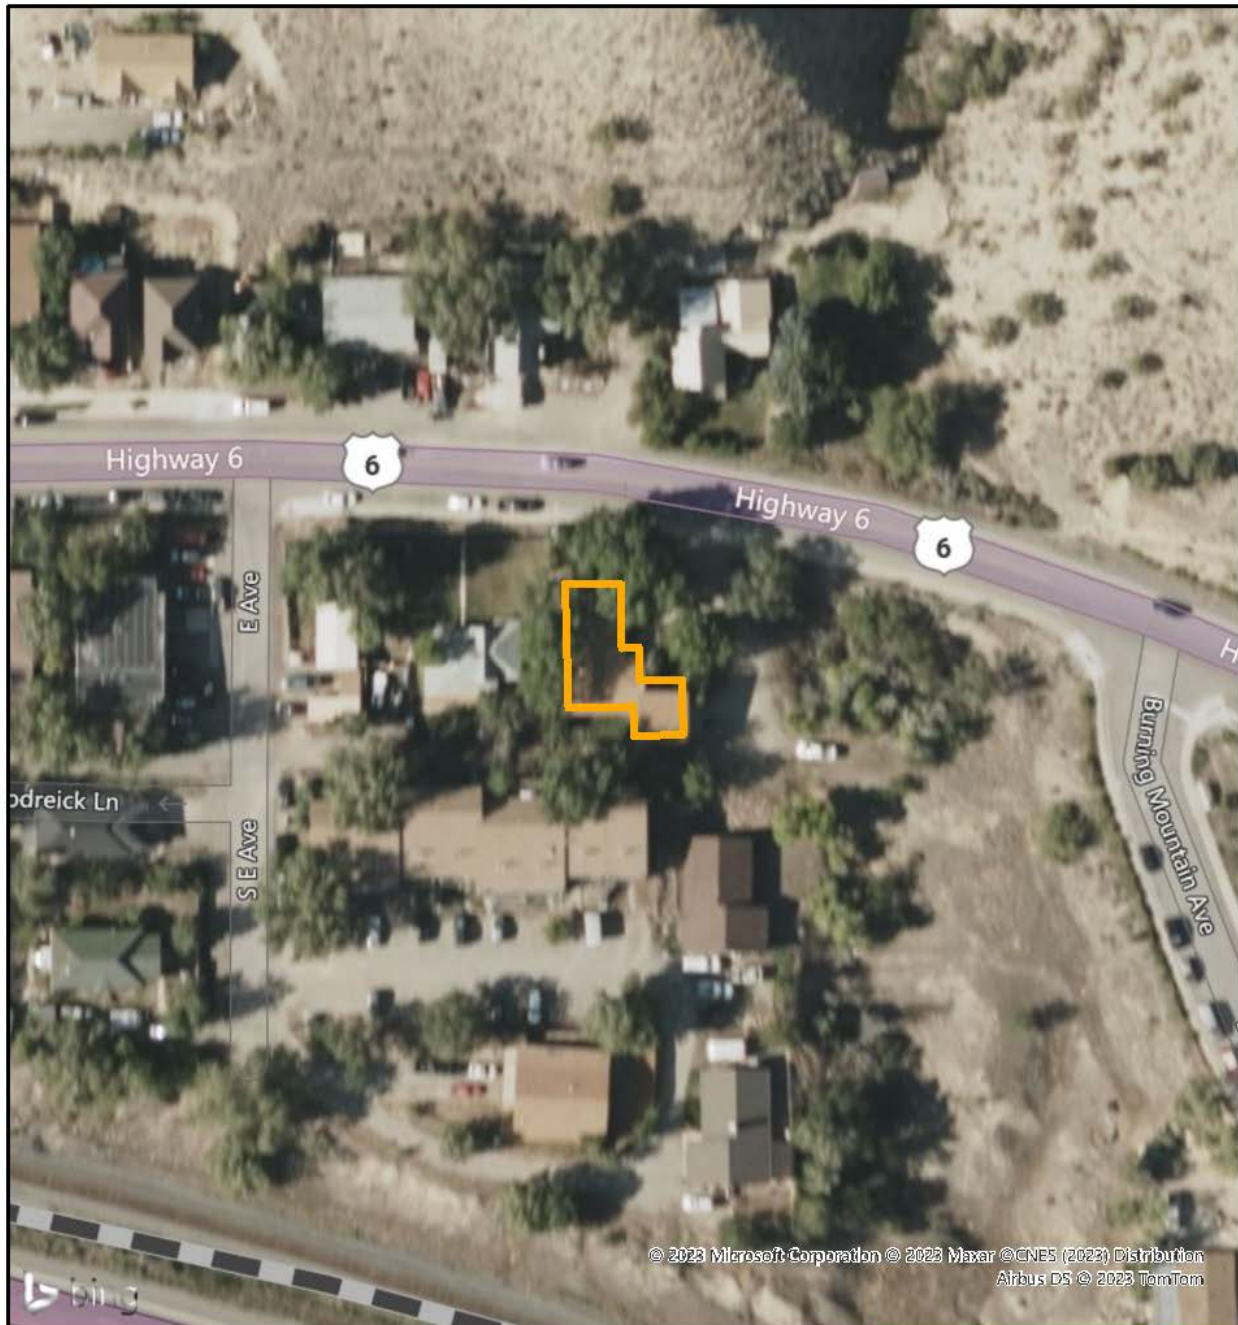
Sketch Map

</div>	<p>Pinyon Environmental, Inc.</p> <p>Sketch Map 681 East Main Street (5GF.5942) New Castle, Colorado Garfield County</p>				
<p>Pinyon Project Number: I 22156.001</p>	<table border="1" style="width: 100%;"> <tr> <td style="width: 50%;">Drawn By: CJB</td> <td style="width: 50%;">Figure: 2</td> </tr> <tr> <td>Reviewed By: CMW</td> <td>Date: 4/10/2023</td> </tr> </table>	Drawn By: CJB	Figure: 2	Reviewed By: CMW	Date: 4/10/2023
Drawn By: CJB	Figure: 2				
Reviewed By: CMW	Date: 4/10/2023

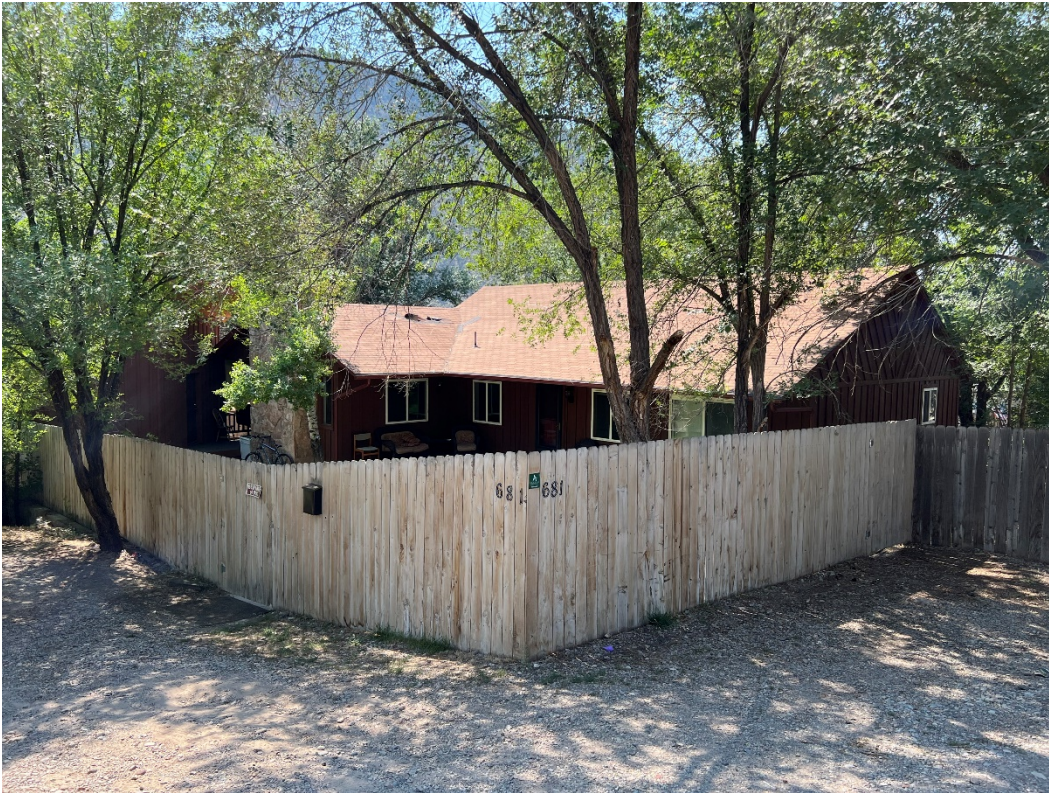
Photo Number: 5GF.5942_1
Description: Looking at the primary (east) and north elevations of the residence.
Date: 9/6/2022
View: Southwest

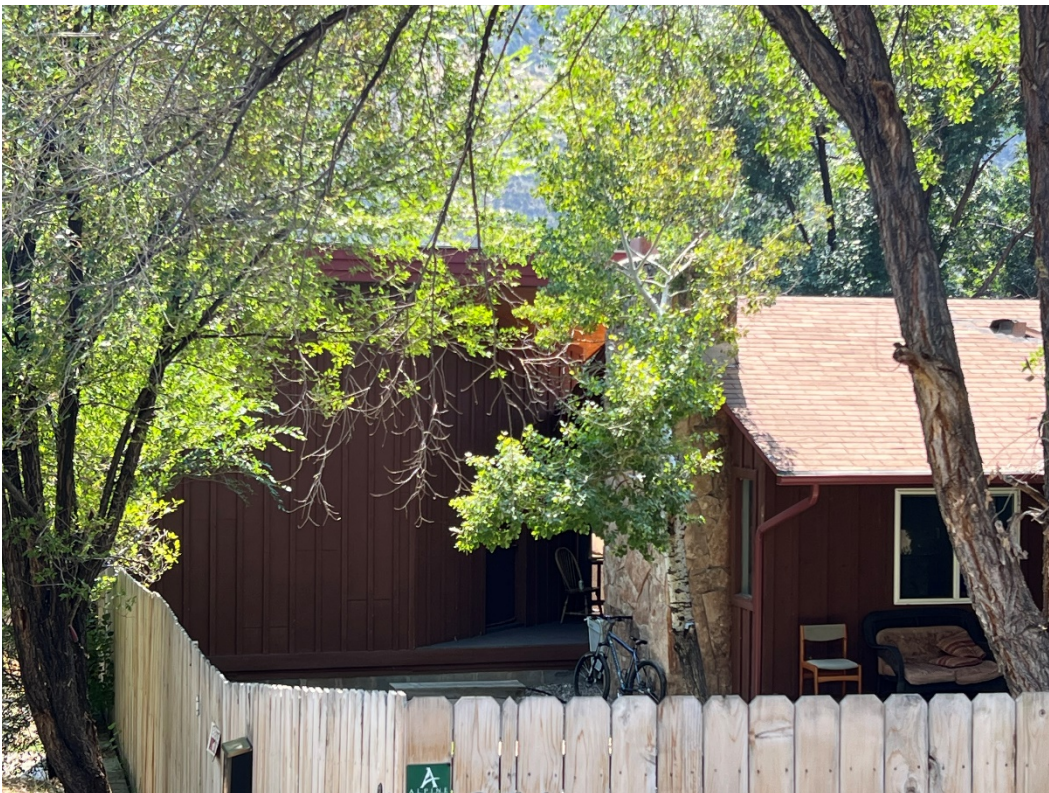
Photo Number: 5GF.5942_2
Description: Close up of the primary (east) elevation of the building. Note the stone masonry chimney.
Date: 9/6/2022
View: Southwest

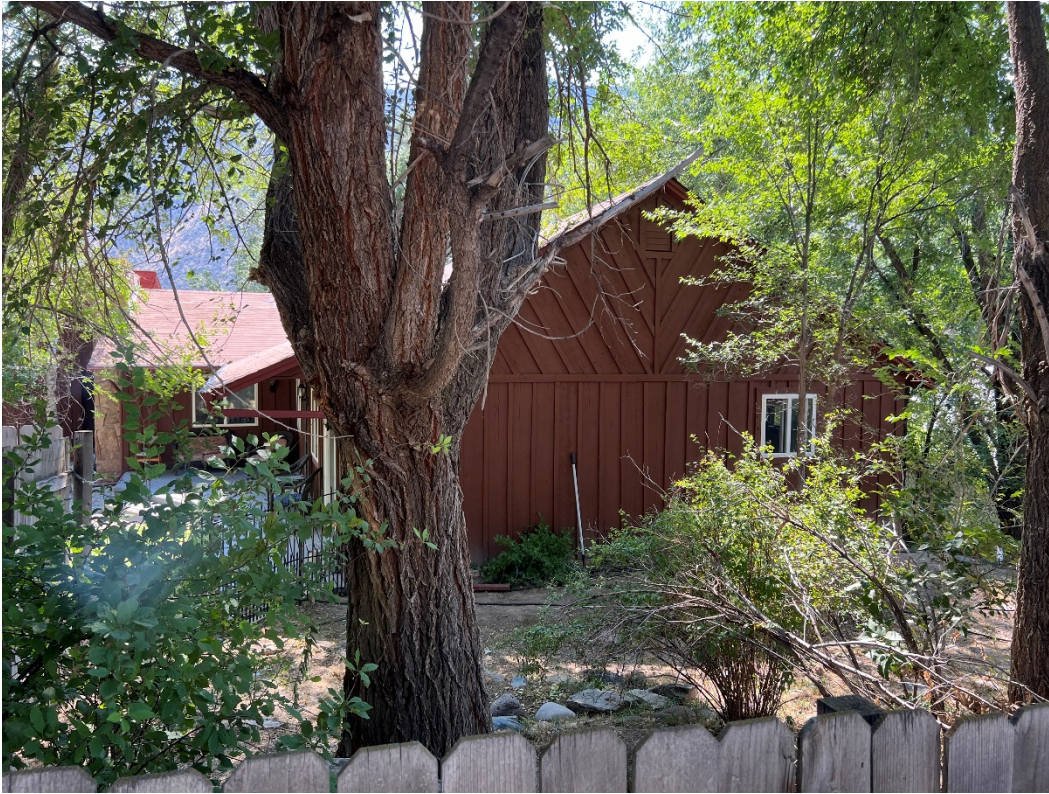
Photo Number: 5GF.5942_3

Description: Looking at the north elevation of the building. Note the decorative chevrons in the gable end.

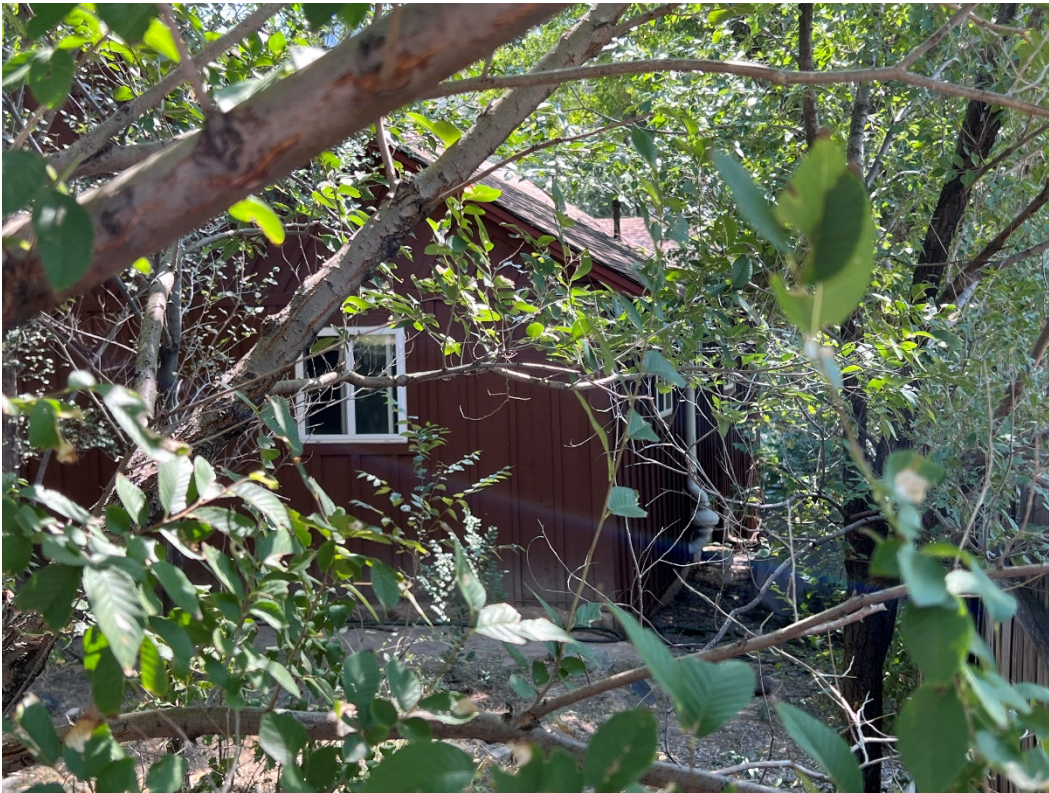
Photo Number: 5GF.5942_4

Description: Looking at the north and west elevations of the building. Note the lower side gable projection near the roofline.
