## COLORADO CULTURAL RESOURCES INVENTORY

### Historical and Architectural Reconnaissance

1. Property Name: Harmony LLC Residence  Historic  Current  Other:
2. Resource Classification:  Building  Structure  Object  Sites/Landscape
3. Ownership:  Federal  State  Local  Non-profit  Private  Unknown

4. Street Address: 681 West Main Street
5. Municipality: New Castle, CO  Vicinity:
6. County: Garfield
- \*\*7. USGS Quad: New Castle, CO Year: 2022  7.5'
- \*\*8. Parcel Number: 212331302002
- \*\*9. Parcel Information: Lot(s): 3-5 Block: 14 Addition: ORIGINAL TWNSTE NEW CASTLE

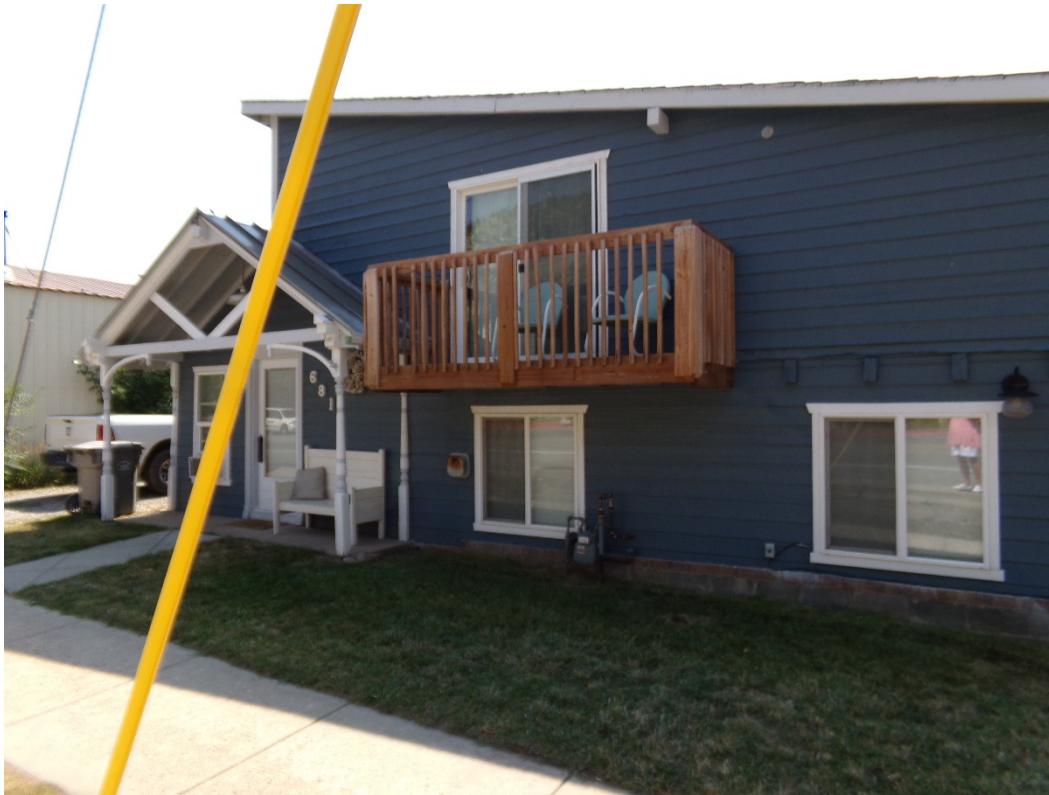
**Photo Number:** 5GF.5899\_1  
**Description:** Looking at the primary (north) elevation of the building.  
**Date:** 9/6/2022  
**View:** Southeast

The two-story, square shaped building was constructed in 1893 as shown through review of Garfield County Assessor's Office records. The approximately 40' by 40' building is not representative of a particular style of architecture. Overall, the residence is a No Style building. Architectural features of the building include a stack stone and poured concrete foundation; shed roof clad in asphalt shingles; subordinate side and front gables; open and closed overhanging eaves; exposed rafter tails under the eaves; and exposed rafter beams; a metal flu chimney; an exterior envelope clad in horizontal weatherboard siding; a full-length front gable porch along the primary (north) elevation and a deck located on second level of primary (north) elevation. The typical window consists of a vinyl one-over-one single hung sash with a decorative wood lintel, sill, and casings. One-by-one sliding sash windows can also be noticed throughout the building. The main entryway is located on the far-left side of the primary (north) elevation and within the partial length front gable porch. The main door consists of a wood exterior door with a single lite. The partial length porch incorporates turned spindle

support columns; chevron features in the gable end; and decorative brackets. A sliding porch door is evident on the second floor in the center of the façade. The deck consists of wood with unornamented railings.

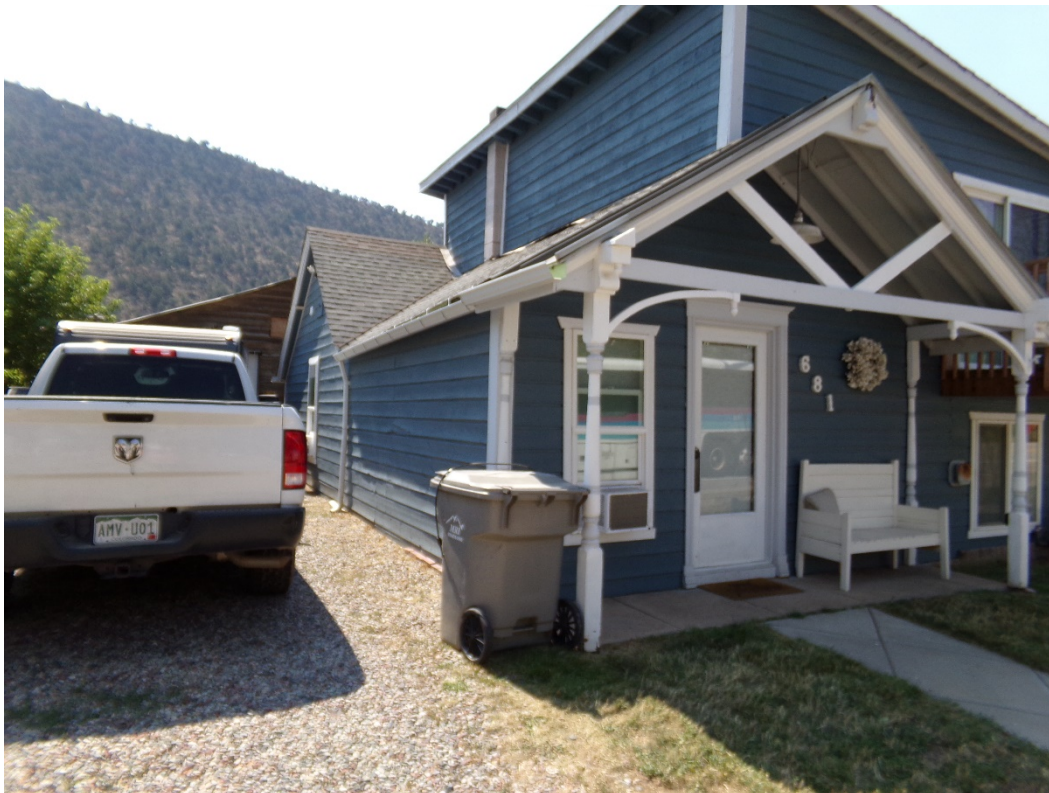
**Photo Number:** 5GF.5899\_2  
**Description:** Looking at the east and primary (north) elevations of the building.  
**Date:** 9/6/2022  
**View:** Southwest

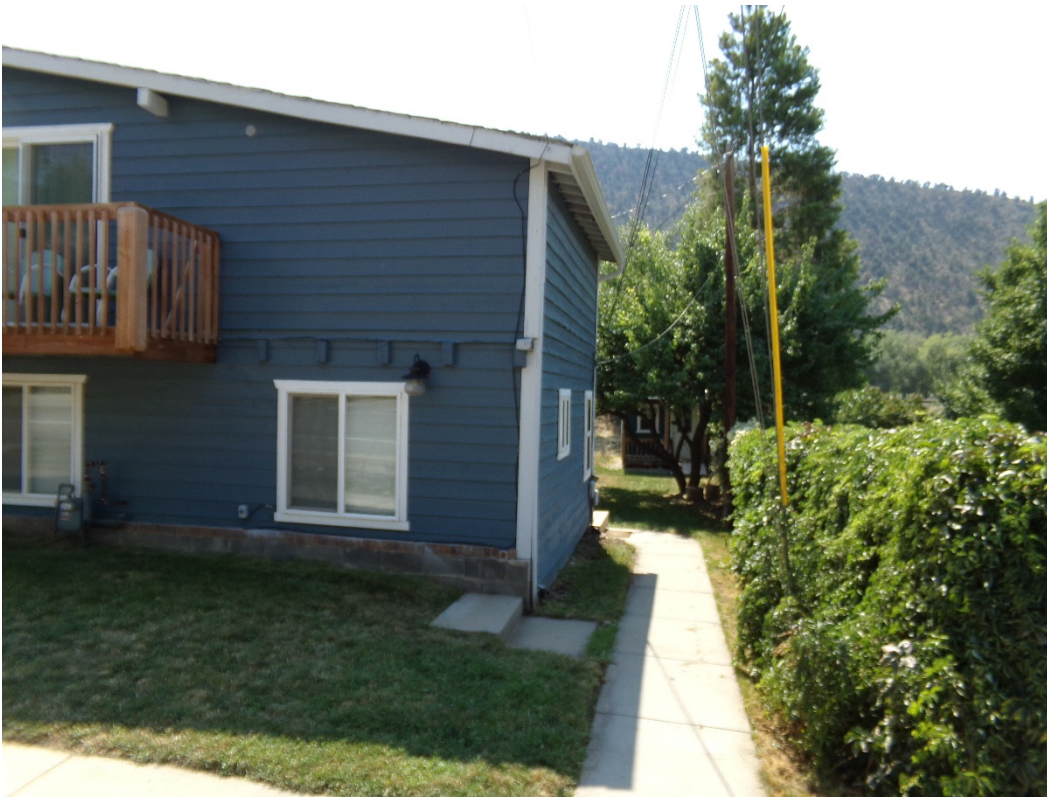
**Photo Number:** 5GF.5899\_3  
**Description:** Looking at the primary (north) and west elevations of the building.  
**Date:** 9/6/2022  
**View:** Southeast

*Sanborn Fire Insurance* maps between 1893 and 1899 demonstrate that an addition was constructed along the south elevation during the period. Historical aerial imagery shows that the two-story shed roof addition along the west elevation of the building was constructed by 1960. In addition, historical street imagery in 2008 reveals that a staircase was present to the second level deck on the primary (north) elevation. Between 2012 and 2022, the staircase was removed, and a one-by-one sliding sash window was constructed on the far-right side of the first level of the primary (north) elevation. Furthermore, window units were replaced due to their vinyl construction.
