COLORADO CULTURAL RESOURCES INVENTORY

Historical and Architectural Reconnaissance

1. Property Name: Robert Mccullough Residence Historic Current Other:
2. Resource Classification: Building Structure Object Sites/Landscape
3. Ownership: Federal State Local Non-profit Private Unknown

4. Street Address: 696 East Main Street
5. Municipality: New Castle, CO Vicinity:
6. County: Garfield
- **7. USGS Quad: New Castle, CO Year: 2022 7.5'
- **8. Parcel Number: 212332200019
- **9. Parcel Information: Lot(s): N/A Block: N/A Addition: N/A
- **10. Acreage: 0.5 Actual Estimated
11. PLSS information: Principal Meridian: 6th Township: 5S Range: 90W
SW ¼ of SW ¼ of SW ¼ of NW ¼ of section: 32
- **12. Location Coordinates:
 UTM reference: Zone 13 ;mE 283104 ;mN 4383056 NAD 1927 NAD 1983
 or
 Lat/Long: Latitude _____ ; Longitude _____ WGS84 Other:

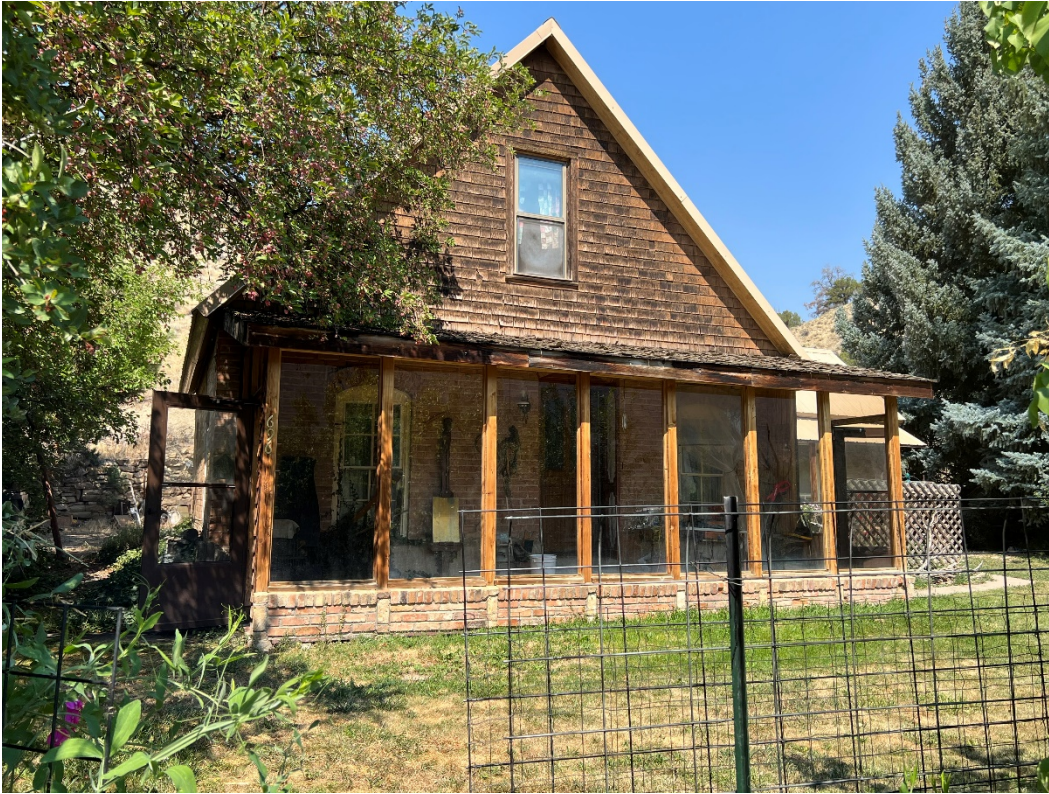
Photo Number: 5GF.5943_1
Description: Looking at the front gable along the primary (south) elevation.
Date: 9/6/2022
View: Northeast

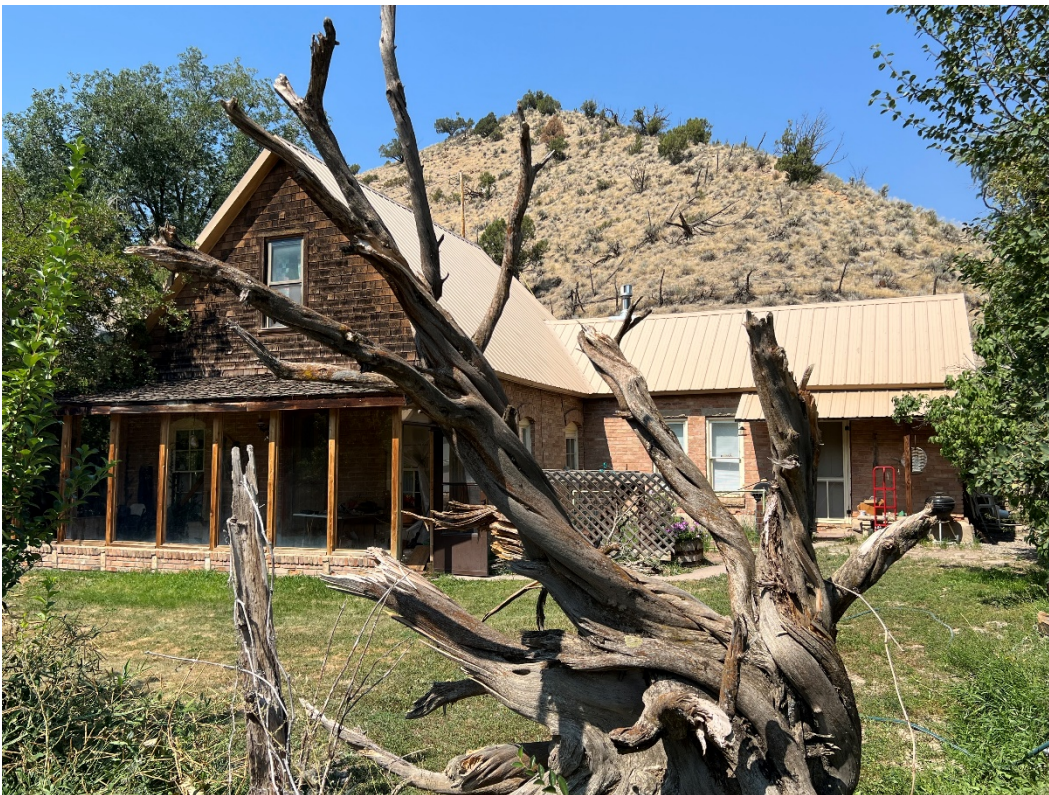
Photo Number: 5GF.5943_2
Description: Looking at the entire facade of the primary (south) elevation. Note the wood shingle exterior in the gable end while brick masonry cladding encompasses the right side of the building.
Date: 9/6/2022
View: Northwest

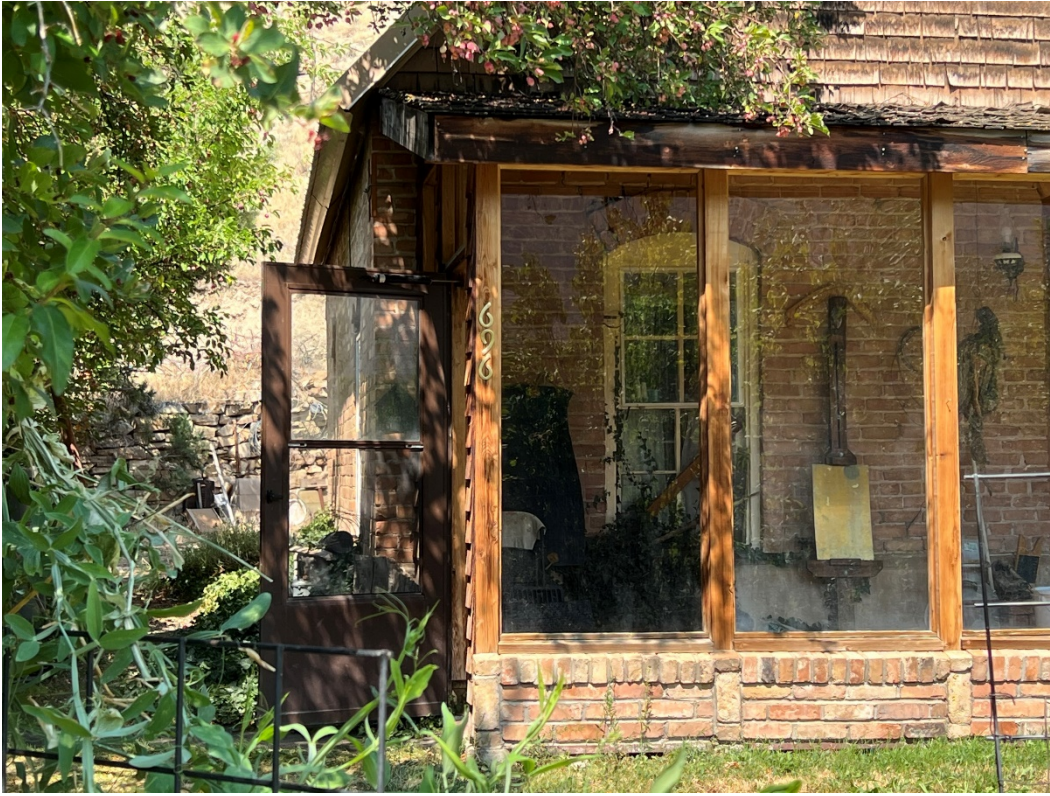
Photo Number: 5GF.5943_3
Description: A small glimpse of the west elevation of the building.
Date: 9/6/2022
View: Northeast
