#### COLORADO CULTURAL RESOURCES INVENTORY

### **Historical and Architectural Reconnaissance**

Property Name: McFarland Residence		☐ Hist	oric 🗵 Currer	it ⊔ Other:
2. Resource Classification:   ⊠ Building	□ Structure	☐ Object	☐ Sites/Lands	cape
3. Ownership: ☐ Federal ☐ State	e □ Local	$\square$ Non-profit		□ Unknown
LOCATION

4. Street Address: 721 West Main Street				
5. Municipality: New Castle, CO		☐ Vicinity:		
6. County: Garfield				**Please check with your project
**7. USGS Quad: New Castle, CO	Year: 2022	⊠ 7.5'		sponsor to determine which fields

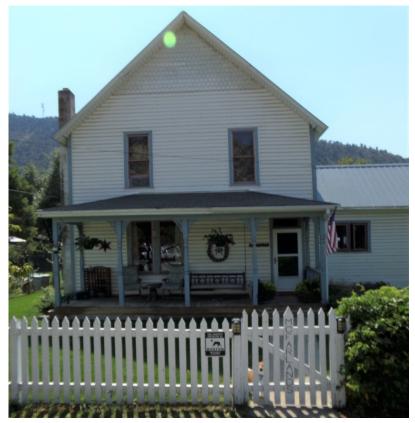
Photo Number: 5GF.5897\_1

Description: Looking at the primary (north) elevation of the building.

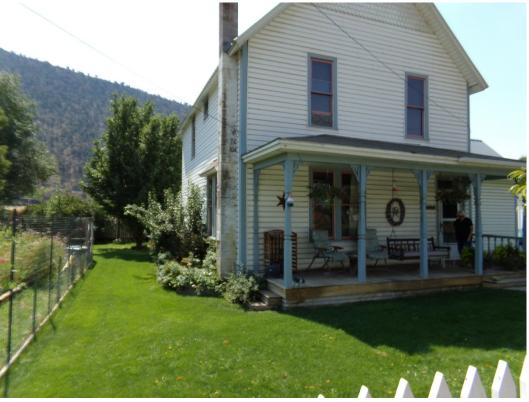
Photo Number: 5GF.5897\_2

Description: Looking at the east and primary (north) elevations of

the building. **Date**: 9/6/2022 **View**: Southwest

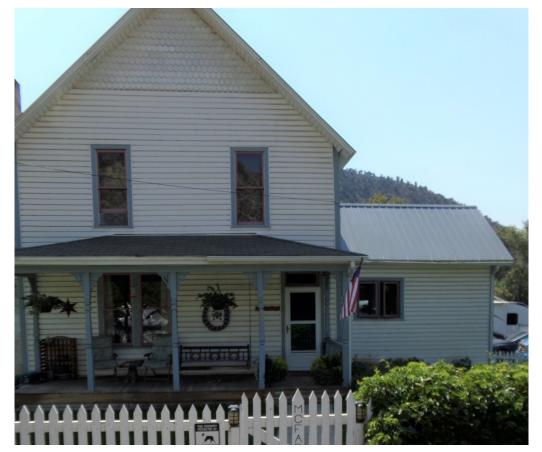
Photo Number: 5GF.5897\_3

**Description:** Looking at the primary (north) elevation of the building.

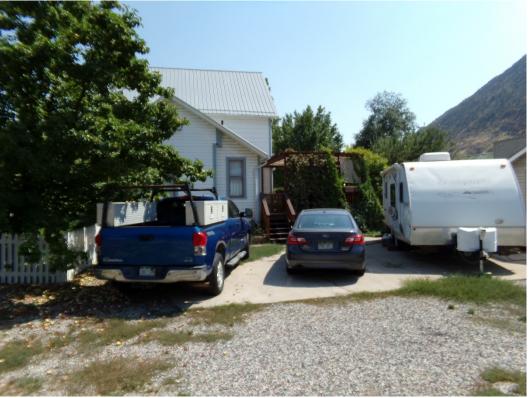
Photo Number: 5GF.5897\_4

Description: Looking at the west elevation of the building. Note that the deck is along the south

elevation. **Date:** 9/6/2022 **View:** East

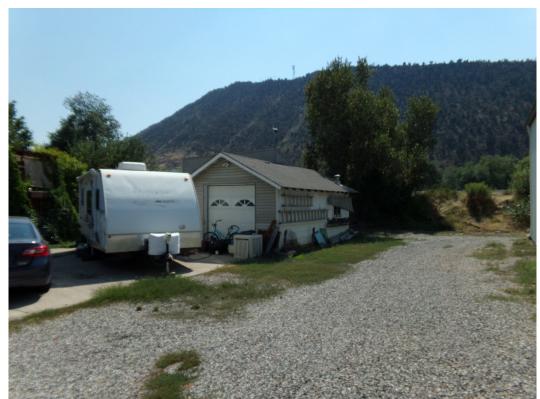
Photo Number: 5GF.5897\_5

A detached garage is located to the southwest of the residence. The approximately 26' by 18' building was constructed circa 1904 as shown through review of a 1904 Sanborn Fire Insurance map. The building features a front gable roof clad in asphalt shingles; exposed rafter tails under the overhanging eaves; an exterior envelope clad in horizontal weatherboard; and a metal flu chimney.

**Description:** Looking at the primary (north) and west elevations of the

detached garage. **Date**: 9/6/2022 **View**: Southeast
