#### COLORADO CULTURAL RESOURCES INVENTORY

# **Historical and Architectural Reconnaissance**

1. Property Name: Reiger Residence					☐ Histo	oric	⊠ Currer	nt 🗆 O	ther:
2. Resource Class	sification:	Building	☐ Structure	e 🗆	Object	□ Si	tes/Lands	cape

3. Ownership:	☐ Federal	☐ State	☐ Loca	ıl 🗆	Non-profit	⊠ Pı	rivate	☐ Unkno	own
LOCATION									
4. Street Address:	732 West Mair	Street							
5. Municipality: N	ew Castle, CO				Vicinity:

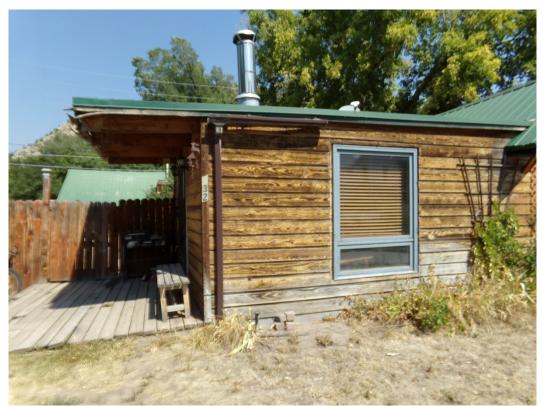
Photo Number: 5GF.5896\_1
Description: Looking at the right side of the primary (west) elevation and the left side of the south elevation.

Date: 9/6/2022 View: Northeast

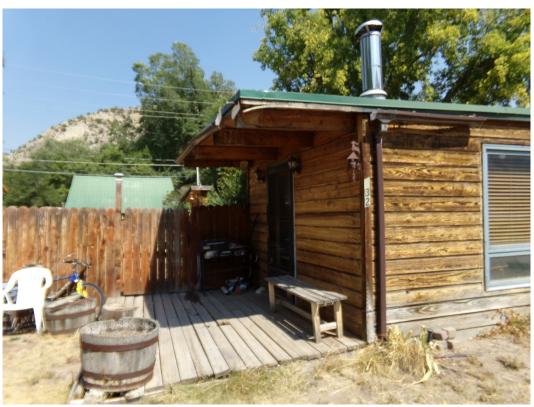
Photo Number: 5GF.5896\_2

Description: Looking at the right side of the primary (west) elevation of the building.

View: Northeast

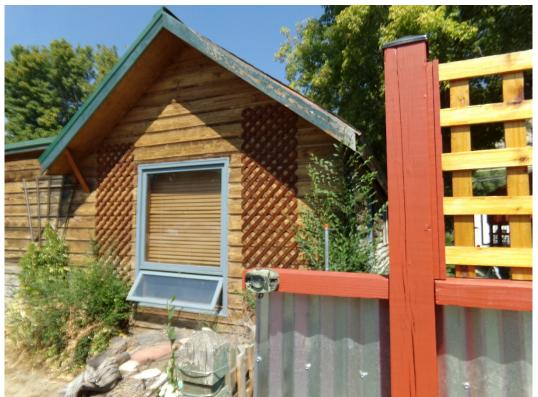
Photo Number: 5GF.5896\_3

Description: Looking at the right side of the south elevation of the building.

Date: 9/6/2022 View: Northwest
