## COLORADO CULTURAL RESOURCES INVENTORY

### Historical and Architectural Reconnaissance

1. Property Name: Castagna-Petersen Residence       Historic     Current     Other:
2. Resource Classification:     Building     Structure     Object     Sites/Landscape
3. Ownership:     Federal     State     Local     Non-profit     Private     Unknown

4. Street Address: 742 West Main Street
5. Municipality: New Castle, CO       Vicinity:
6. County: Garfield
- \*\*7. USGS Quad: New Castle, CO      Year: 2022     7.5'
- \*\*8. Parcel Number: 212331224010
- \*\*9. Parcel Information: Lot(s): 8      Block: 16      Addition: ORIGINAL TWNSTE NEW CASTLE
- \*\*10. Acreage: 0.05       Actual     Estimated
11. PLSS information: Principal Meridian: 6<sup>th</sup>      Township: 5S      Range: 90W  
SE ¼ of SW ¼ of SE ¼ of NW ¼ of section: 31

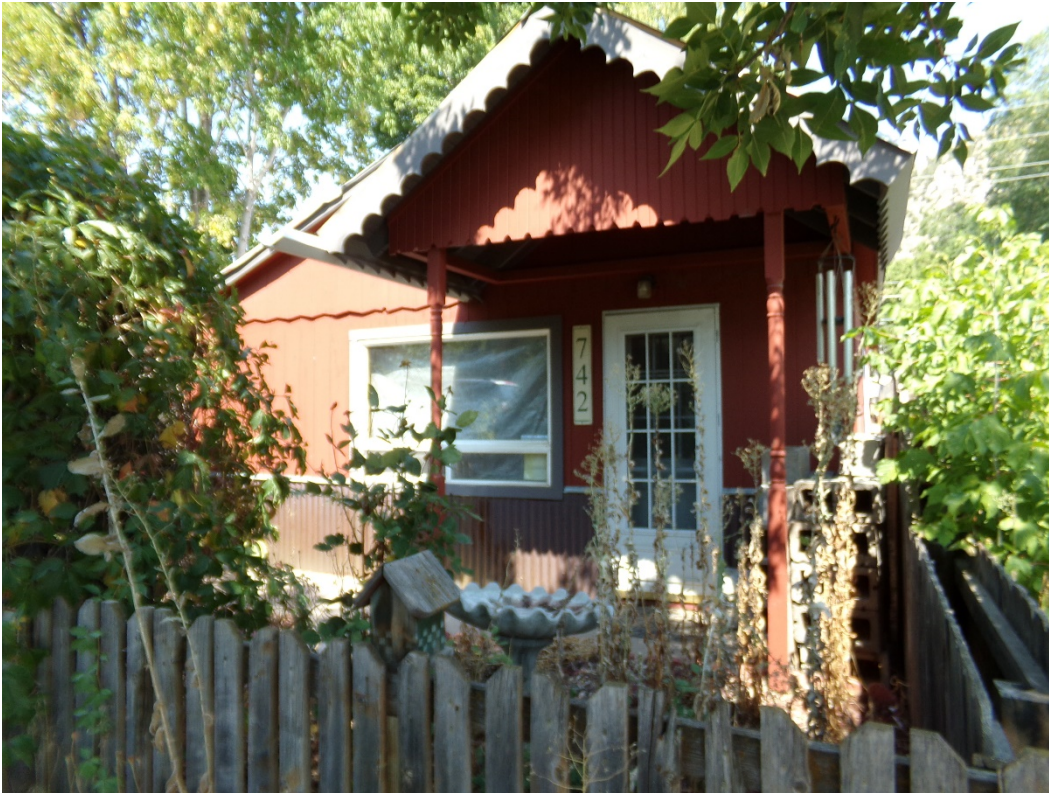
**Photo Number:** 5GF.5895\_1  
**Description:** Looking at the primary (south) elevation of the building.  
**Date:** 9/6/2022  
**View:** Northwest

The one-story, rectangular shaped building was constructed circa 1893 as shown through review of Garfield County Assessor's Office records. The approximately 41' by 20' building is not representative of a particular style of architecture. Overall, the residence is a No Style building. Architectural elements of the building include a stacked stone foundation; a cross gable roof clad in corrugated metal; open and closed overhanging eaves; an exterior envelope clad in weatherboard and corrugated metal siding; scalloped weatherboard in the gable ends; a scalloped fascia; and a partial-length front gable porch along the primary (south) elevation. The typical window consists of a vinyl one-by-one sliding sash. Additional windows throughout the building include picture windows; awning windows; and one-over-one single hung sashes. The main entryway is located on the far-right side of the primary (south) elevation. The main entryway consists of a wood panel door with nine-lites. The door is fronted by a storm door with 12-lites. The main entryway is protected by a front gable overhang that is supported by turned spindle columns. A scalloped fascia can be noticed along the gable.

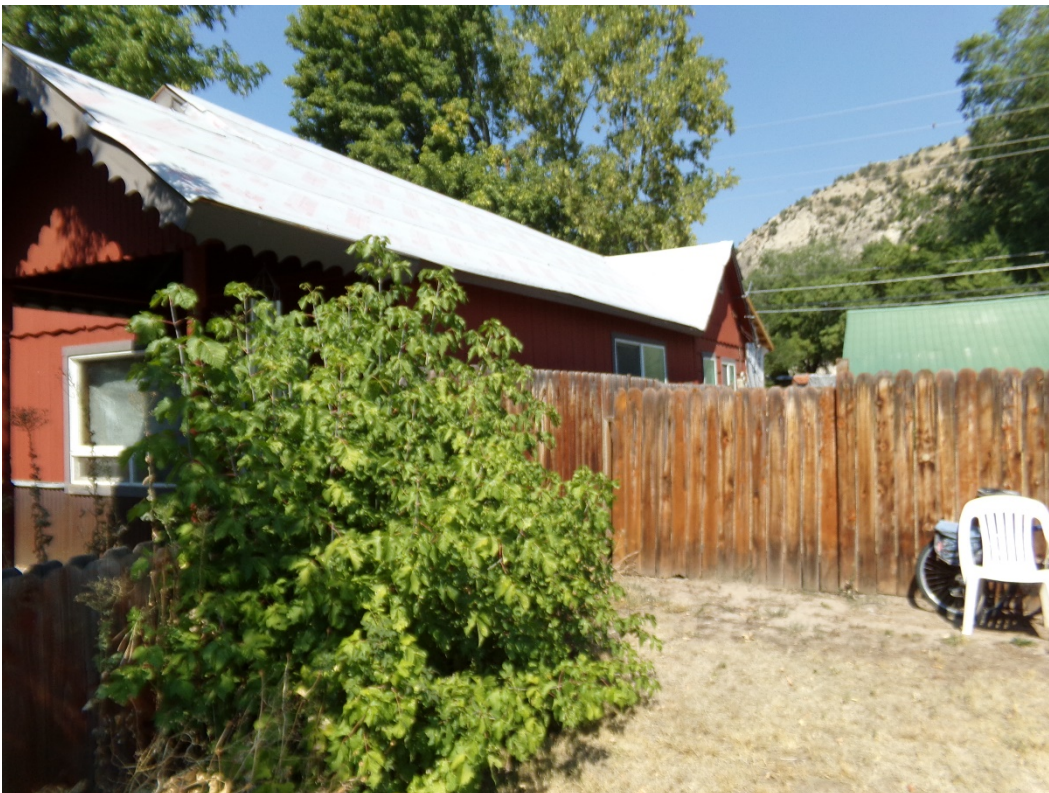
**Photo Number:** 5GF.5895\_2  
**Description:** Looking at the east elevation of the building.  
**Date:** 9/6/2022  
**View:** Northwest

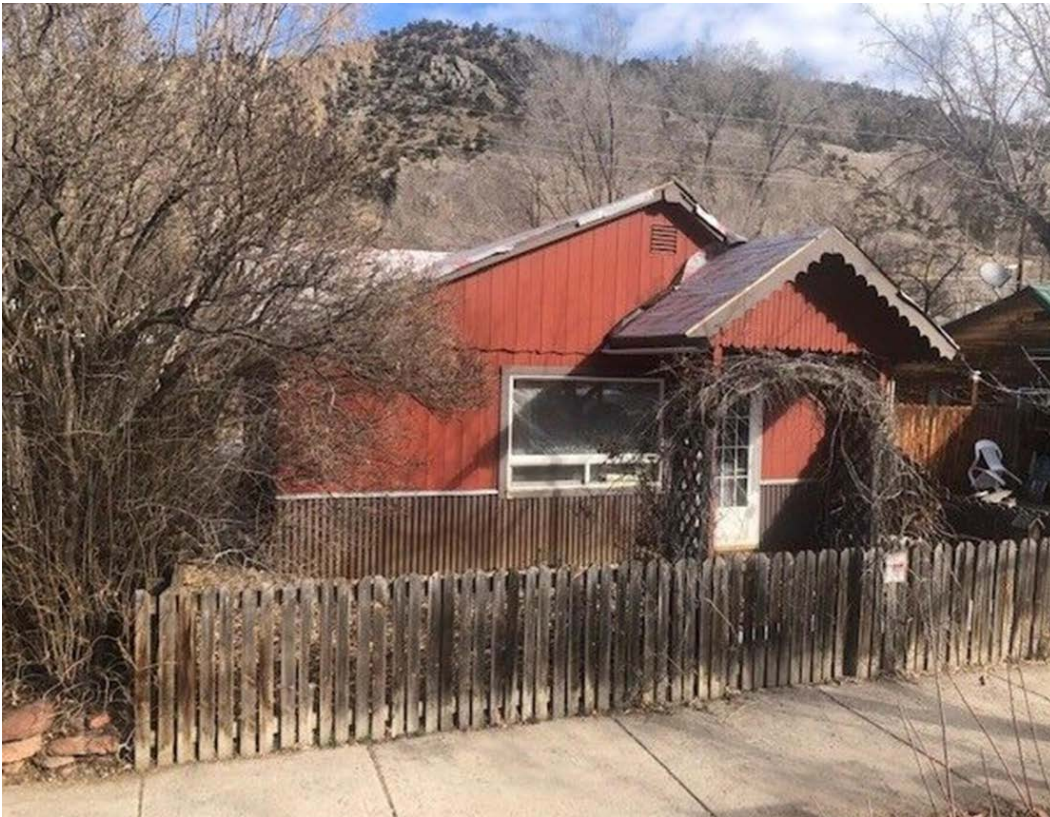
**Reference Photo 1**

**Description:** Looking at the primary (south) elevation of the building.
