# COLORADO CULTURAL RESOURCES INVENTORY

## Historical and Architectural Reconnaissance

1. Property Name: Rittle Residence  Historic  Current  Other:
2. Resource Classification:  Building  Structure  Object  Sites/Landscape
3. Ownership:  Federal  State  Local  Non-profit  Private  Unknown

4. Street Address: 802 West Main Street
5. Municipality: New Castle, CO  Vicinity:
6. County: Garfield
- \*\*7. USGS Quad: New Castle, CO Year: 2022  7.5'
- \*\*8. Parcel Number: 212331200016
- \*\*9. Parcel Information: Lot(s): N/A Block: 16 Addition: N/A
- \*\*10. Acreage: 0.41  Actual  Estimated
11. PLSS information: Principal Meridian: 6<sup>th</sup> Township: 5S Range: 90W  
SW ¼ of SW ¼ of SE ¼ of NW ¼ of section: 31

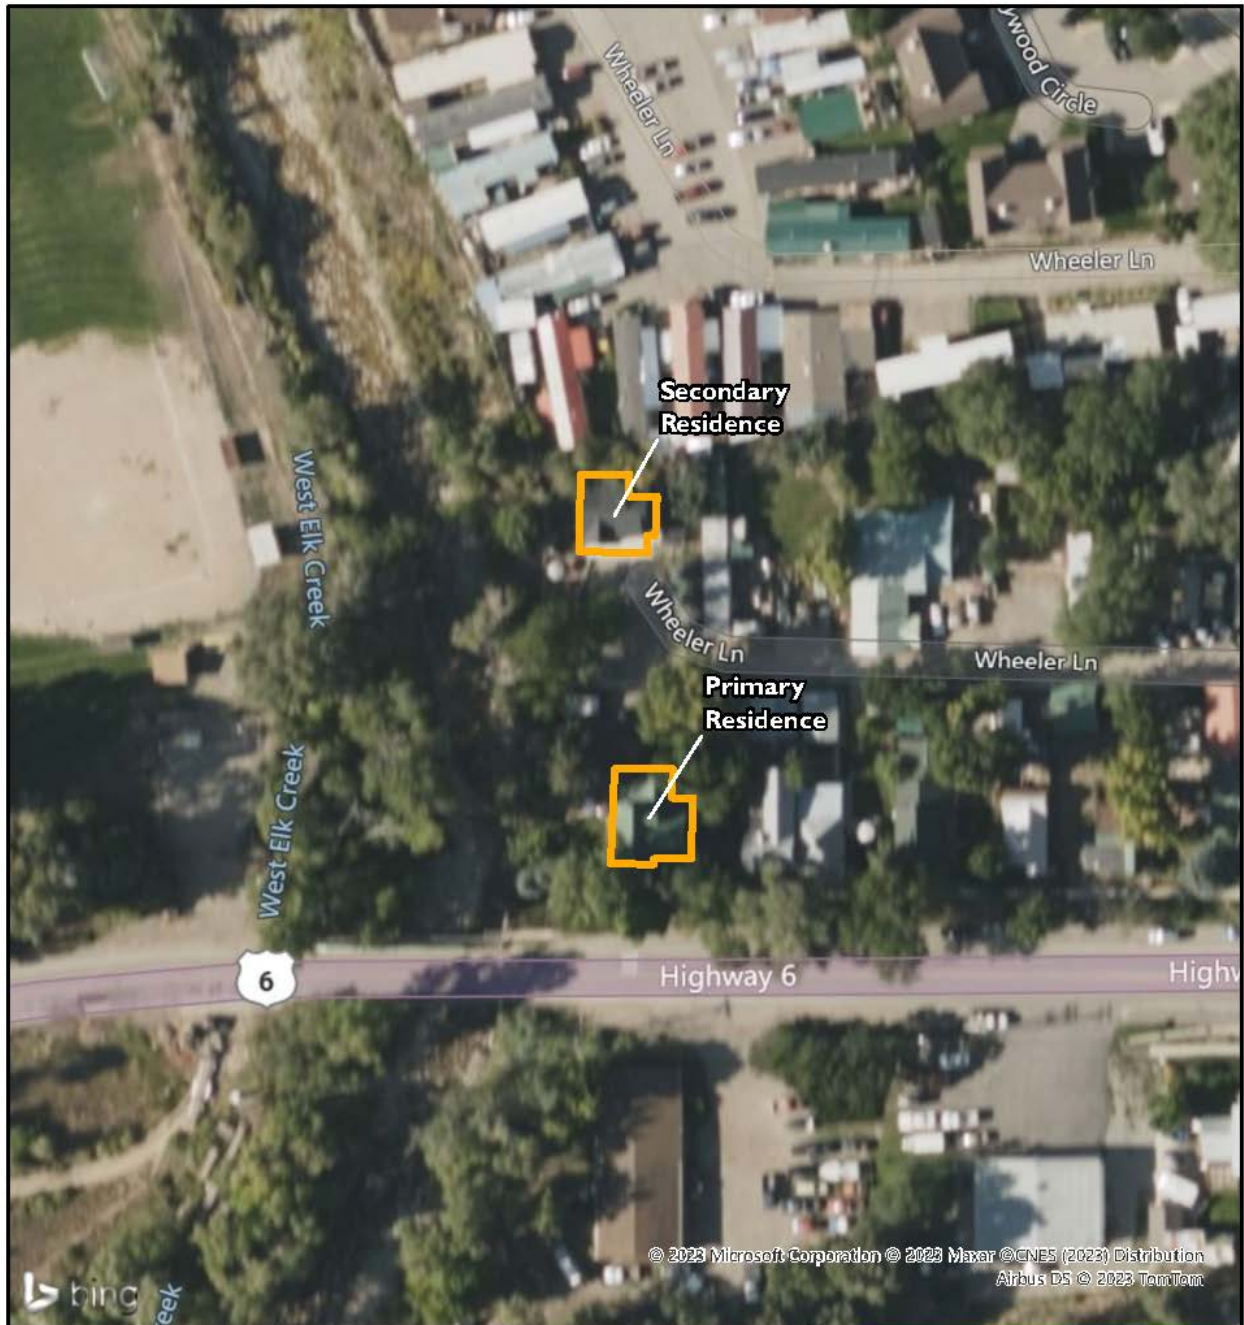
### Sketch Map

Feet     </div>	<p><b>Pinyon</b> Environmental, Inc.</p> <p><b>Sketch Map</b> 802 West Main Street (5GF.5891) New Castle, Colorado Garfield County</p>				
<p>Pinyon Project Number: I 22156.001</p>	<table border="1" style="width: 100%;"> <tr> <td style="width: 50%;">Drawn By: CJB</td> <td style="width: 50%;">Figure: 2</td> </tr> <tr> <td>Reviewed By: CMW</td> <td>Date: 4/10/2023</td> </tr> </table>	Drawn By: CJB	Figure: 2	Reviewed By: CMW	Date: 4/10/2023
Drawn By: CJB	Figure: 2				
Reviewed By: CMW	Date: 4/10/2023

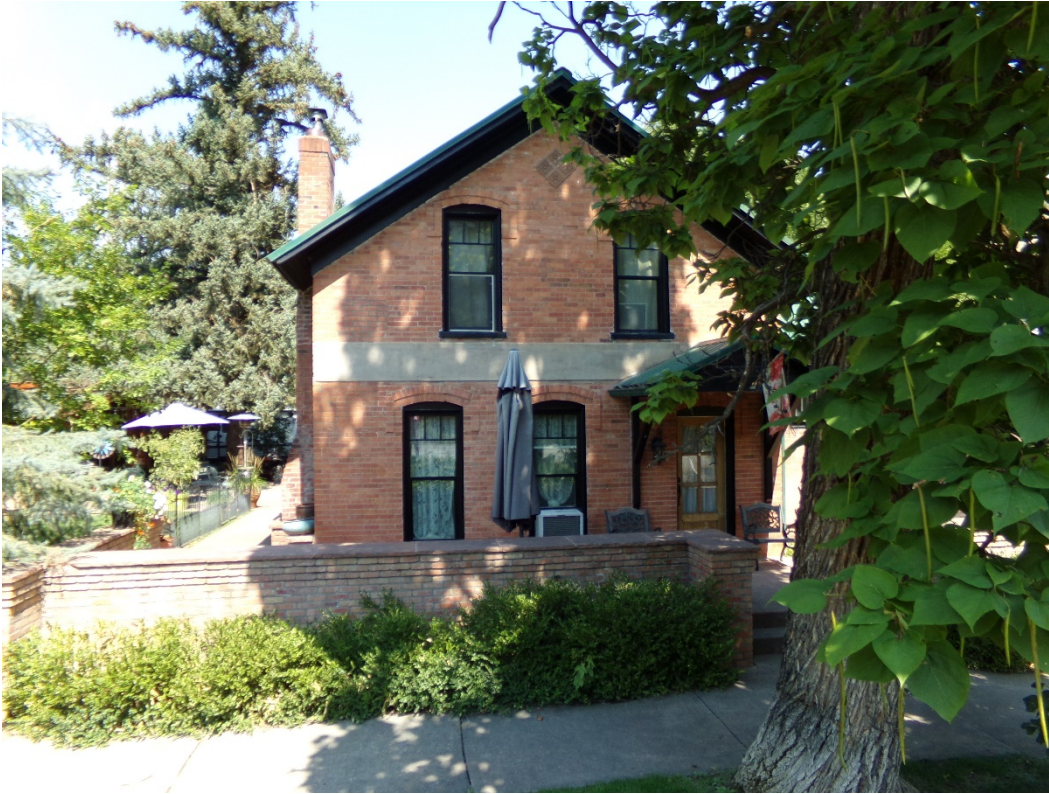
**Photo Number:** 5GF.5891\_1  
**Description:** The primary (south) elevation of the building.  
**Date:** 9/6/2022  
**View:** North

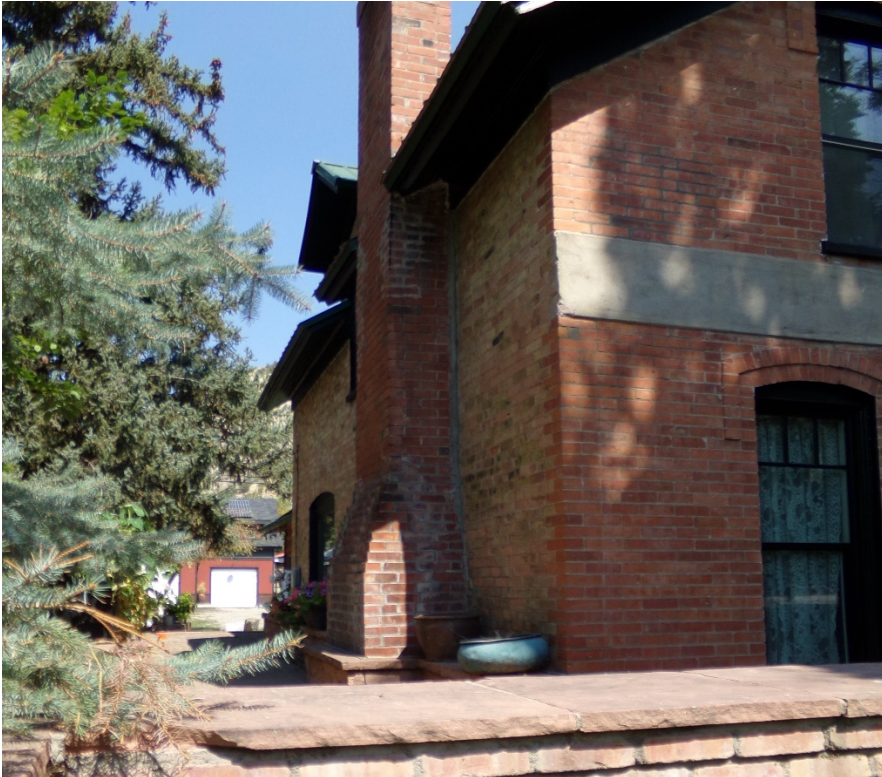
**Photo Number:** 5GF.5891\_2  
**Description:** Looking at the west and primary (south) elevations of the building.  
**Date:** 9/6/2022  
**View:** Northeast

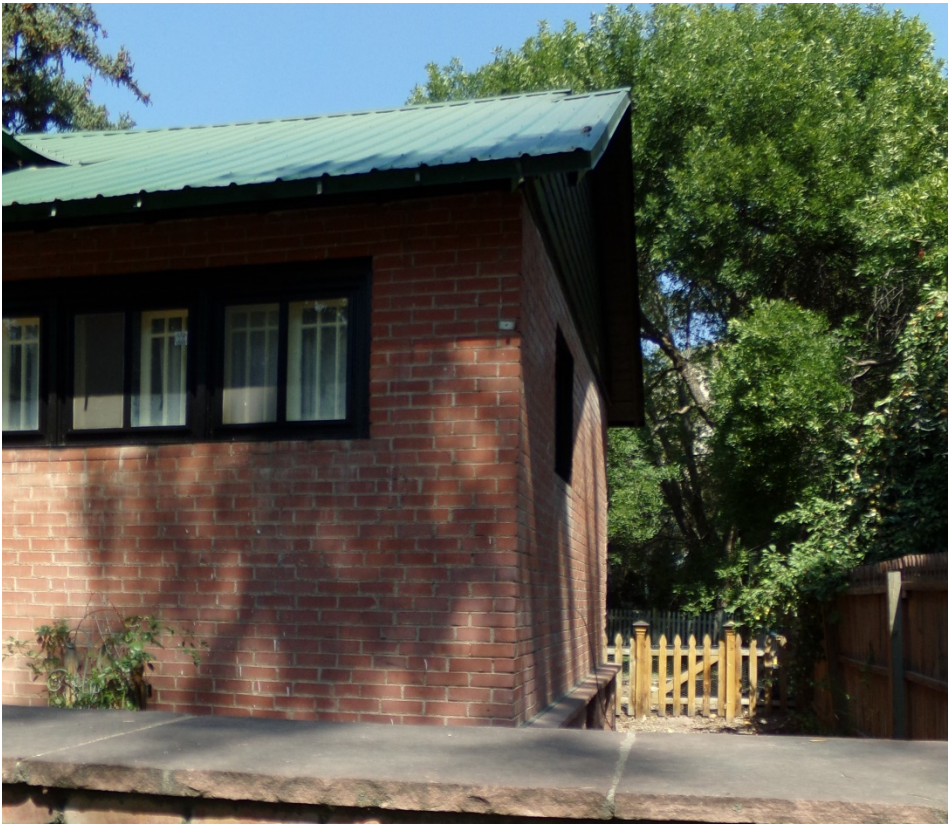
**Photo Number:** 5GF.5891\_3  
**Description:** The far-right side of the primary (south) elevation and east elevation of the building.  
**Date:** 9/6/2022  
**View:** North

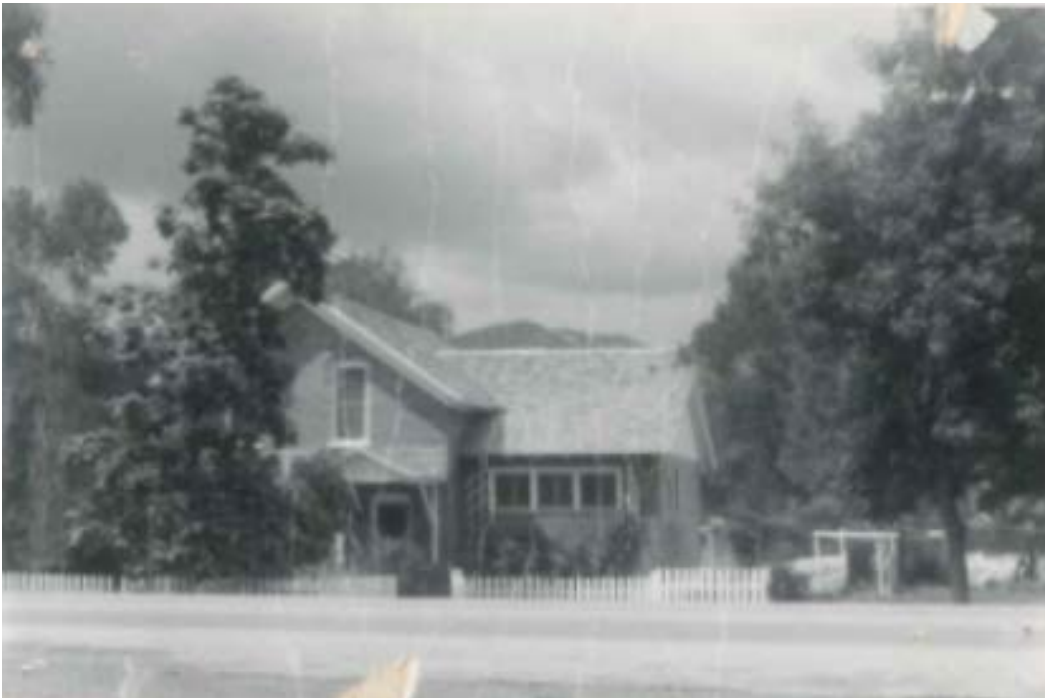
**Reference Photo 1**  
**Description:** Context view of the building from Main Street.  
**Date:** 1974  
**Source:** Garfield County Assessor's Office

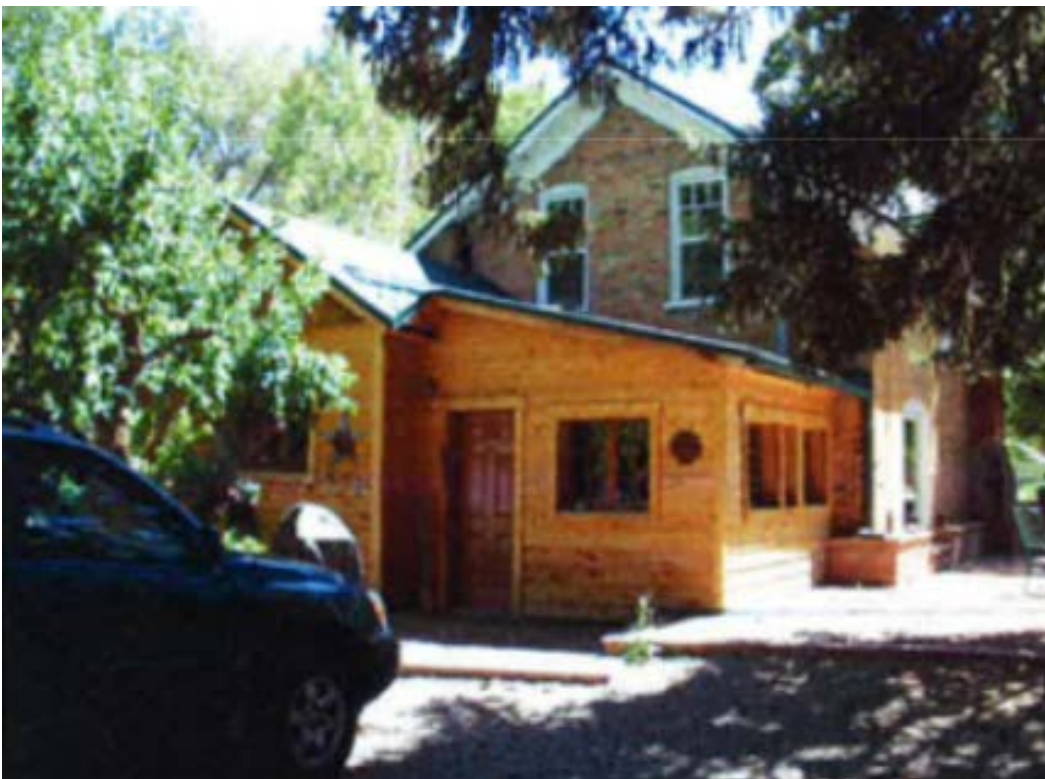
**Reference Photo 3**

**Description:** Looking at the north and west elevations of the building.

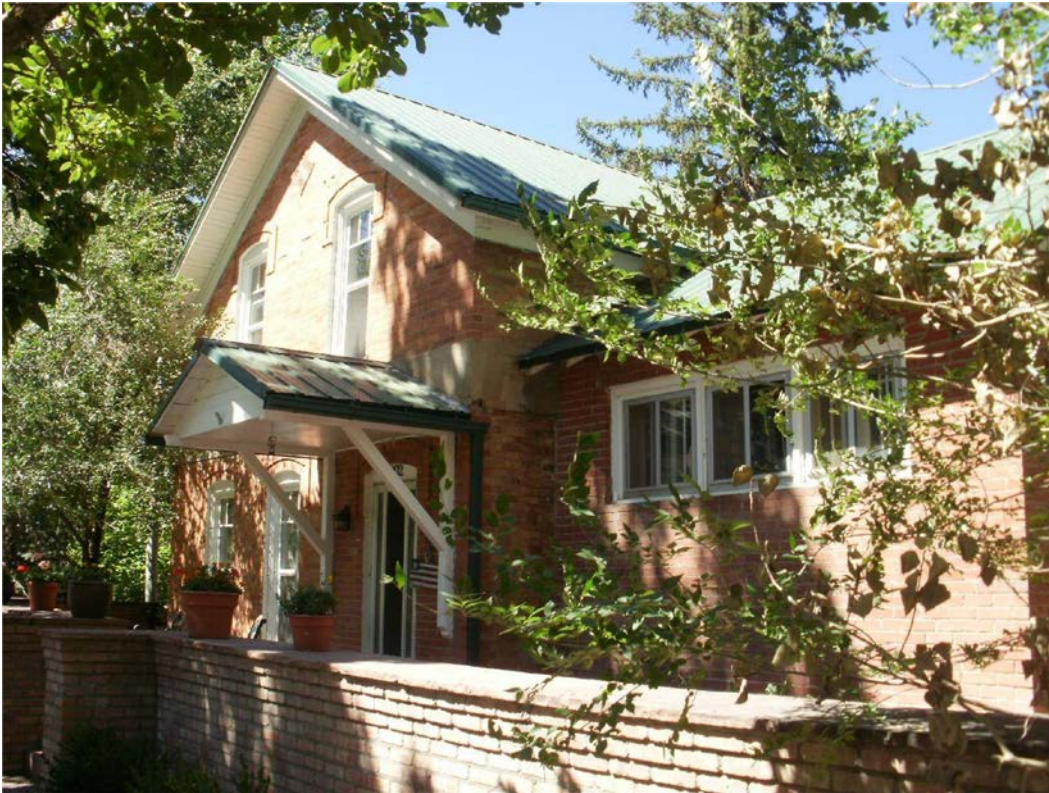
**Reference Photo 4**

**Description:** Looking at the primary (south) elevation of the building.

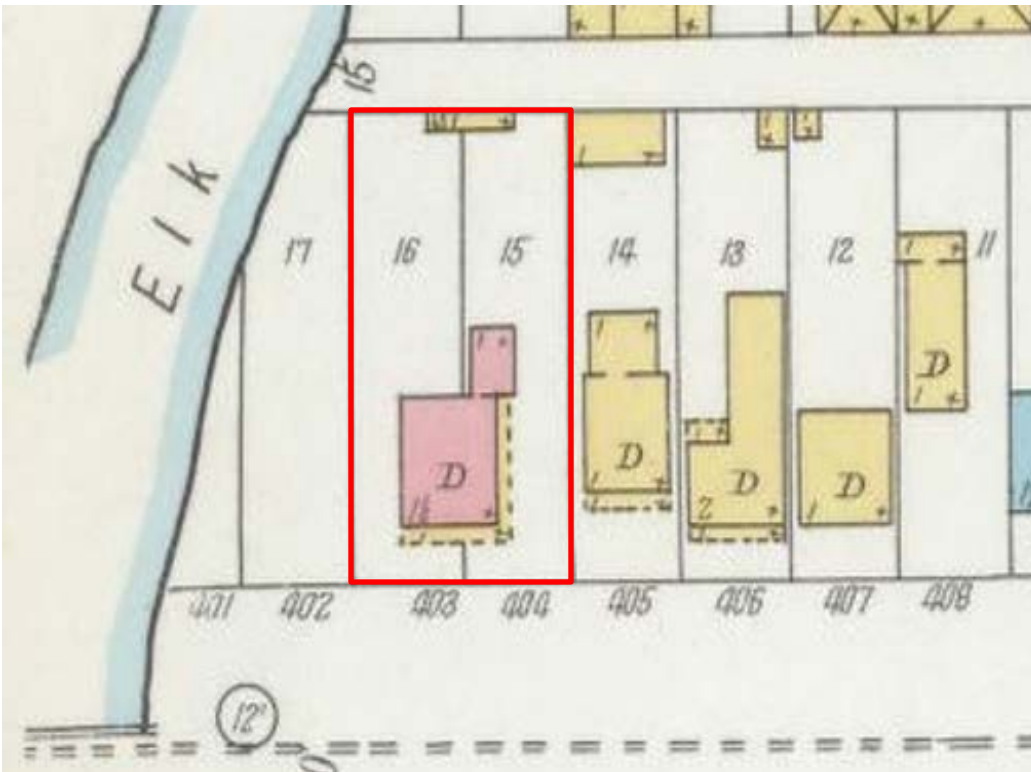
**Reference Photo 5**

*Sanborn Fire Insurance* maps between 1899 and 1904 demonstrate that a full-length porch was located along the primary (south) and east elevations of the residence. The building also consisted of a smaller layout at the time. Garfield County Assessor’s Office records indicate that an addition along the north elevation was constructed in 1914. Additional records reveal that another addition was constructed along the east elevation was constructed in 1942 and the roof was replaced in 1971. A historical image of the building in 1974 demonstrates that the full-length porch along the primary (south) elevation was replaced by a partial length front gable porch. By 2010, the exposed rafter tails under the eaves were closed.

**Description:** 1899 Sanborn Fire Insurance map illustrating the residence. The property is outlined in red.

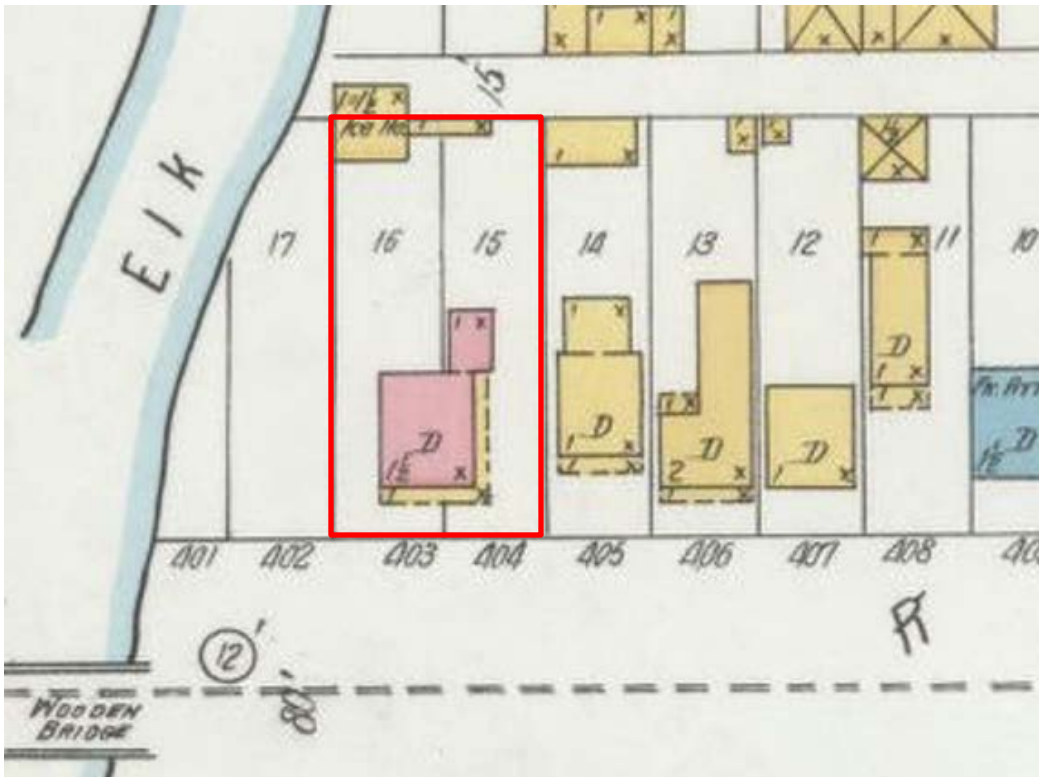
**Reference Photo 6**

**Description:** 1904 Sanborn Fire Insurance map of the resource. The property is outlined in red.
