New Castle - Reconnaissance Survey

Town of New Castle, Colorado

Town of New Castle
Historic Preservation Commission
450 West Main Street
New Castle, Colorado 81467

Pinyon Project No.:

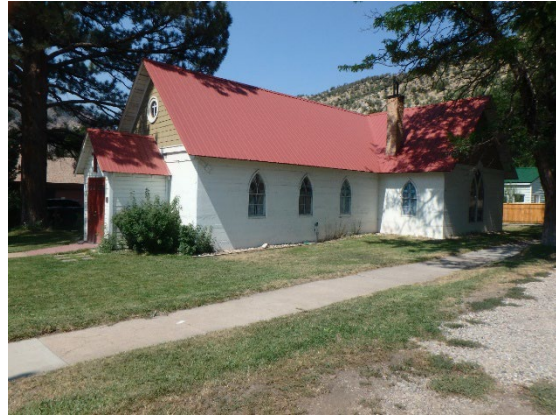
Gothic Revival

Common characteristics include:

- Gothic (pointed) arch windows
- Steep pitched gable roof
- Masonry construction
- Limited or wide overhanging eaves
- Exposed rafter tails
- Open rake roof-wall junctions

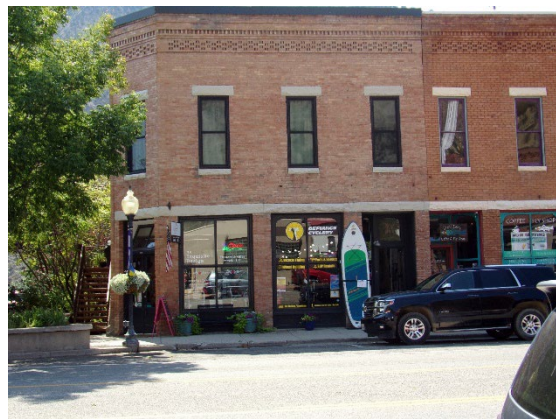
Nineteenth Century Commercial

Common characteristics include:

- Multi-story
- Decorative frieze
- Door transom
- May have corbelled cornice
- Decorative brickwork
- Stone or brick belt course
- Parapet
- Usually single or double entryway; multiple entryways present with corner building

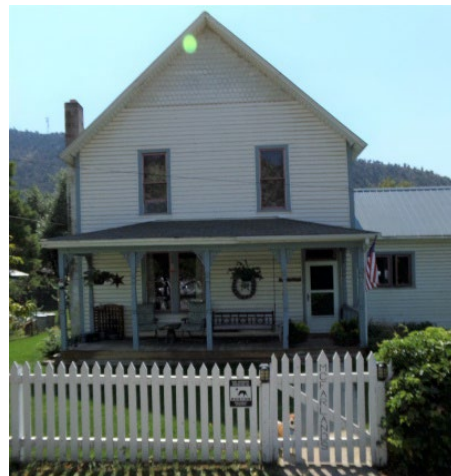
Edwardian

Common characteristics include:

- Multi-story
- Partial or full-length porch
- Multi-gable roof
- Asymmetrical
- Typically features some Queen Anne style elements including decorative fish scale shingles and/or turned spindle work

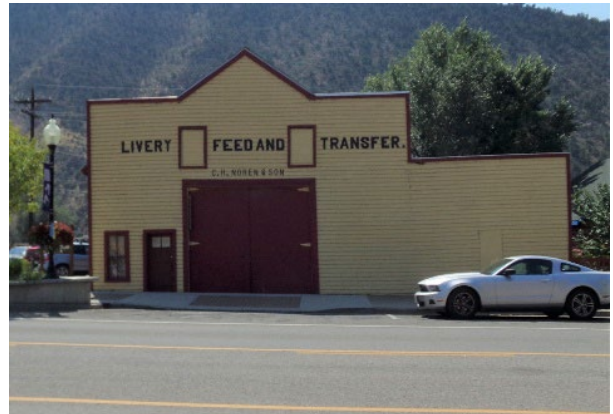
False Front Commercial

Common characteristics include:

- Multi-story
- Parapet that extends above the roof and sides of a building
- Early examples constructed of wood; later examples utilized brick masonry
- Decorative cornice
- Typically, a front gable roof behind false front

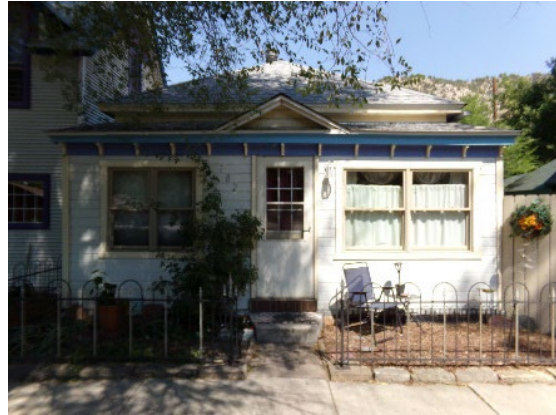
Hipped Roof Box

Common characteristics include:

- One-story
- Square plan
- Hipped roof
- Overhanging eaves with exposed rafter tails
- Decorative woodwork
- Typically utilized a clapboard exterior envelope

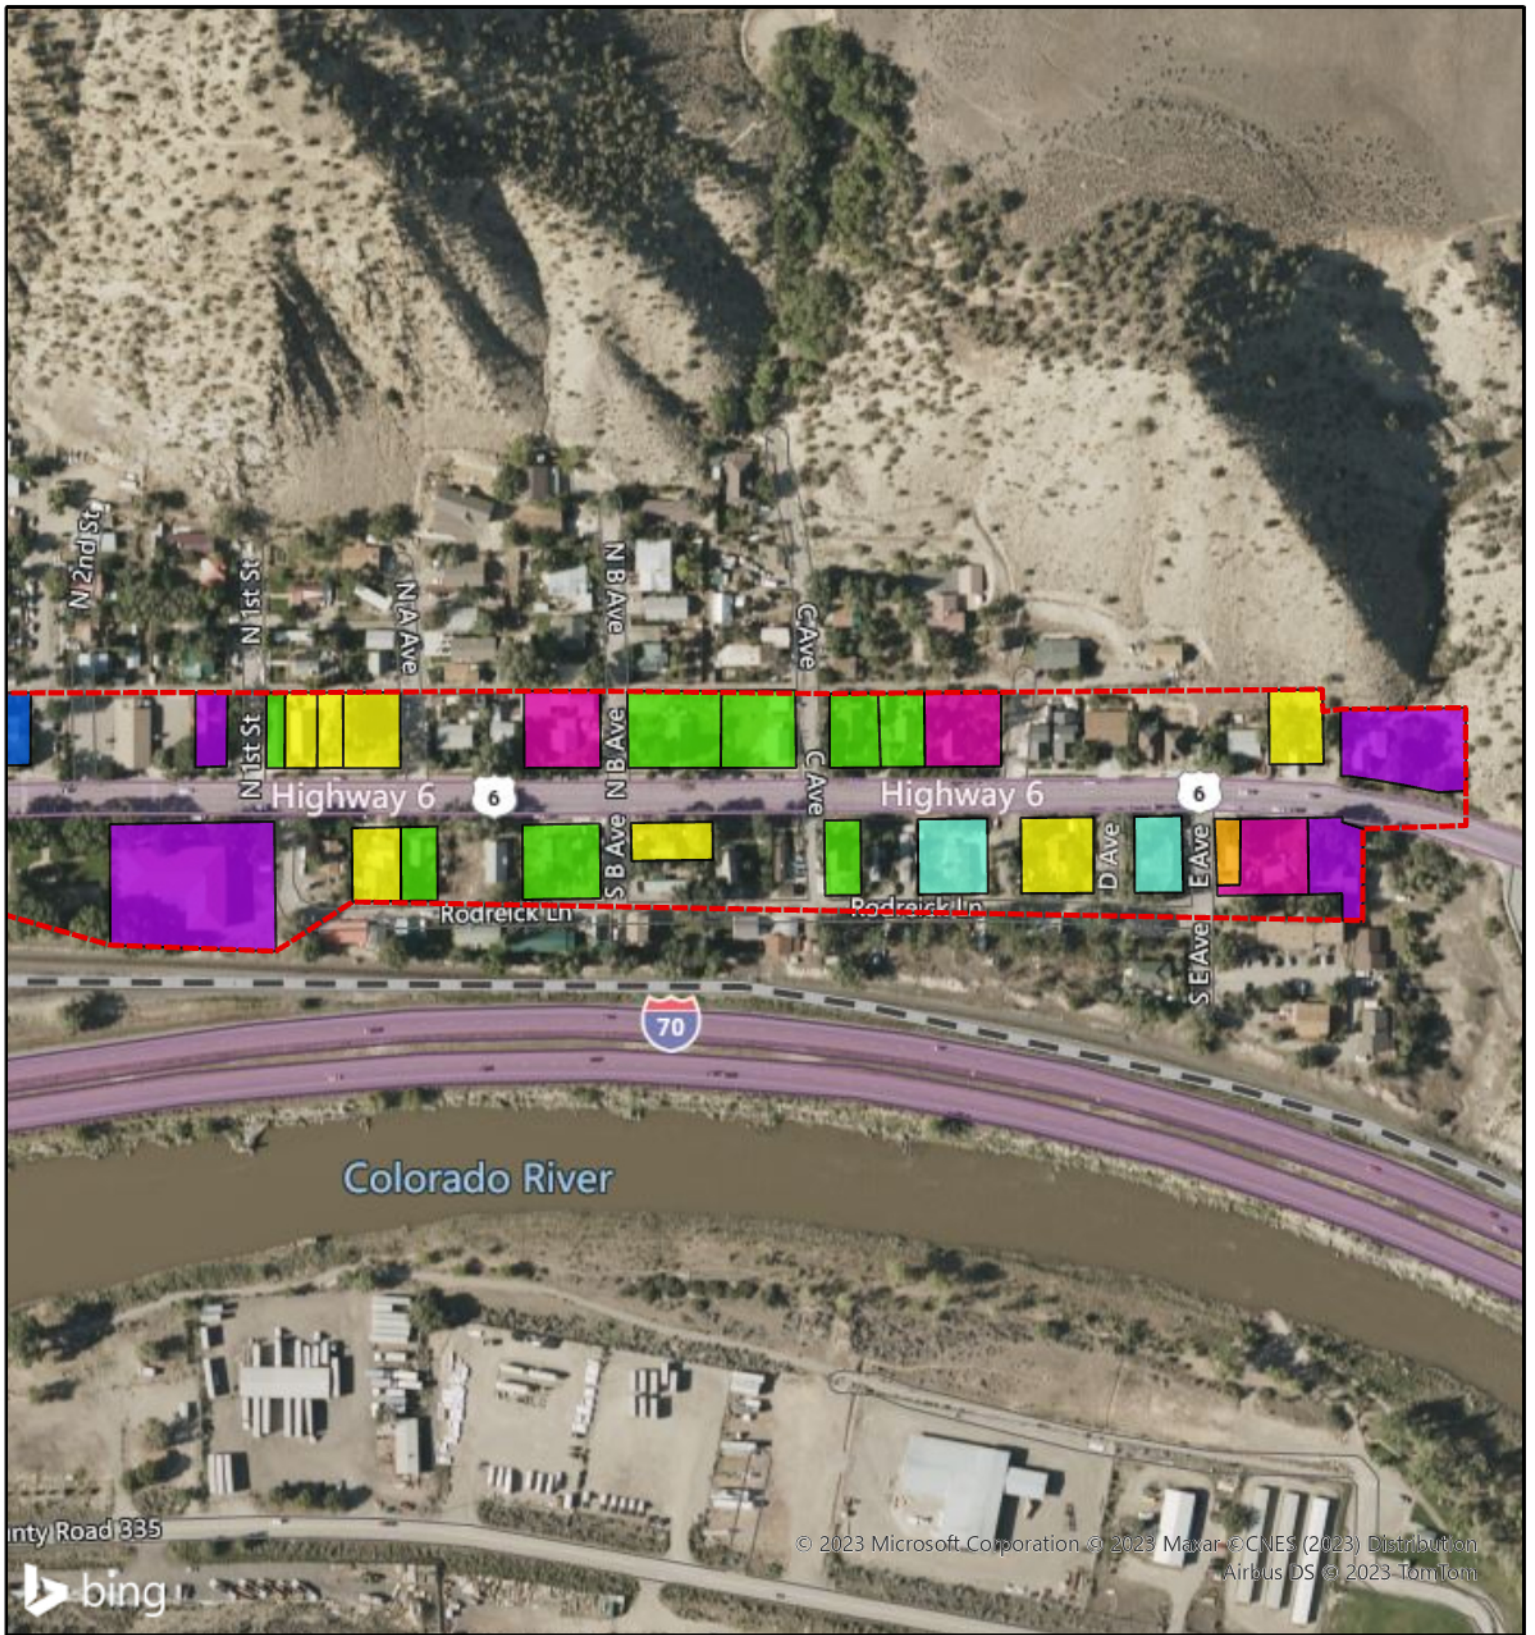
Figure: 1

Project Map
Reconnaissance Survey
Study Area
New Castle, Colorado

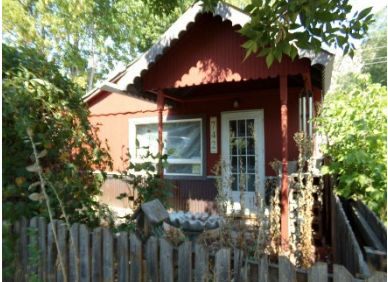
742 West Main Street (5GF.5895)	1893	No Style; One-story; Vertical weatherboard	Low	Yes

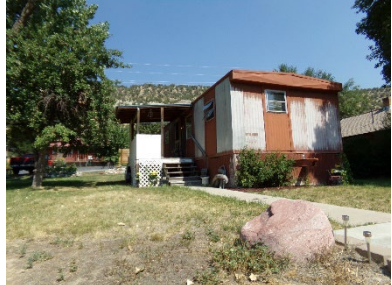
562 West Main Street (5GF.5904)	1974	Prefabricated mobile trailer; One-story; Corrugated metal	N/A (outside period of significance)	No

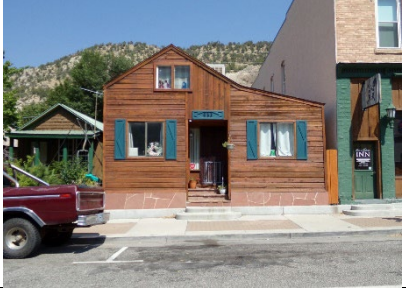
Address/Site Number	Year built	Notes	Individual Assessment (high, medium, low)	Contributes to potential Historic District	Photographs
532 West Main Street (5GF.5908)	1893	No Style; One-story; Horizontal and vertical weatherboard	Low	Yes

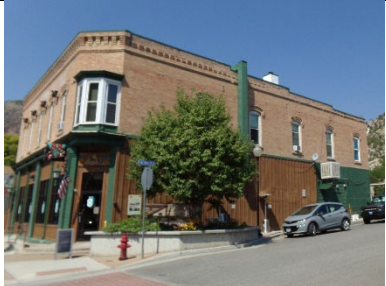
502 West Main Street (5GF.1166)	Ca. 1893	Nineteenth Century Commercial; Two-story; Brick masonry Field - Not Eligible (1996); Local landmark	Medium	Yes

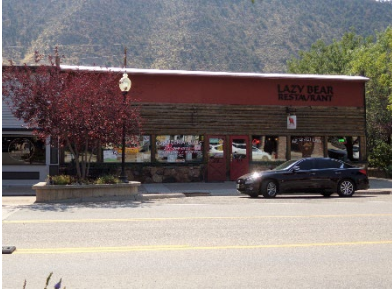
Address/Site Number	Year built	Notes	Individual Assessment (high, medium, low)	Contributes to potential Historic District	Photographs
275 West Main Street (5GF.2374)	Ca. 1888	Nineteenth Century Commercial; One-story; Stucco (Formally 299 West Main Street) Field - Not Eligible (1996); Local landmark	Low	Yes

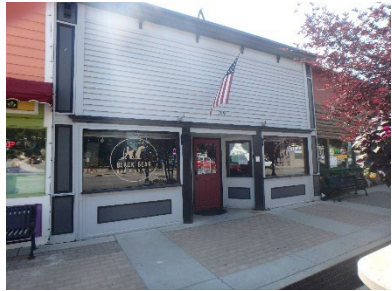
219 West Main Street (5GF.2372)	1892	Nineteenth Century Commercial; One-story; Brick masonry (Formally 239 West Main Street) Field - Not Eligible (1996); Local landmark	Low	Yes

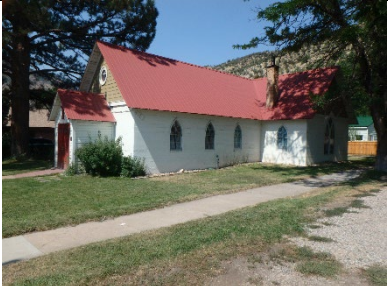
100 East Main Street (5GF.2368)	1909	Gothic Revival; One-story; Concrete Field - Eligible (1996); Local landmark	High	Yes

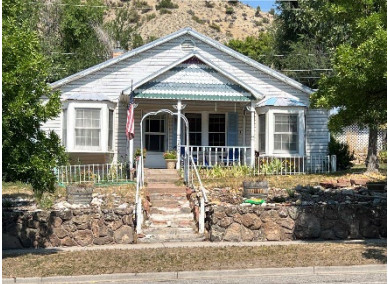
Address/Site Number	Year built	Notes	Individual Assessment (high, medium, low)	Contributes to potential Historic District	Photographs
296 East Main Street (5GF.5929)	1893	No Style; One-story; Vinyl siding	Low	Yes

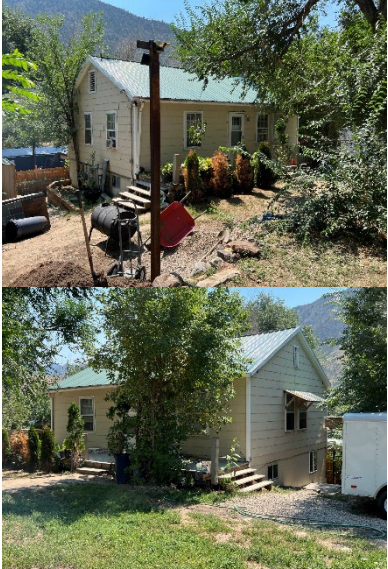
311 East Main Street (5GF.5931)	1950	Minimal Traditional; One-story; Asbestos siding	Medium	Yes

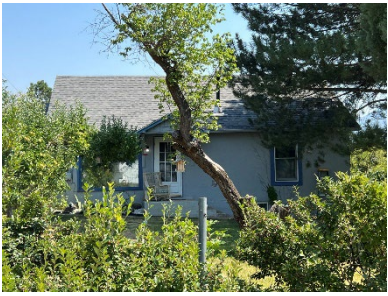
Address/Site Number	Year built	Notes	Individual Assessment (high, medium, low)	Contributes to potential Historic District	Photographs
316 East Main Street (5GF.5932)	1938	Minimal Traditional; One-story; Stucco	Medium	Yes

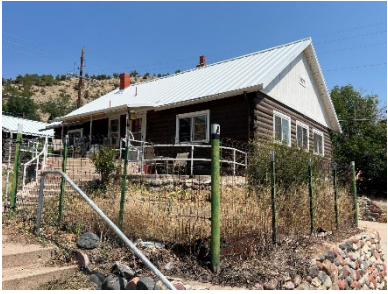
396 East Main Street (5GF.5933)	1940	Rustic; One-story; Log	Medium	Yes

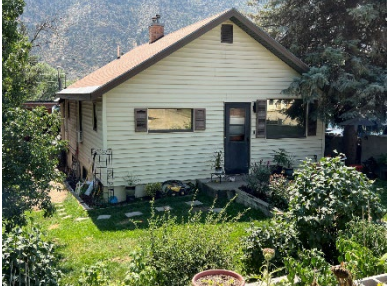
403 East Main Street (5GF.5934)	1936	No Style; One-story; Vinyl siding	Low	Yes

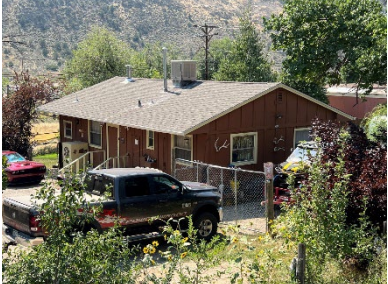
407 East Main Street (5GF.5936)	1970	No Style; One-story; Board and batten	Low	Yes

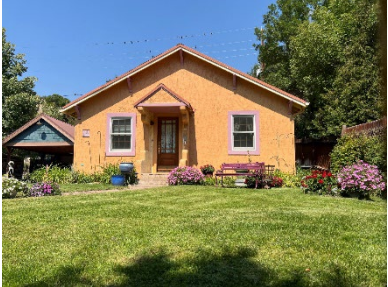
Address/Site Number	Year built	Notes	Individual Assessment (high, medium, low)	Contributes to potential Historic District	Photographs
436 East Main Street (5GF.5937)	1936	Vernacular Bungalow One-story; Stucco	Medium	Yes

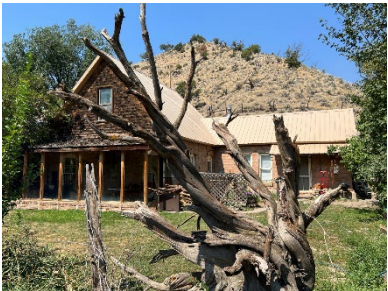
Address/Site Number	Year built	Notes	Individual Assessment (high, medium, low)	Contributes to potential Historic District	Photographs
696 East Main Street (5GF.5943)	1903	Shingle/Gabled Ell; 1.5-story; Shingle and brick masonry	Medium	Yes
