COLORADO CULTURAL RESOURCES INVENTORY

Historical and Architectural Reconnaissance

1. Property Name: Daniel Difiore Residence Historic Current Other:
2. Resource Classification: Building Structure Object Sites/Landscape
3. Ownership: Federal State Local Non-profit Private Unknown

4. Street Address: 641 East Main Street
5. Municipality: New Castle, CO Vicinity:
6. County: Garfield
- **7. USGS Quad: New Castle, CO Year: 2022 7.5'
- **8. Parcel Number: 212331401002
- **9. Parcel Information: Lot(s): 3-5 Block: L Addition: Spencer's 2nd
- **10. Acreage: 0.22 Actual Estimated
11. PLSS information: Principal Meridian: 6th Township: 5S Range: 90W
NE ¼ of NE ¼ of NE ¼ of SE ¼ of section:

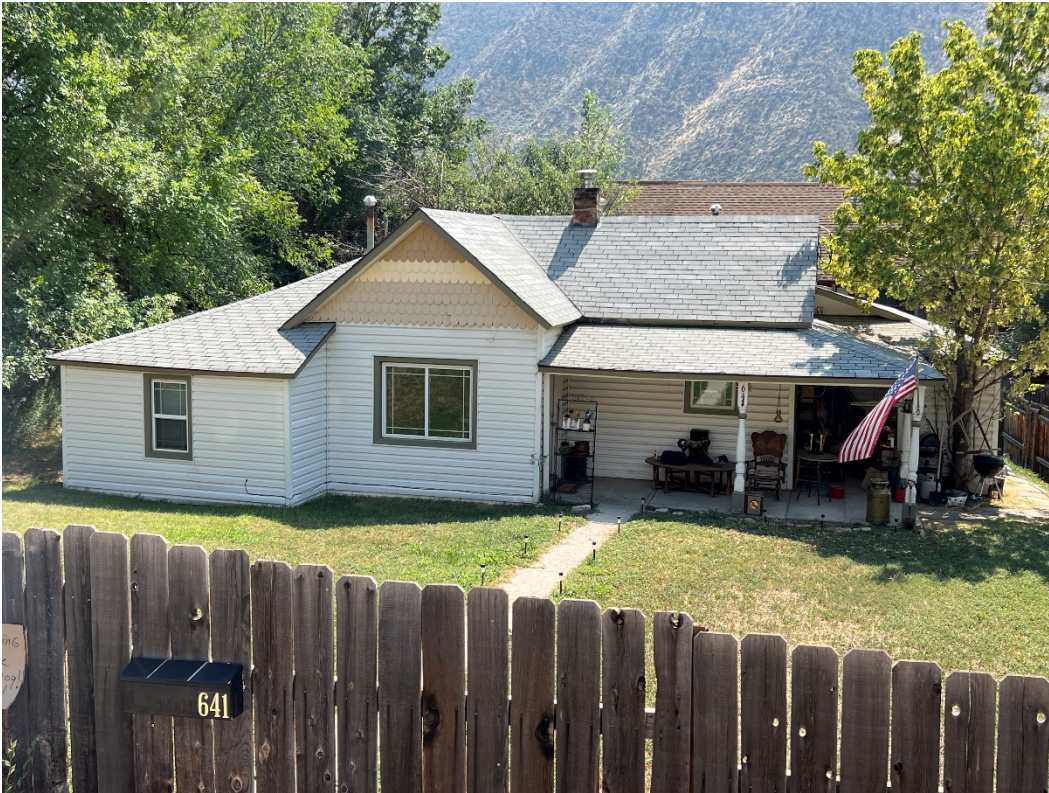
Photo Number: 5GF.5940_1
Description: Looking at the primary (north) elevation of the building.
Date: 9/6/2022
View: Southeast

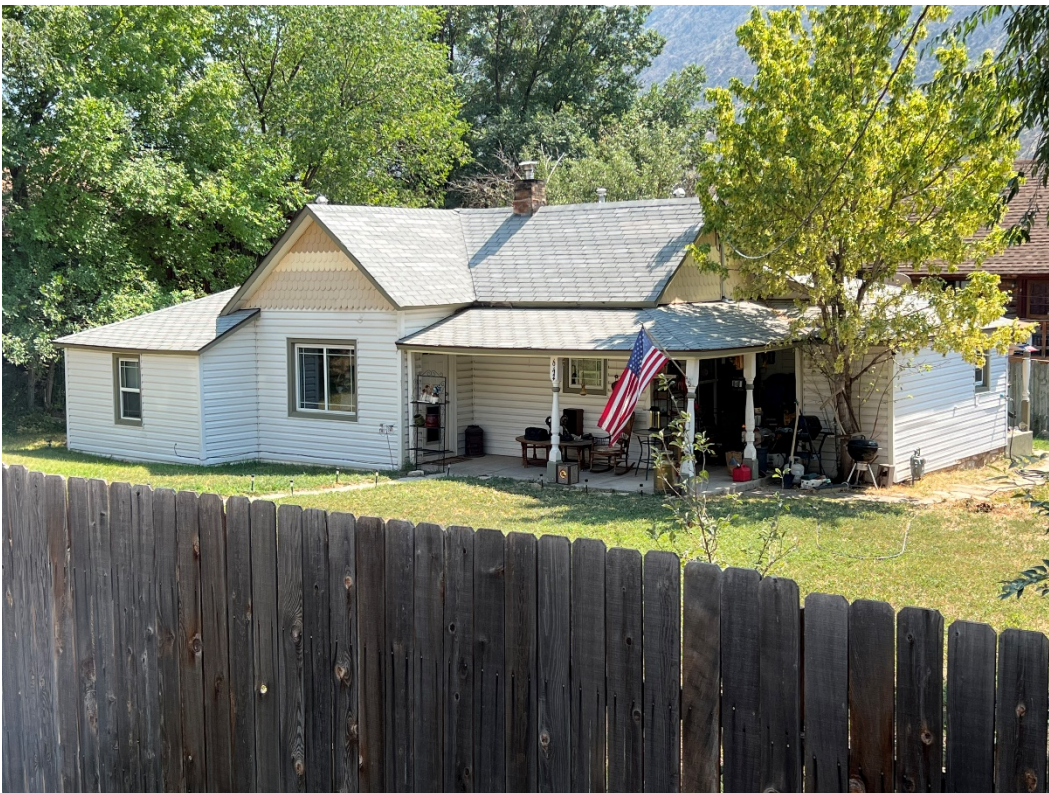
Photo Number: 5GF.5940_2
Description: Looking at the primary (north) and west elevations of the building.
Date: 9/6/2022
View: Southeast

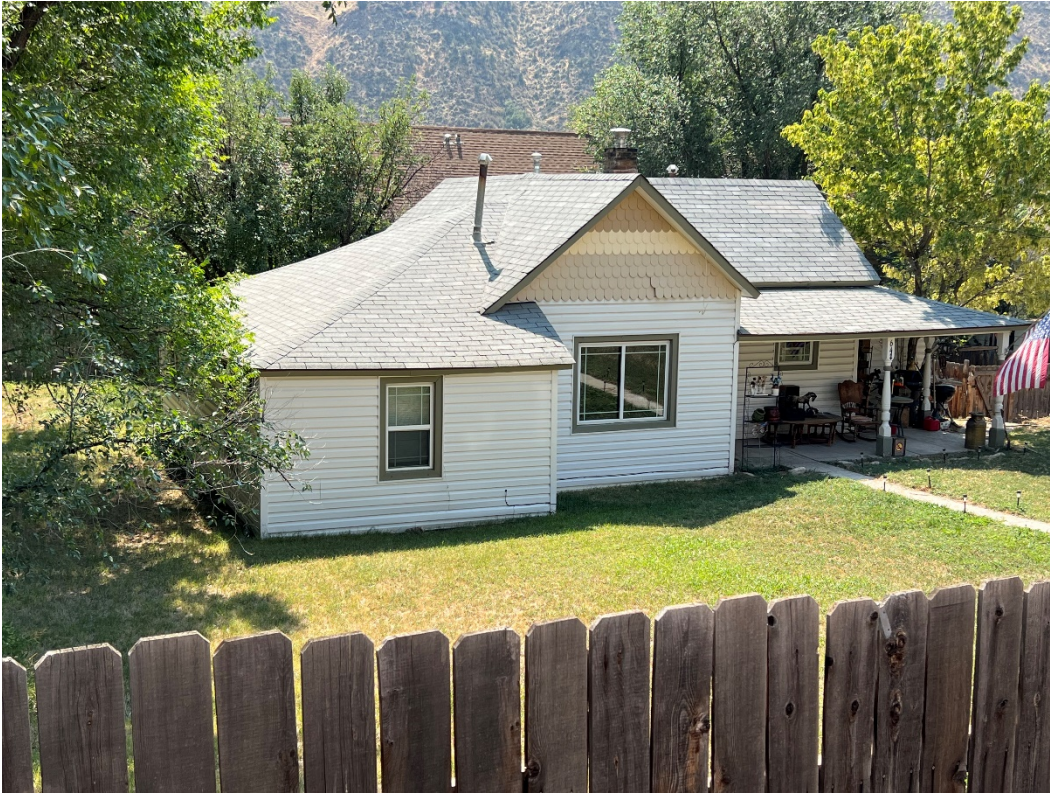
Photo Number: 5GF.5940_3

Description: Looking at the east and primary (north) elevations of the building.
